GEOLOGICAL ENGINEERING FOR HAZARD ASSESSMENT OF PAD AWI-14, SALAK FIELD, WEST JAVA, INDONESIA

Keywords: Salak, Awi-14, geothermal, geohazard, landslide 2010, geotechnical analysis, geological engineering, construction

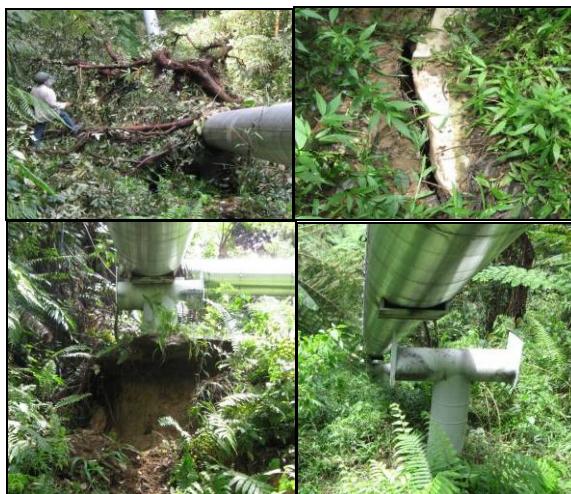
On November 2010, landslide was identified at between brine lines AWI 2 to AWI 14. There are some cases to geotechnical issue found from preliminary observation such as identified landslide near pipe support where three trees fell down and shifted brine pipe line, other landslide observed along pipeline 40 m, width 24 m and subsidence 1.5 m depth, other landslide indication also discovered i.e. pipe line hanging, pipe support moved and tilted (*Kristianto, et all 2010*). The brief recommendation at that time was covered landslide area with tarpaulin/ terram to stop water infiltration on unconsolidated soil surface, protected soil dirt spill to the Cibeureum River and avoided further slope erosion.

Figure 2. Fallen tree and pipe movement on Awi-14 Awi-2 brine pipeline

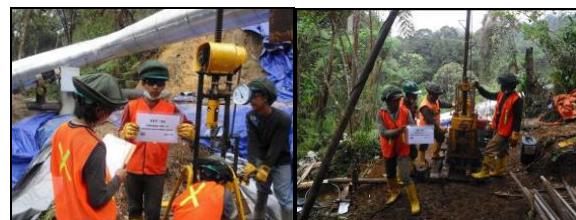
The CPT cone test has been carried out at 9 points, utilizing DCPT device of 2.5 tons capacity in accordance with ASTM D3441-75T. The cone resistance value and local friction or friction sleeve value has been observed at every 20 cm depth interval. The penetration speed is maintained at approximately 2 cm/sec. Those tests have been performed to reach cone resistances value > 160 Kg/cm².

Figure 4. Soil investigation activity Aw-14

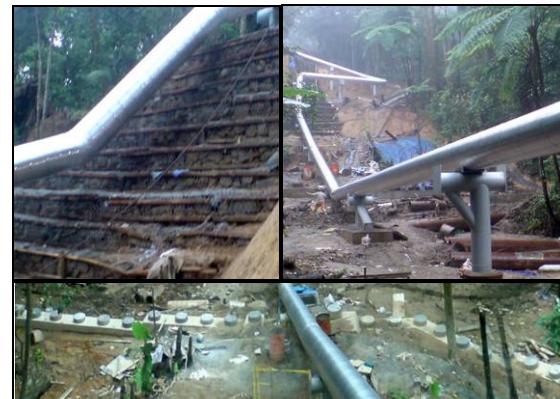
Figure 9. Implementation of the engineering construction Soldier pile as permanent landslide restoration in 2011 - 2012

With combination and comparison four stages of analysis above, the best design for reinforcement program was installation of soldier-pile with 18 meter of length, from those analyses it is indicated that the soldier pile will located below failure area and possibly could secured the area. In the end of 2011, construction of sheet pile and the drainage improvement were done and succeed to stabilize the area, support Awi-14 as injection well area.
