SOIL STABILIZATION USING HORIZONTAL DEEP DRAINAGE AT AWI-14 BRINE LINE PIPE AND WELL PAD, STAR ENERGY GEOTHERMAL SALAK FIELD, WEST JAVA, INDONESIA

Adi Gunawan TP¹, Satrio Wicaksono²

¹Star Energy Geothermal Salak, Sukabumi, Indonesia

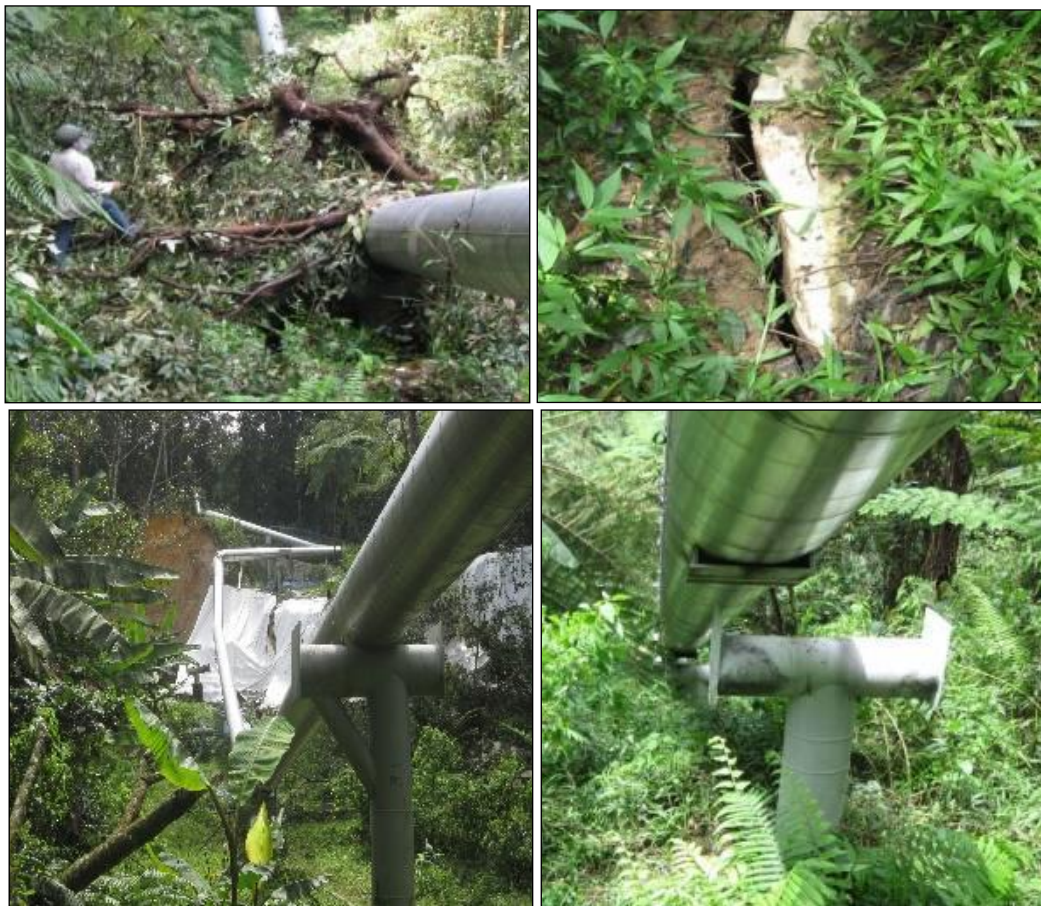
On November 2010, landslide was identified at between brine lines Awi-2 to Awi-14 (Figure 2). There are some cases to geotechnical issue found from preliminary observation such as identified landslide near pipe support where three trees fell down and shifted brine pipe line, other landslide observed along pipeline 40 m, width 24 m and subsidence 3 m depth, other landslide indication also discovered i.e. brine line pipe hanging, pipe support moved and tilted (Gunawan, Adi, et.al, April 2011). The brief recommendation at that time was covered landslide area with tarpaulin/ terram to stop water infiltration on unconsolidated soil surface, protected soil dirt spill to the Cibeureum River and avoided further slope erosion (Salak Operation, 2010 – 2011).

Figure 2. Fallen tree and pipe movement on Awi-14 brine line pipe

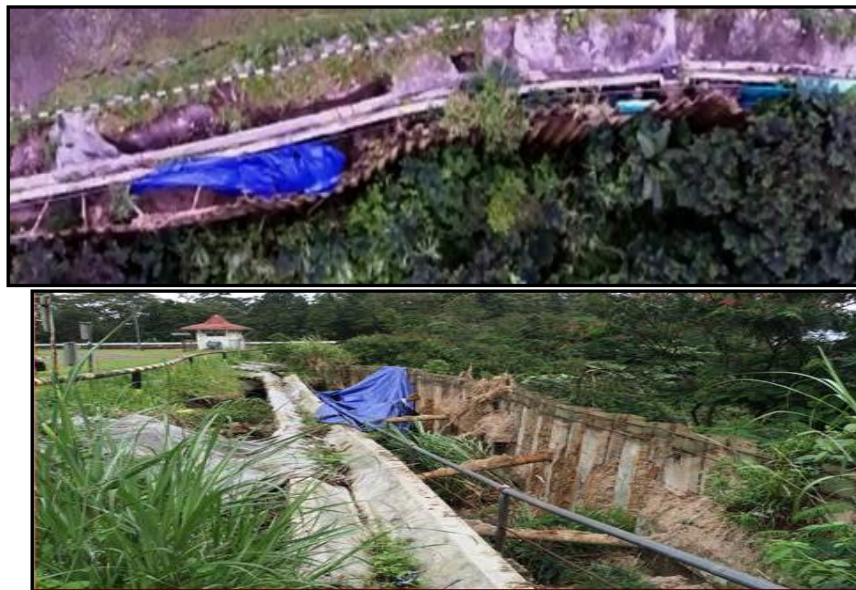
Hereafter on December 2015, subsidence case also happened at northern of Awi-14 well pad behind of sheet pile (Figure 4). Soil subsided 1 to 2 m depth and shifted the sheet pile 2 to 3 m away from well pad.

Figure 4. Soil subsidence and sheet pile shifting at Awi-14 well pad

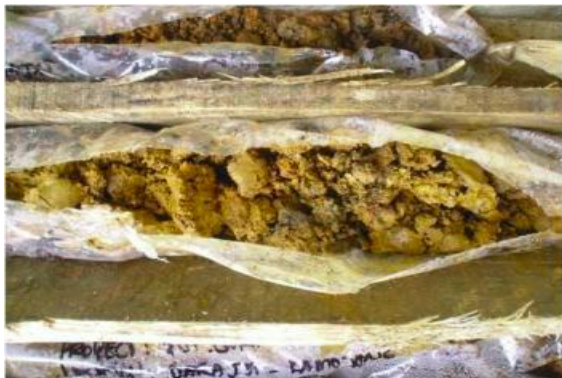
Special explanation for Orange Tuff (Figure 8) unit, which blanketed most of the site area (generally less than 3m in thickness), occurs as medium plasticity clay soil. Some thin intercalations of Silty Tuff frequently also occur within this unit. Hydrothermal processes have altered the Tuffaceous soils into light grey to blue grey, high plasticity, soft to firm clay which is an expansive or reactive soil due to the presence of montmorillonite (smectite) minerals, in other words Orange Tuff material usually stables in undisturbed condition but it becomes very sensitive to the water in disturbed condition. It also found that the landslide failure plane often coincides with the hydrothermally altered clay layer which occurs at the base of the Tuffaceous soil deposits.

Figure 8. Orange tuff in core box

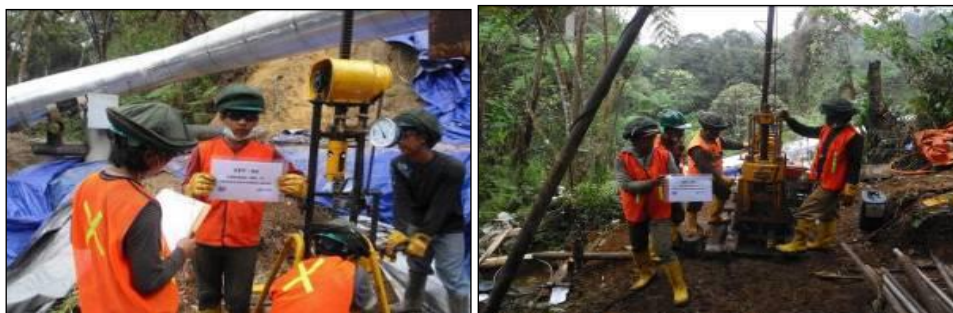
In order to gain direct information about the soil character beneath surface, then geotechnical soil investigation should be conducted (LAPI ITB, 2011). The works consisted of CPT and shallow drilling with SPT (Figure 9).

Figure 9. Soil investigation activity Awi-14 pipeline

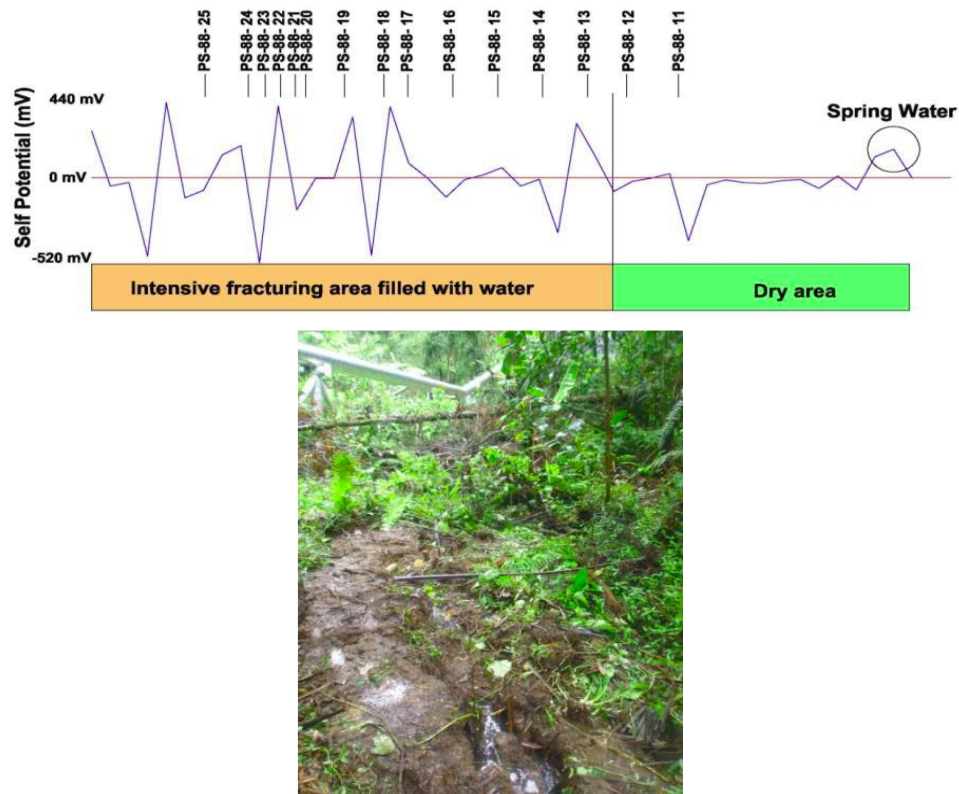
The SP survey resulted anomaly profile and the fluctuating potential differences occurred from beginning measurement to last failure pipe support. Indicate that there was intensive fracturing filled with water. The constant potential difference is occurred from several spot, which indicated dry area. At the end of line, there is a high anomaly that possibly spring water (Figure 12). High ground water table potentially exist at soil under Awi-14 pipeline

Figure 12. Self-Potential profile at crack area along Awi-14 brine line pipe, crack filled with water

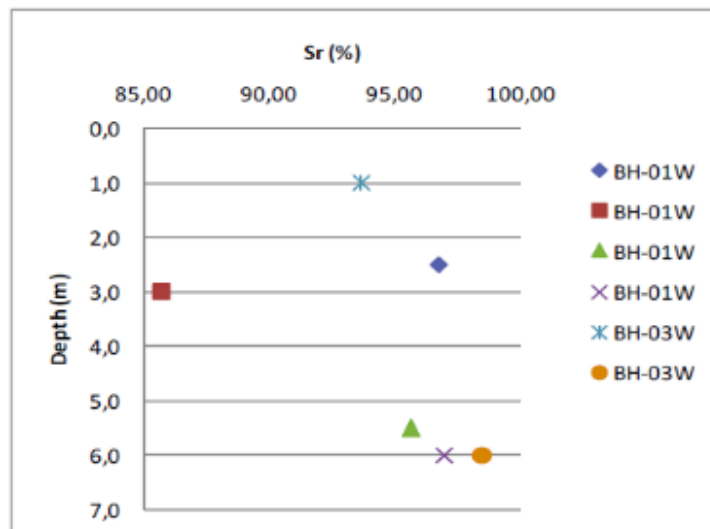
High saturated degree or S_r (%) was got from laboratory test that taken from soil data at Awi-14 well pad (Figure 13)

Figure 13. Sr (%) for various depth at Awi-14 well pad taken from BH-14-01-W & BH-14-03-W

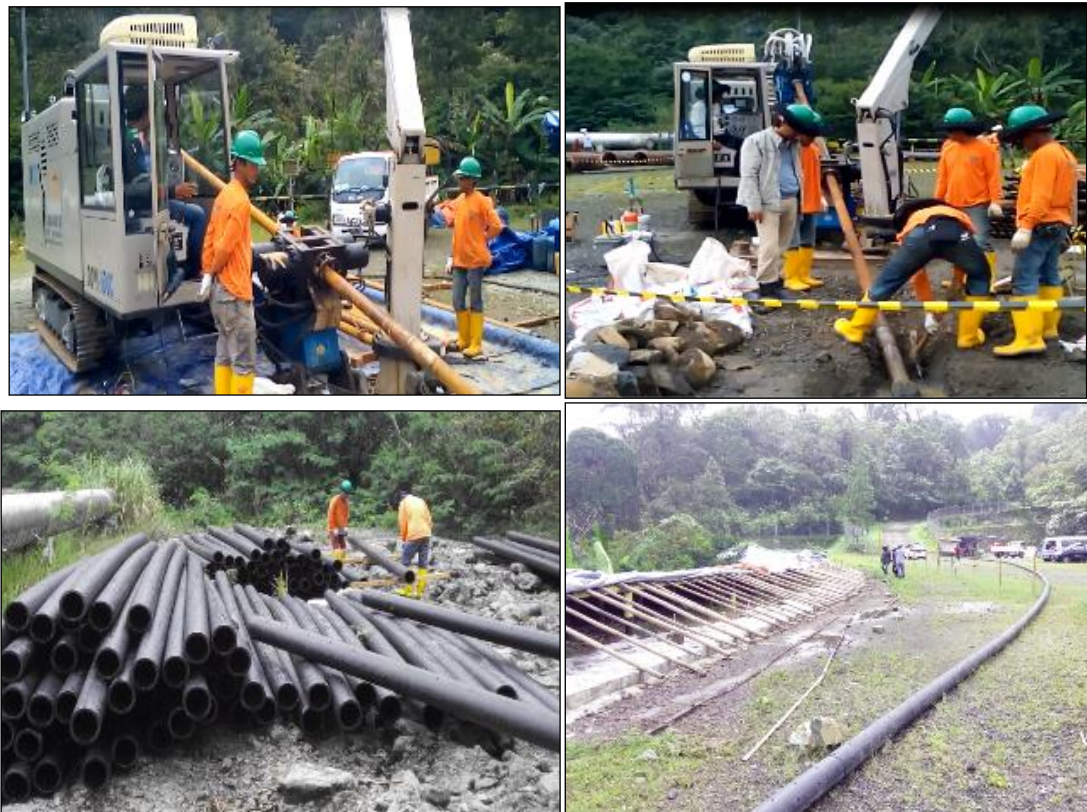
Figure 14. Horizontal drilling activity and HDPE perforated pipe 6" preparation before pulling back

Awi-14 brine line pipe landslide restoration project was executed on November 2014 with scope of work: installation of five (5) line of HDD that consist of horizontal drilling and installation of perforated HDPE pipe 6", while Awi-14 well pad restoration project was executed on May 2016 with only two (2) line of HDPE perforated pipe 6" installed (Figure 14). Horizontal drill machine type DDW-500C with pull back capacity 50 ton was used to execute this project, the work sequence as following flow chart (Figure 15).

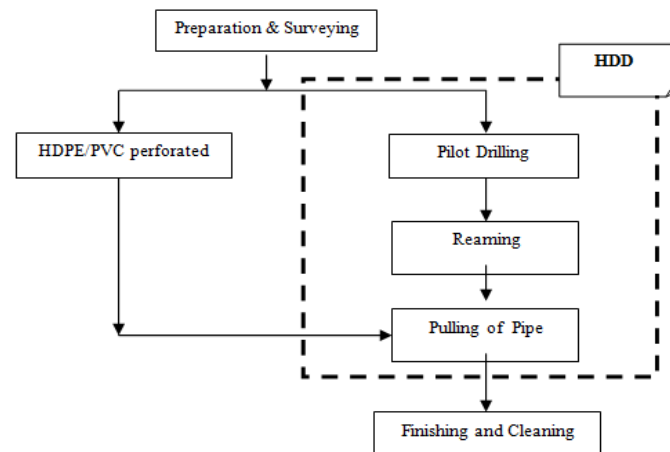
Figure 15. Horizontal drilling activity and HDPE perforated pipe 6" installation flow chart

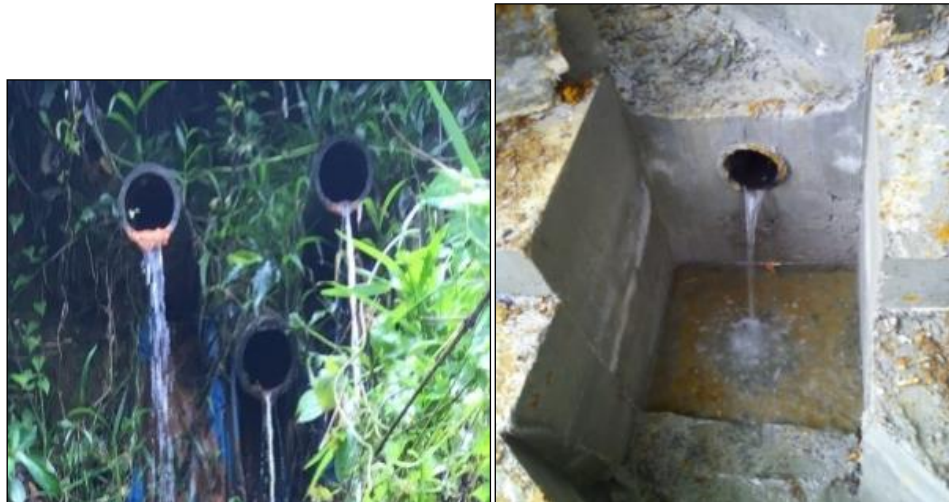
Figure 18. Completed installation of five (5) line of HDD at Awi-14 brine line pipe (left photo) and two (2) line of HDD at Awi-14 Well pad (right photo). Those HDD has successfully dropped ground water level

Prior horizontal drilling, pilot bore plan must be provided. This bore plan will ease the operator to track the drilling distance, elevation, and angle of drilling in accordance with HDD design layout plan and elevation (Figure 16 and Figure 17). Completed installation of HDD has shown the result of water release from landslide area (Figure 18). This condition will improve the slope safety factor.

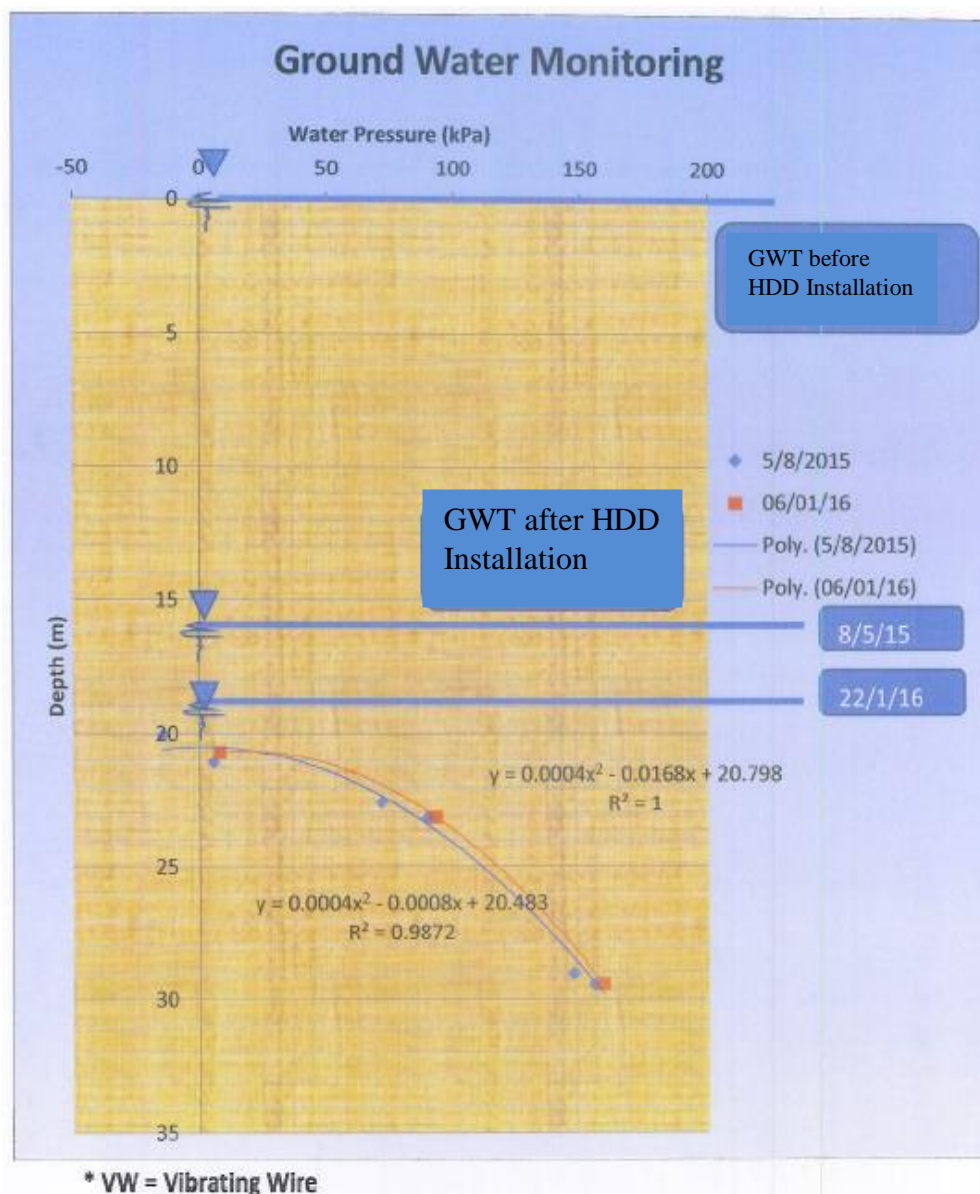
installed near bore hole 3 (BH-3) as the highest ground water level that measure during soil investigation. After HDD installed, ground water level dropped drastically to the level that expected -13 to -15 m. It could be read from piezometer that installed (Figure 20)

Figure 20. Data of GWT level and hydrostatic pressure taken from vibrating wire piezometer and stand pipe shown the decreasing of GWT after HDD installed
