## THERMAL INFRARED VIDEO IMAGERY OF THE ROTORUA GEOTHERMAL FIELD

M.A. Mongillo

Geophysics Division, DSIR, Wairakei

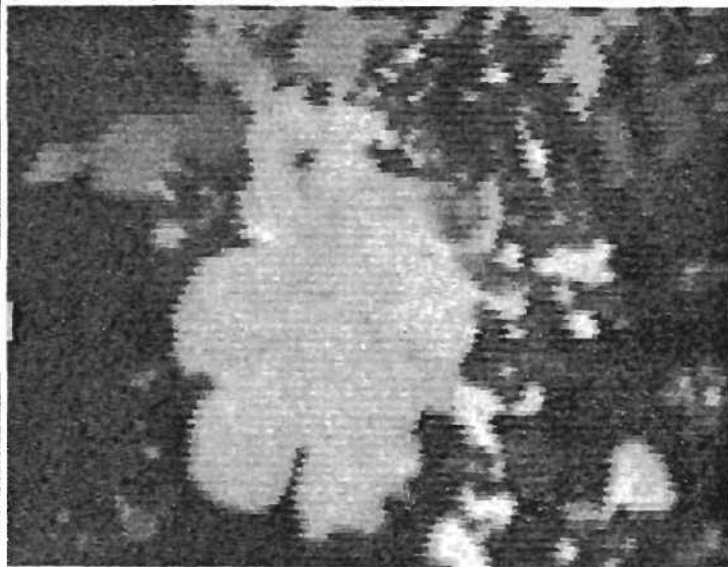
Figure 3a: Raw, uncorrected image (RIRWAK8).

Initial visual examination of the IR imagery indicated the presence of a periodic horizontal banding problem. Closer scrutiny of 11 of the digitized images showed that the banding was the result of a periodic intensity variation in alternating groups of four lines and a periodic relative shift in their horizontal locations (Figure 3a). The latter problem appears to have been caused by an incorrect instrument phase adjustment (Inframetrics Operations Manual, p 5-4; J. Hansberry, Inframetrics, pers. comm. 1988).

Figure 3 presents imagery of Lake Roto-a-Tamaheke and its vicinity. Figure 3a shows an almost entire "raw" (i.e. unprocessed) frame grabbed image. The banding problem is clearly illustrated. Figure 3b presents the results after processing and filtering the image to correct the banding. Lake Roto-a-Tamaheke has a temperature  $-50^{\circ}\text{C}$ . Many of the bright features on the imagery correspond to hot pools whose temperatures range from  $50$ - $100^{\circ}\text{C}$ .

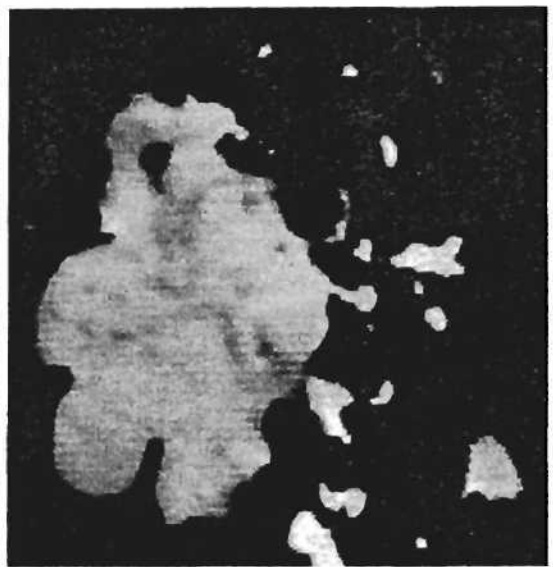
Figure 3d: High temperature stretched image (W8CS205T255).

Figure 3c illustrates the results of density slicing of the image into  $2^{\circ}\text{C}$  steps (instrument temperature scale). Note the clear definition of the higher temperature (brighter) areas both around the lake's edge and nearby. Details in the higher temperature areas of the image are enhanced in Figure 3d by setting the areas corresponding to the cooler 80% of the image to black and contrast stretching the remaining (20%) higher temperature areas so they range in appearance from black to white. The structure in the lake's surface temperature becomes quite apparent.

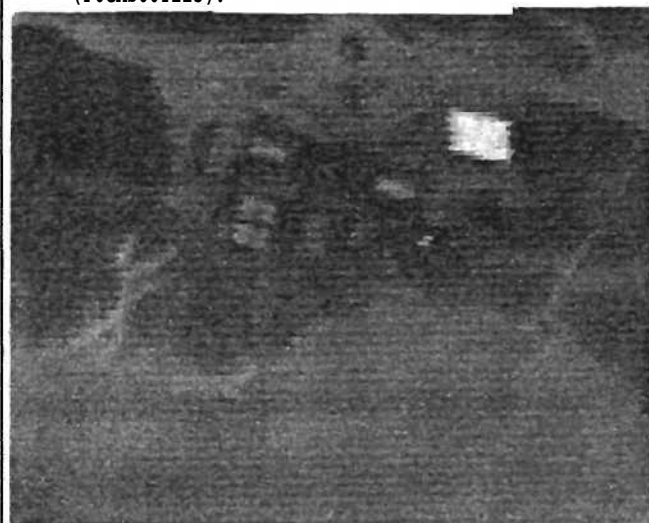
Figure 4c: Polynesian Pools area, raw, uncorrected (RIRPOLY1).

The Polynesian Pools area and nearby Lake Rotorua are presented in figures 4c (raw image) and 4d. Contrast sketching the 10-60% brightness range was performed to enhance the middle-brightness areas. The brightest rectangular feature is actually two large cooling vats containing water used by part of the complex and the other four bright rectangular features are hot pools. The two rectangular features which appear to have "crosses" in them (just left of image centre) are two groups of four pools ( $\sim 3$ - $4$  m across) which are built over top the Radium and Priest Pools (T. Lloyd, pers. comm. 1988). Also note the hot streams flowing into the lake (left and right of the image) and the drain of hot water from the pools complex (centre left of image).

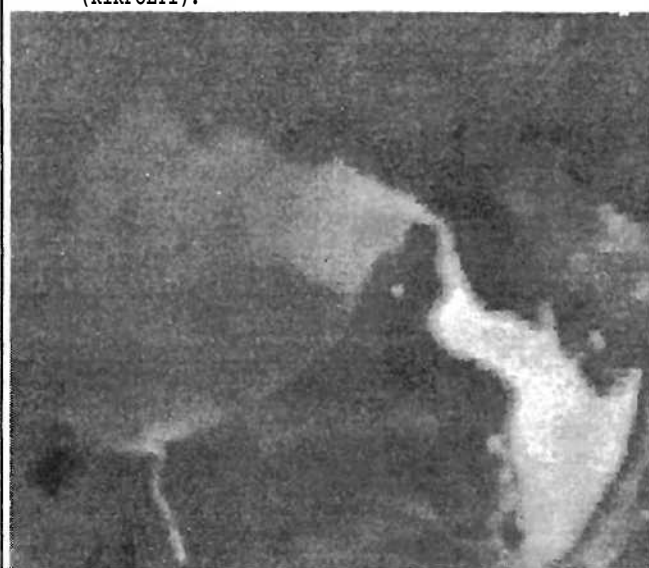
Figure 4e: Ohinemutu area, corrected, filtered (04C1WF).

Imagery of the Ohinemutu area is shown in corrected/filtered image form in Figure 4e. The flow pattern of hot water discharging into Ruapeka Bay (above and left of centre) from the smaller hot embayment (lower right) is clearly discernable. The

individual bright spots along the top edge of Ruapeku Bay correspond to hot springs having temperatures of  $-92-98^{\circ}\text{C}$ . A warm stream flowing into the bay can also be seen at the lower left of the imagery. Figure 4f illustrates the results of the histogram-equalization process which redistributes image brightness levels on the basis of their frequency of occurrence, thus stretching the group that occurs most often over a greater brightness range, hence providing greater detail. Note that the cooler areas located along the bottom and right side of the image show much more detail than does the unenhanced image (Figure 4e). The brighter grey areas in the lower right of the image correspond to patches of hot barren ground.
