The lake burst - 151 died.
Review of Exhibit 28.

3. THE CAUSE OF THE LAHAR (as cause of the disaster)

Vause, L.S.: Mason, D.J.M. (1993). Mt Ruapehu Crater Lake 1953 Lahar - a Recurring Disaster. Proceedings of the 15th Geothermal Workshop. New Zealand Geothermal Institute.

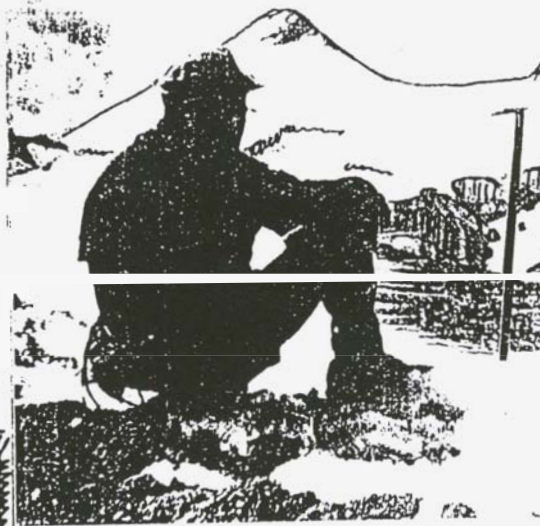
1. Written warning not heeded.
 2. The lake is rising/
 3. The glacier is receding.
- The crevasse over outlet
collects dam debris, and
supports debris wall

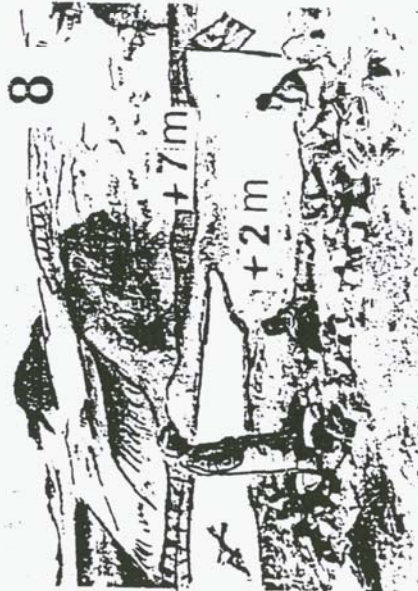
Masons Camp 24.2.1954 was beside hot fumaroles. The flat area is about 2m above lake level. The camp site was 7m below lake level of 24.12.53. The great ice cliffs had receded at least 70 metres.

Circulation should rise **from** the higher altitude and marginally hotter north vent and to sink to the lower cooler main vent. Mason identified Ngapha and small boiling springs on the bench, or beach, where they **camped** after the Tangiwai Disaster (Fig 8). Those fumaroles would have **been** deep under the ice-cliffs which had previously covered the bench level. It is likely that such geothermal energy would usually vent with less resistance at the lake edge. Such boiling features can exist under ice.

Of more **importance** is the relationship of the bench or beach • **only** 1 or 2 metres above the ice cave outlet sill. (Fig 8).

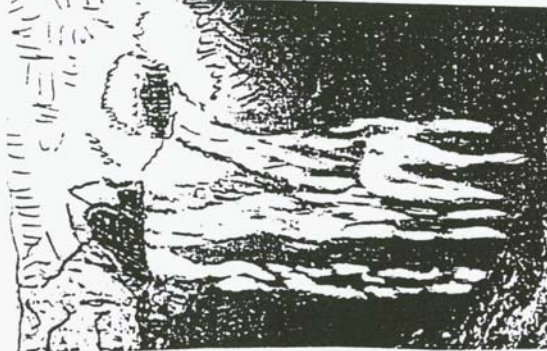
16.2.54

Photograph L. Stream from Crater Lake dropping over rock face where it issues from channel beneath ice. Remains of collapsed ice in mid-foreground.

That is, the warm lake water exits the central crater over a sill and then waterfalls down the barrier wall in an almost vertical **54m** drop inside **of** the ice cave of the larger crater. It then exits some **70m** below lake level, **as** a source of the Whangaehu River (Fig 6). Christie established the lake outlet sill **as** 8295ft **ASL**.
