Evaluation of Corrosion Resistant Alloys as Construction Material for Acidic Geothermal Wells

James Nogara^{1*} and Sadiq J. Zarrouk²

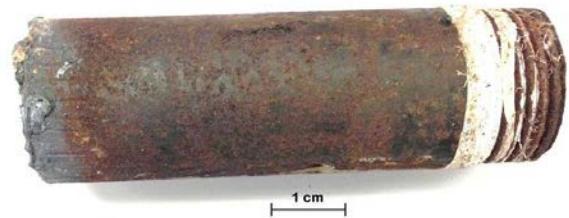
Figure 2 Carbon steel pipe (1") used to transmit X2D fluid for 1 month at low flow condition. A section of pipe was cut near the thread (Figure 7). The inner surface of the pipe is coated with corrosion product and scale.

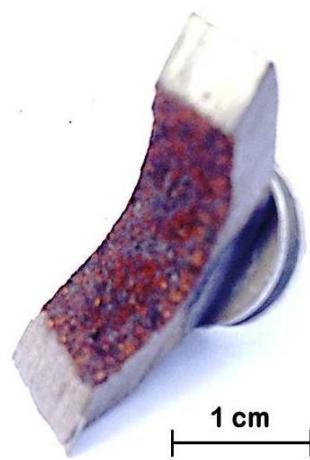
Figure 7 A small section (about 1 cm long) was cut from the pipe in Figure 2 and attached to a stub mount. The inside surface of the pipe is covered with about 1 mm thick corrosion product.
