# HISTORIC MoW GEOTHERMAL DEVELOPMENT IMAGES

Andy Bloomer<sup>1</sup>, Paul Bixley<sup>2</sup>

**Keywords:** Wairakei, Kawerau, Ohaaki, photographs.

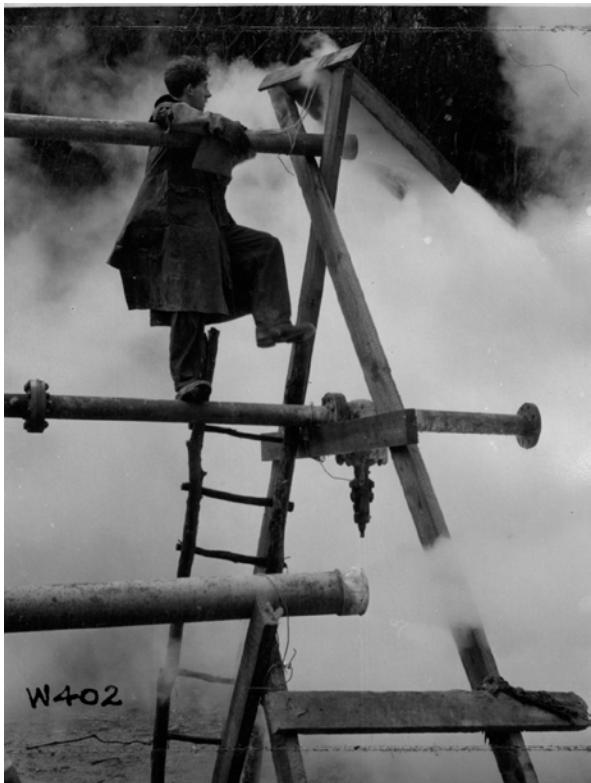
**Figure 2; KA4 Nov. 1955, Test 549. Fitting deflector**

Techniques for measuring well output and downhole conditions had to be developed. These were jointly developed by the MoW and DSIR. Some have been superseded, such as using a calorimeter for determining well enthalpy. Others are still in use today; sometimes refined, sometimes used very much as first developed in the 1960s.

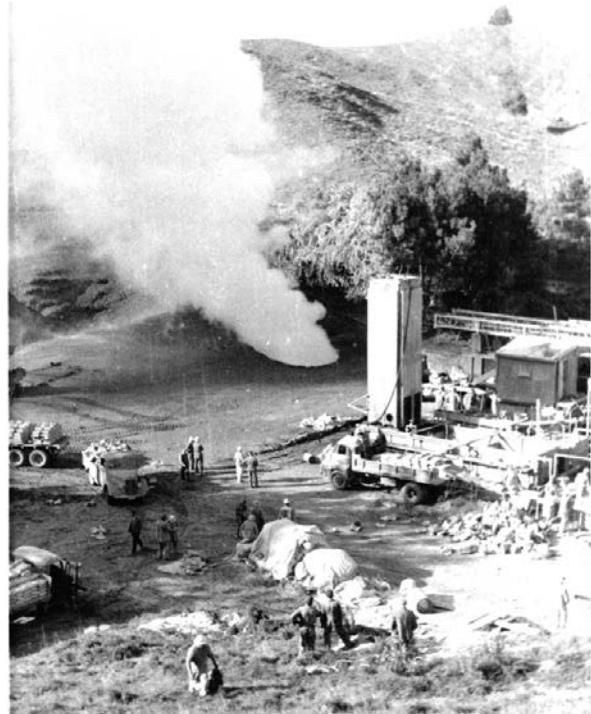
**Figure 3: WK204 General view of rig equipment, 3.5.60**

The well blew out in May 1960, while drilling at about 400m. It was known as the “rogue bore”. The failure was later attributed to lack of an intermediate casing and poor casing cementing as well as a series of mishaps that resulted in loss of well quench.

The site had been grouted in an attempt to provide safety to the rig and equipment and this may have assisted. Grouting of the well was attempted until, it is reputed, all the cement within a 100km radius had been used up. The rig was then removed from the site, in a precarious operation, but no one was injured and the only equipment lost was the drilling cellar. The ensuing boiling crater became a tourist attraction until the discharge ceased of its own accord thirteen years later, in 1973. An extensive photographic record, including some video, is held; some of which has been well published.

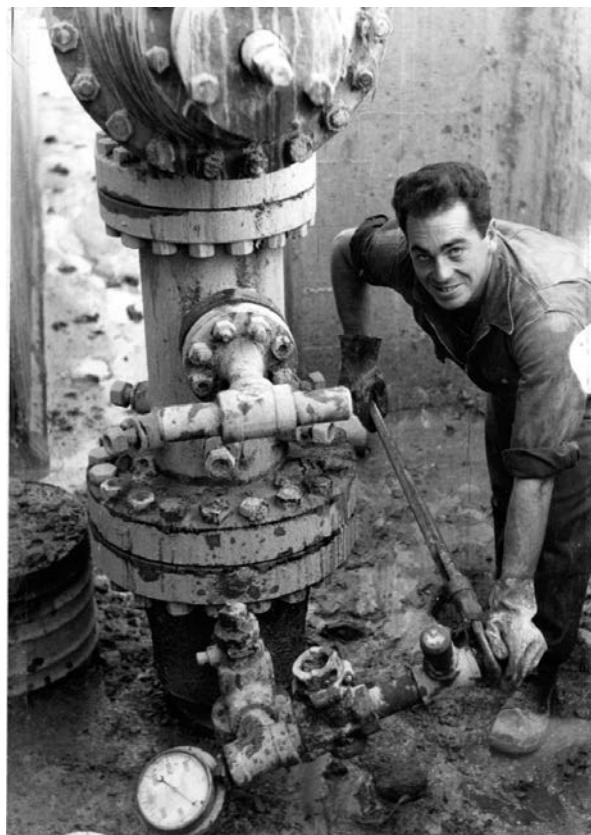
**Figure 4: WK204 Wellhead equipment after removal of rig, 4.5.60**

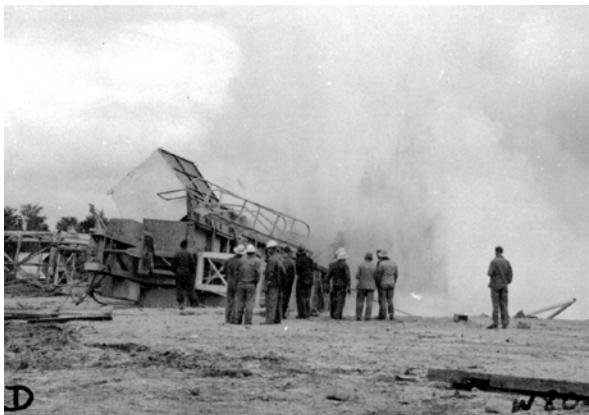
**Figure 6: KA9 and T32 rig collapse, 12 June 1956**

The first six exploration wells at Kawerau were drilled by MoW. But due to their commitment at Wairakei the following nine wells were drilled by Brown Drilling Company from the USA. The first four of which encountered problems. KA7 blew out, as did KA9 after attempting to set casing at 120m; that resulted in severe damage to the T32 drilling rig.

As the work was not under the control of the MoW there are few photographs of the well drilling, but there are images of the subsequent damaged rig and crater.

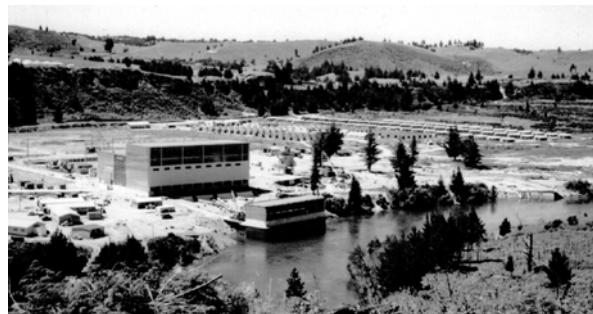
Progress photos from various vantage points, such as the top of the top of the Bluff on the steam mains, or from the opposite bank of the Waikato River, can be compared with current views.

**Figure 8: 'A' Station views from across the river, 16.1.59**

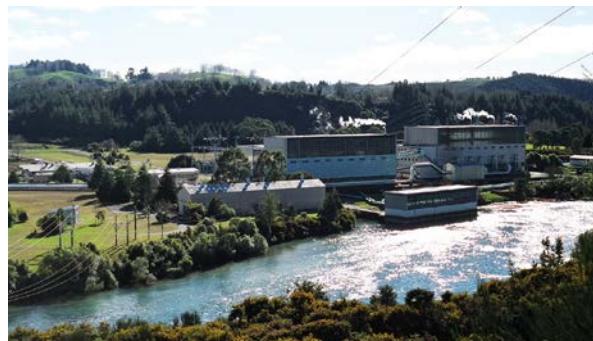
**Figure 9: 'A' and 'B' Stations, 14.9.05. Cf Fig. 8**

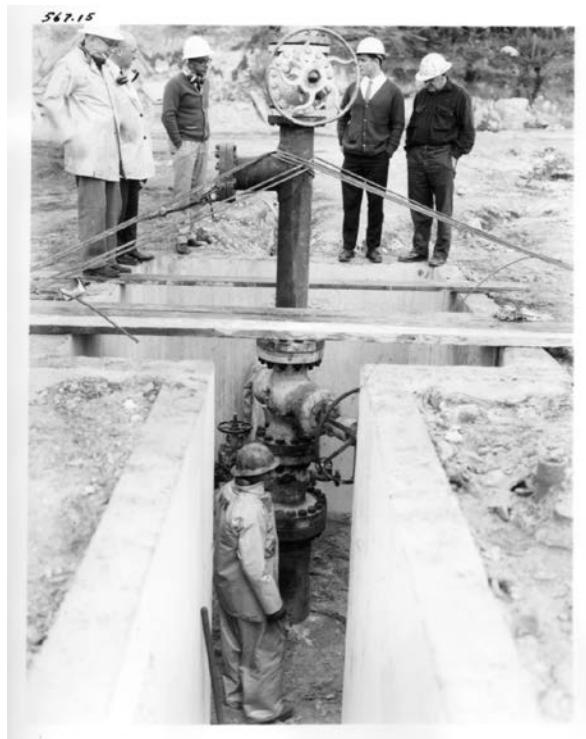
**Figure 10: KA3 before the first discharge, 1967**
