Development of New Field Testing Tools for Geothermal Power Plant Risk Assessment of Corrosion and Scaling

We are developing two field testing tools for geothermal power plant risk assessment of corrosion and scaling under NEDO's "Research and Development of Geothermal Power Generation Technology Program". The first tool is the portable flow loop corrosion tester. The second one is the Gamma-ray pipe section profiler to measure the scale blockage rate of piping. We are developing the portable flow loop corrosion tester using 1" piping for geothermal single and two-phase flow condition. This tester can be easy to handle by a few workers without a crane and is low cost. The tester can be set up for three corrosion rate measurement methods – ER(Electrical Resistance) Corrosometer®, LPR (Linear Polarization Resistance), and Cylinder coupon exposure tests. The tester can also be set up for any injection systems of acids (H₂SO₄, HCl, to simulate extreme acidic condition), NaOH (for neutralization) or anti-corrosion/anti-scalant inhibitors. We have already trialed this tester in liquid flow condition (Kakkonda, Iwate) and two-phase flow condition (Okuaizu, Fukushima) in 2016-2017. The ba

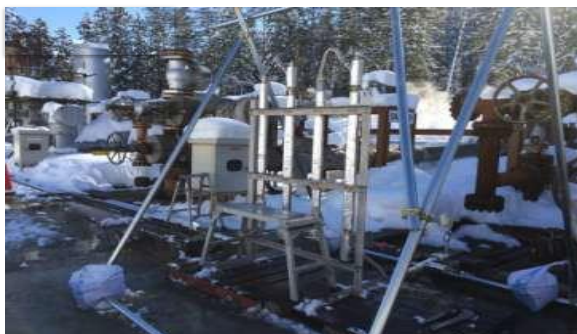
Figure 6: Pictures of PFCT at Okuaizu in Feb. 2016

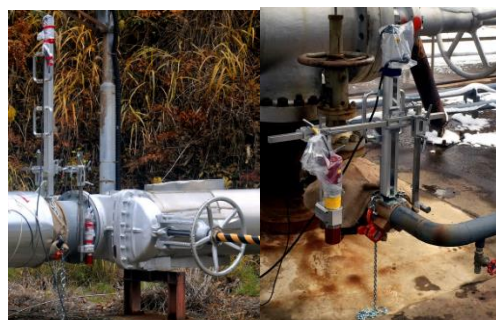
Figure 13 Setting up of Gamma-ray pipe section profiler (GPSP) in the field

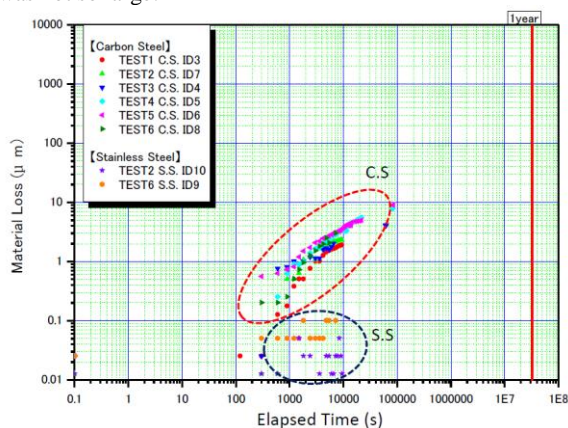
Figure 16 shows all of Corrosometer® curves for Kakkonda field testing obtained using PFCT. The variation in the data was not so large.

Figure 16 Kakkonda: Corrosometer® plot of all tests (material: CS and SS)

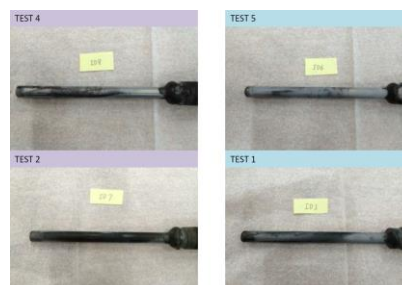
Figure 17 Okuaizu1: The surface of Corrosometer® Probes (CS) after testing

Figure 17 illustrates the appearance of the Corrosometer® probes after testing while. Figure 18 shows all of Corrosometer® curves for Okuaizu1 field test. Since the material loss was very small, the variation in the data was range that could be ignored.

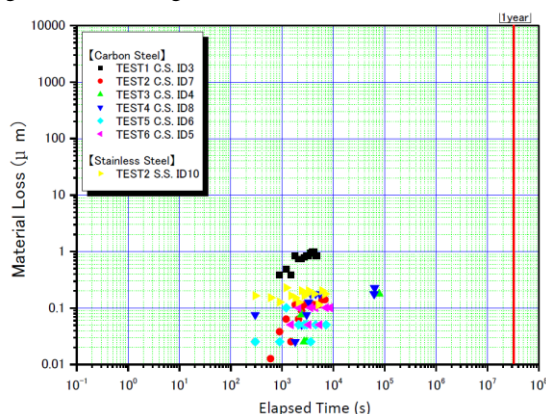
Figure 18 Okuaizu1: Corrosometer® plot of all tests (material: CS and SS)

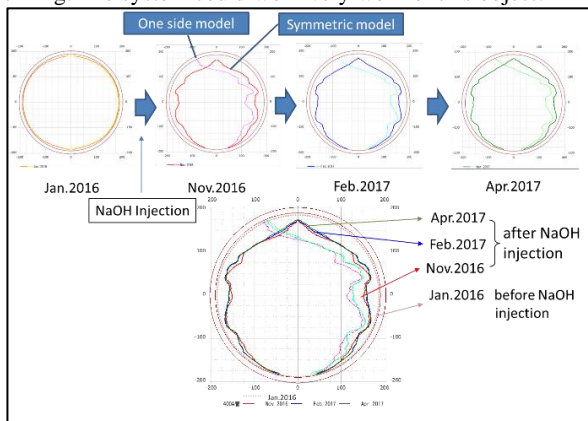
Figure 21 and 22 show the pipe section profiling data of a production pipeline (2 phase) of Okuaizu steam field during Jan.2016 to Apr.2017. This pipeline (400A) was being treated by neutralization using NaOH injection for acidity counter-measure of geothermal fluid. We started to measure before neutralization and monitored the scaling thickness change after neutralization at 330cm downstream from the NaOH injection port. Figure 21 shows comparison of scaling thickness during Jan.2016 to Apr.2017. After NaOH injection, we could find scaling but it was not changing during Nov. 2016 to Apr.2017. Therefore, we tried to measure additional 4 pipe sections (45cm, 78cm (covered by thermal insulator), 150cm (covered by thermal insulator), and 284cm) between

Figure 21 Scaling inspection of two phase production piping using GPSP in Okuaizu - Fixed point monitoring in Jan.2016 – Apr.2017
