TE MIHI GEOTHERMAL POWER STATION – HOTWELL PUMPS – A TALE OF UNINTENDED CONSEQUENCES

Dugald Morrison¹

¹Contact Energy Geothermal Resources and Development, Brandon Street Wellington, New Zealand

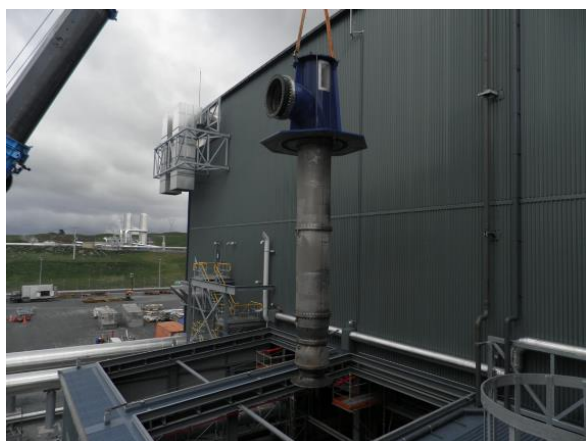
Figure 5: HWP withdrawal through removable roof.

The oversized pump flange requires an oversized lifting withdrawal void that creates an interference with the discharge pipe, fire water sprinkler pipework, seal water filter Equipment and HWP can vent lines.

The fire water distribution pipework is supported from the CW sump pit roof. The CW sump roof is a removable roof panel that provides mobile crane maintenance access to the CW sump for the hot well pump, the CW discharge valves and any other equipment requiring crane access for removal.

Vertical and horizontal legs of cable tray are installed in the lifting withdrawal area. Only the horizontal cable tray run should be fitted across the lifting area to the terminal box to allow for minimal work to pull cable and tray out of the lift withdrawal area.

The various piping connections such as seal water and NCG vent lines traversing the lifting withdrawal area would ideally have been provided with removable spools that were suitably located with terminal connections not requiring additional scaffolding and lifting to access.

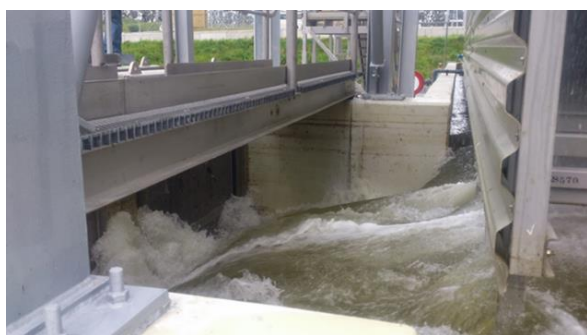
Figure 6: Initial hydraulic step at cold well inlet.

Initial commissioning identified a significant hydraulic step as soon as the second HWP was put into operation (Figure 6). With two pumps (5.8m³/s) in operation there was approximately a 1m hydraulic step into the cold well and the turbulent flow resulted in a high level of air entrainment into CW system which also affected the performance of the non-condensable gas extraction system.

The air entrainment was such that the ultrasonic CW flow measurement failed whenever a second HWP was in service.

The original intake design was provided with a central pillar to support duplicate sets of intake screens to meet contract requirements. The CT basin was designed with an intended 150mm freeboard. The submergence depth of the cold well intake was such that it should have been possible to lower the CT basin level so as to enable CE to use the Ohaaki power station CT “super sucker” equipment to clean the basin floor. A lowered basin level would have provided clearance beneath structural members for the floating discharge hose on the “super sucker”.

The EPC contractor implemented the following mitigations at the cold well to reduce the velocity and head loss through the inlet channel:

- CT basin water level elevated to within 20mm of the top of CT basin thus eliminating any freeboard (increased cross section to reduce velocity)
- CT basin over flow outlet level raised
- Centre pillar removed (increased cross section to reduce velocity)
- Redundant intake screens at the intake step removed and replaced with a single intake screen set back into the full depth of the cold well
- Bell mouth intake in CT basin to improve flow distribution into the cold well intake channel
- Intake channel modified with an Ogee plate spillway transition installed to convert potential energy to kinetic energy. This replaced the concrete stepped intake floor to in an endeavor to produce a smooth flow down the ogee ramp to assist with reducing the standing waves from the hydraulic step.

The open channel flow in the cold well intake approach channel still exceeds the maximum 0.9 – 1.2m/s velocity recommendations in ANSI/HI 9.8. However the modifications installed reduce most of the hydraulic step, turbulence and entrained air.

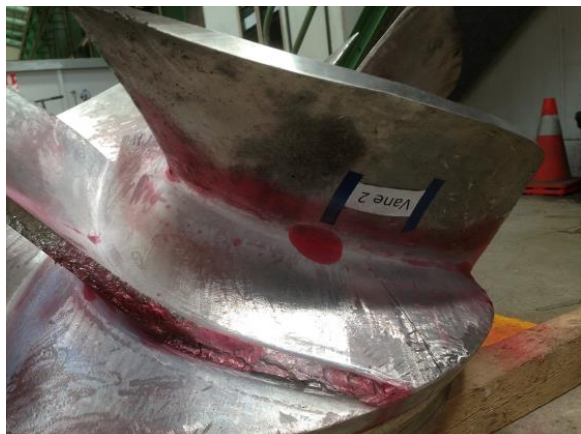
Figure 7: Unit 2B HWP impeller failure.

The reliability run commenced with the HWP operating with elevated levels of vibration. Analysis of the vibration spectrum indicated relatively high cavitation “curtain”. A sudden step change in vibration levels occurred indicating the in service failure of the 2B hotwell pump vane 1 after approximately 1150 hours of operation. The 2B HWP was removed for inspection and the failed section of impeller was found in the bottom of the pump can (Figure 7). The pump impeller was found to have multiple fatigue cracks at the base of the vanes. Large areas of cavitation damage were found on leading and trailing edges and on both the suction and pressure faces of the impeller vanes. Up to 6 mm deep

material loss was observed. The cavitation damage showed the presence of both impeller inlet cavitation from vortices into the impeller and recirculation cavitation at the discharge of the impeller. The pump bowl also exhibited areas of cavitation damage.

A replacement impeller was manufactured by the OEM. The other pumps were stripped down and rebuilt at AIE Ltd workshops. This involved weld rebuild, match machining impeller and bowl, and rebalancing the impellers.

The remediation works identified and implemented were the installation of a false floor and inlet flow cone to the HWP can and the removal of can guide vanes.

In addition a Belzona epoxy coating was also applied to the impellers. This coating lasted less than a year before it delaminated. The coating was subsequently replaced with a two part Belzona anti-cavitation coating. This coating also incurred delamination within 1 year of operation.
