# Scaling Mitigations for the Binary Plant Vaporizer: Upper Mahiao, the Philippines

Chee Ann S. Candido<sup>1</sup> and Sadiq J. Zarrouk<sup>2</sup>

<sup>1</sup> Energy Development Corporation, 42F One Corporate Center, Julia Vargas cor. Meralco Ave, Ortigas, Pasig City, Philippines

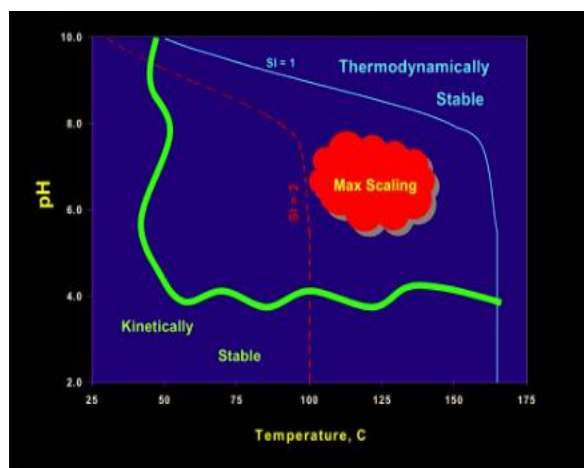
**Figure 4. Silica stability map for amorphous silica at 270°C (Kaplan, 2004)**

The effects of brine quality can be evaluated by determining the thermal stability of amorphous silica with respect to pH and temperature. Figure 4 shows the stability map for amorphous silica based on a 270°C reservoir and 100 psi 1st flash pressure by Paul Hirtz (Kaplan, 2004). Amorphous silica is thermodynamically stable above 165°C and at lower temperature and high pH values greater than 8, while it is kinetically stable at temperatures below 50°C and pH values less than 4. Thermodynamic stability prevents any possibility of scale deposition, while kinetic stability results in an extended period before deposition occurs (Kaplan, 2004).

From the data in Table 2, the brine pH of Upper Mahiao is greater than 5.6. The silica stability map in Figure 4 suggests that for the silica in the brine to be kinetically stable at all temperatures, the pH should be less than 4, thus the brine in Upper Mahiao is considered not kinetically stable (Telen, 2015).

The Silica Stability Map in Figure 4 suggests that at an SSI value of 1, the silica in the brine is thermodynamically stable. For the stability to be sustainable in the system, the brine plant can be operated at a brine outlet temperature greater than 170°C, keeping the SSI less than 1. Brine SSI levels become supersaturated at the vaporizer outlet due to temperature decline. The minimum outlet temperature of brine in the vaporizer should be about 150°C for a maximum allowable SSI of about 1.2 which can be observed in Figure 6, an SSI vs. temperature graph applicable to Upper Mahiao (Telen, 2015).

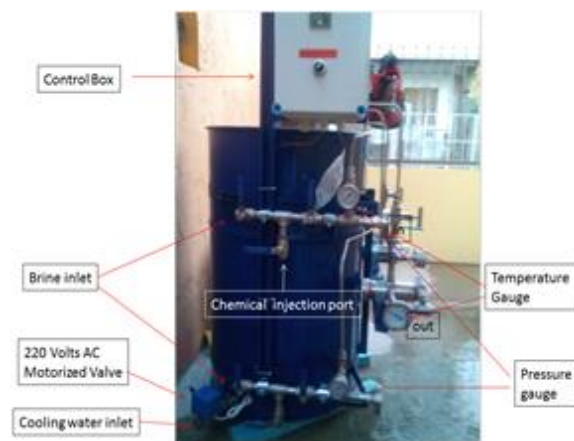
**Figure 5. Crab cooker configuration**

As part of the rehabilitation program, a crab cooker (Figure 5) which will act as the polymerization vessel will be fabricated to be used for the induction time testing as well as the right dosing of chemical inhibitor to improve the kinetic stability as well as the brine quality of Upper Mahiao (Telen, 2015).

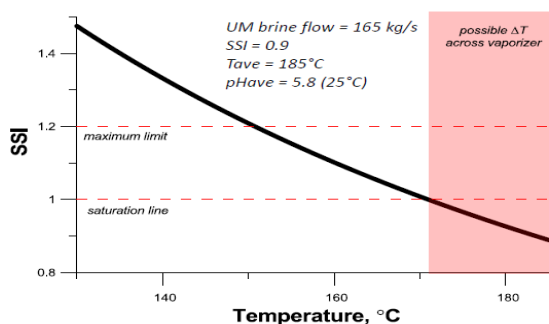
Figure 6. SSI vs. Temperature (Telen, 2015)

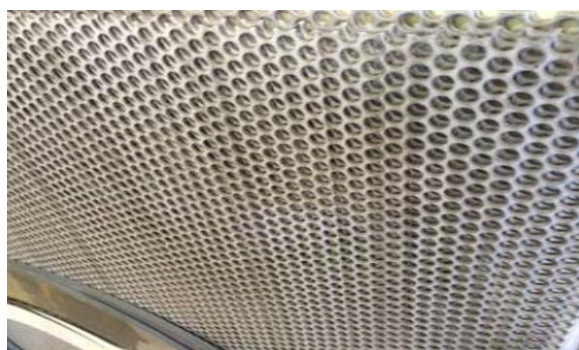
**Figure 10. Basket strainer element**

Basket strainers are composed of a screen or element formed like a basket with a lifting handle so the debris, solids or corrosion products captured and retained in the screen can be easily removed for disposal. To ensure that there will be no more solids carry over to the vaporizer inlet, two basket strainers are to be installed upstream of the vaporizer with the element as shown in Figure 10 (Telen, 2015). There will only be one strainer used at a time; the second strainer will be a backup when the other strainer undergoes maintenance so there will be no opportunity loss in the operation.

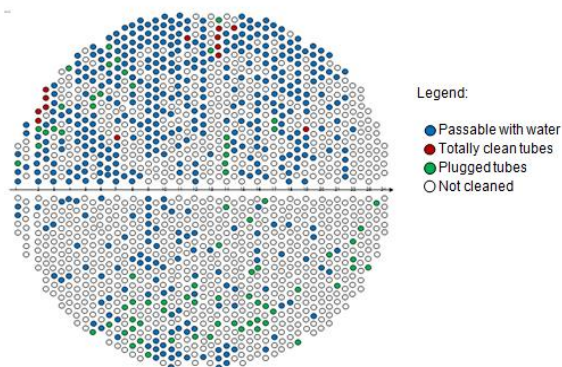
**Figure 12. Vaporizer tube status after the water blasting and mechanical cleaning in 2015**

As part of the rehabilitation program, silica removal was done using a combination of water blasting and mechanical cleaning in June 2015 and due to hardened scales, the slow rate of cleaning (1 to 2 tubes per day). The cleaning results were 461 tubes passable with water, 13 tubes totally cleaned, 74 tubes that were previously plugged, and 937 tubes were not cleaned or assessed if either clogged or passable with water since the activity was eventually stopped in August 2015 (Figure 12). Another method which is the combination of mechanical and chemical cleaning was evaluated. This includes mechanical drilling of the tubes to ensure chemicals will pass through the tubes: 1st pass of chemical cleaning to loosen silica component which includes chemical recirculation in the tubes, hydro test to check for tube leakage, 2nd pass of chemical cleaning to remove silica component, and neutralization and passivation to protect the tubes from corrosion. However, due to the large volume of chemical waste that can be produced and accumulated during the process of cleaning, the method has been put aside (Telen, 2015). The rehabilitation team is now looking into other economically and environmentally safe options to be used for the vaporizer cleaning.

The degree of the deposition may vary along the tubes which also affects the brine flow rate. The cleaning results showed that some tubes have increasing thickness of deposition from the brine inlet to the brine outlet. Some tubes were mechanically drilled half way in the tubes but not through to the end because of the hardened deposits. The difference of scale deposits in each tube is also affected by the accumulated corrosion products in the inlet of the vaporizer that slow down the brine velocity into the vaporizer.

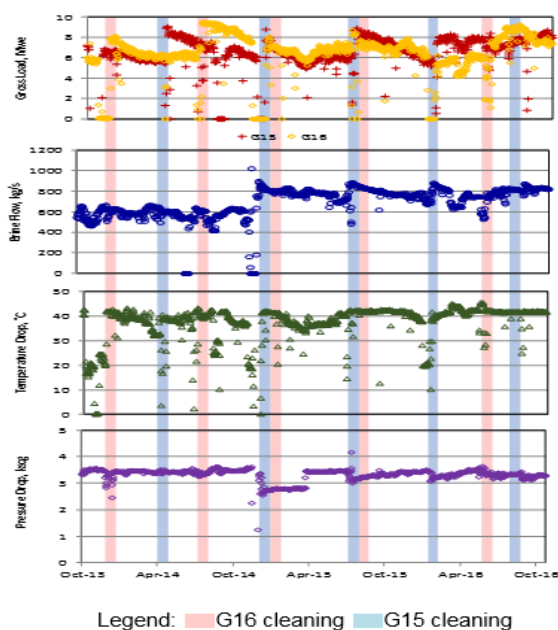
**Figure 13. Wairakei G16 and G15 Gross load, brine flow, temperature drop and pressure drop (Morris, 2016)**

Figure 13 shows the effect of an acid cleaning on the brine inlet and outlet temperature and pressure (Morris, 2016). The brine flow as shown in the blue plot increased after the cleaning and the nominal outlet temperature of the combined fluid in the green plot is increased due to the cleanout. The pressure drop is decreasing and the temperature drop is increasing after the cleaning which indicates that the heat transfer efficiency is increasing. The generation data for the same period from October 2015 to February 2016 shows significant increase in generation for G15 generating unit after the cleaning. Wairakei binary plant also utilized periodic acid dosing along the brine which significantly slowed down the silica deposition in the vaporizer. This resulted in a reduced frequency in the vaporizer cleaning using HF, only one cleaning being needed for G15 and G16 in 2015.
