MODIFICATION OF UNIT 1 COOLING TOWER (CT) TO IMPROVE THE CT PERFORMANCE IN STAR ENERGY GEOTHERMAL (WAYANG WINDU) LTD

Amri Zein¹, Mahendra Kuntoaji¹

¹Star Energy Geothermal (Wayang Windu) Ltd., Pangalengan, Bandung, West Java, Indonesia

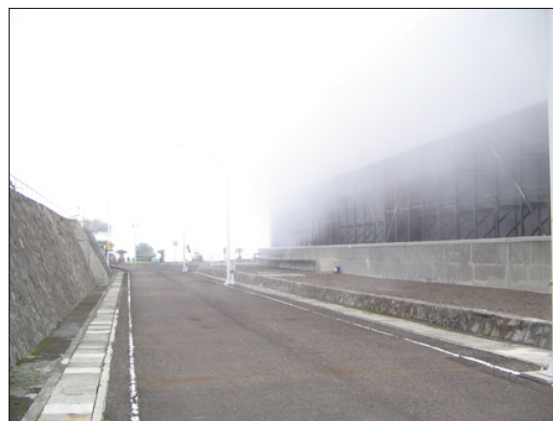
The Unit 1 CT fan stack was designed with a height of 6 feet only and had relatively straight vertical panels which did not produce significant velocity recovery. On other hand, as the Wayang Windu Geothermal Plant is located in the mountains, the CT is exposed to swirling and shifting winds. These types of winds can force down the exiting plume (hot air) from the CT and it may be drawn back into the CT which increases the entering wet bulb temperature. This phenomenon is called recirculation. The increase of wet bulb temperature has the impact of decreasing of CT performance. Figure 1 shows the plume recirculation in Unit 1 CT.

Figure 1: Major plume recirculation in Unit 1 CT.

In order to reduce the effect of plume recirculation, a new design with a higher fan stack was proposed. In addition, there was an opportunity to modify fan stack design to get higher fan blade efficiency. SEGWWL engineers conducted an engineering study based on available design data, simulation and experimental methods. The aim is that the new fan stack design will produce significant velocity recovery to convert some of the wasted velocity pressure energy at the top of the fan stack into useful work at the plane of the fan, and therefore fan efficiency will be increased. By improving fan efficiency, additional motor power can be made available to further

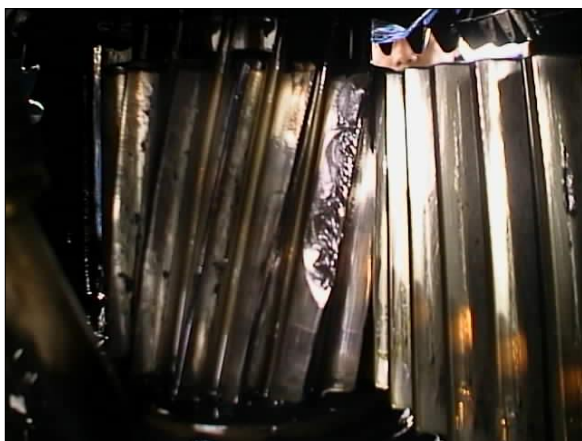
Unit 1 CT gearboxes (brand: Sumitomo, model: PX8065R2Y-RRV) have been operating since commissioning in year 2000. This common industrial gearbox was designed with a low thermal Service Factor (SF) design of 0.96 (below the minimum thermal SF required of 1.0) and marginal mechanical Service Factor (SF) design of 2.04 (minimum requirement SF for CT is 2.0). Since the start of operations, gearbox failure has been identified with failure of gear teeth components after only 1 year of operations. Further investigation revealed that a poor cooling process and H₂S exposure in the gearbox breathing air were the causes of these failures. The oil cooling system used air withdrawn by a radial fan installed on the input shaft which produced low heat transfer due to the oil capacity and small size of the gearbox housing. Improvement works have been done by installing gas absorbent media on the breathing line, providing an additional oil tank to improve cooling performance and changing lubricant oil from a mineral type to a synthetic type. Although these approaches prolong the gearbox lifetime for up to 2 to 3 years of operation, however, more maintenance efforts and funds should be spent especially to purchase the gearboxes spare parts (which became listed as “obsolete” spare parts) and the synthetic lubricant oil. Due to the spare parts being categorized as “obsolete” spare parts, special spare parts manufacturing was required which resulted in a long delivery time and high spare part cost. Figure 2 shows a picture of failures of the CT gearboxes.

Figure 2: Severe gear tooth defect of CT gearbox

In order to improve the reliability of the CT gearbox, it was proposed to change the gearbox design, considering both the opportunity to improve the CT performance and economical capital cost. The engineering study and execution work of the CT upgrading project are reported in this paper.

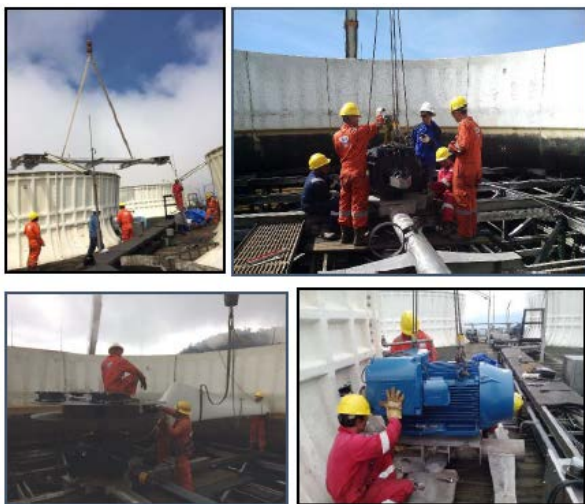
The execution works were conducted with good preparation and completed within one month for each cell. The works were started by dismantling the existing torque tube, CT hub and fan blades; continued with modification of the torque tube frame (steel frame for gearbox and electric motor mounting), CT structure reinforcement work and reinstallation of the torque tube, hub and fan blades. The final step is assembly of drive shaft and final alignment between gearbox and electric motor. Figure 8 shows photographs of work execution.

Figure 8: Photographs of work execution

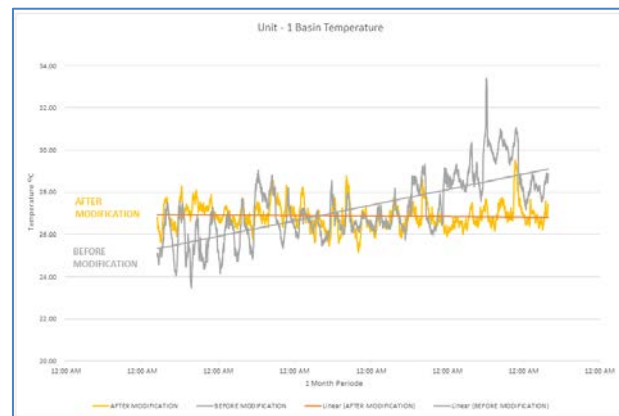
During CT cell commissioning and monitoring phase, CT outlet temperature and condenser pressure data were taken for comparison. It is revealed that the outlet water temperature after modification is lower than before modification and the condenser pressure after modification is lower than before modification as shown in Table 4. Trends of outlet water temperature data are also captured, which can be seen in Figure 9. Within a time period of 1 month before at November 2014 and after modification at January 2018, the decreasing water outlet temperature is shown by the trend chart. In addition, air flow measurement and thermal imaging monitoring were conducted. The point of thermal imaging measurement is shown in Figure 10.

Figure 9: Trending of CT Outlet Water Temperature

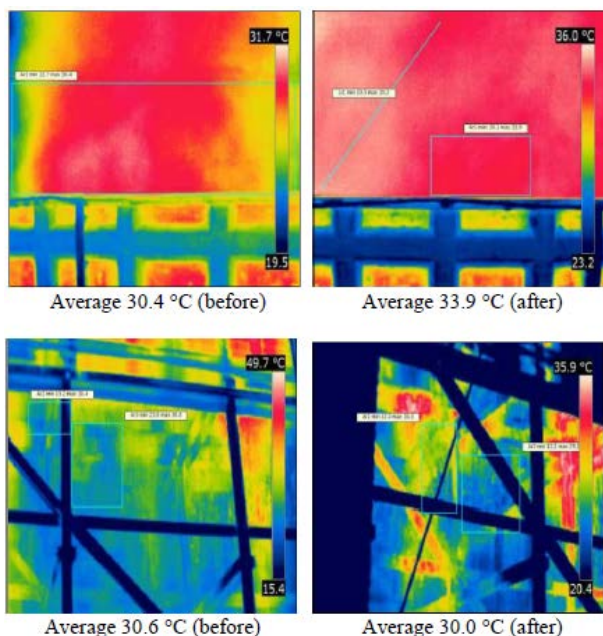
As shown in Figure 11, significant improve of heat recovery from the new fan stack was revealed by the comparison of conditions before and after the CT upgrade project. The outlet plume temperature is hotter and the outlet water temperature is cooler after the project work. These data confirm the improvement of CT performance.

Figure 11: Thermal Imaging Data Comparison
