NGATI TUWHARETOA GEOTHERMAL ASSETS LTD REBOILER PLANT WATER/STEAM CHEMISTRY IMPROVEMENTS TO RESOLVE ONGOING CORROSION ISSUES AND PREVENT FUTURE TUBE FAILURES

David Addison¹, Nik Vandervegte² and Nellie Olsen¹

¹Thermal Chemistry Limited, New Zealand ² Ngati Tuwharetoa Geothermal Assets Ltd, New Zealand

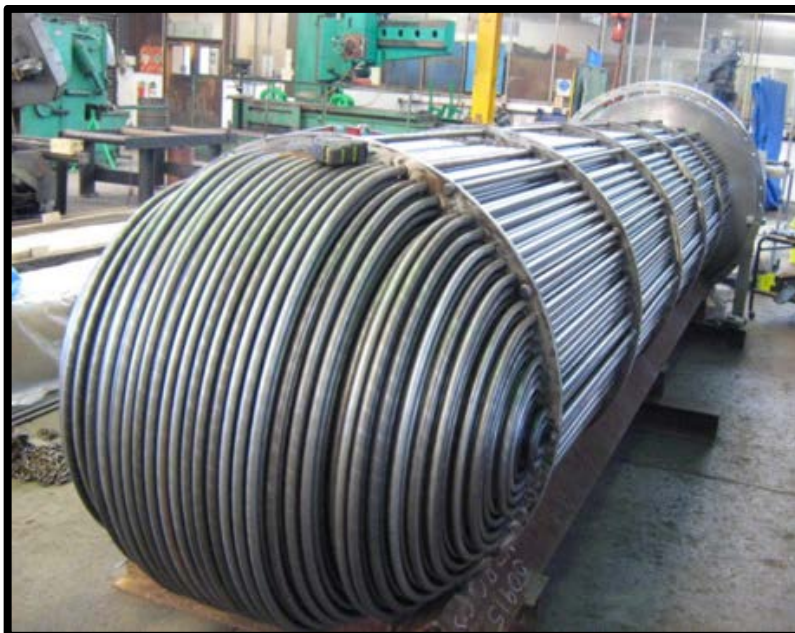
Figure 3: NTGA Carbon Steel Tube Bundle under Construction

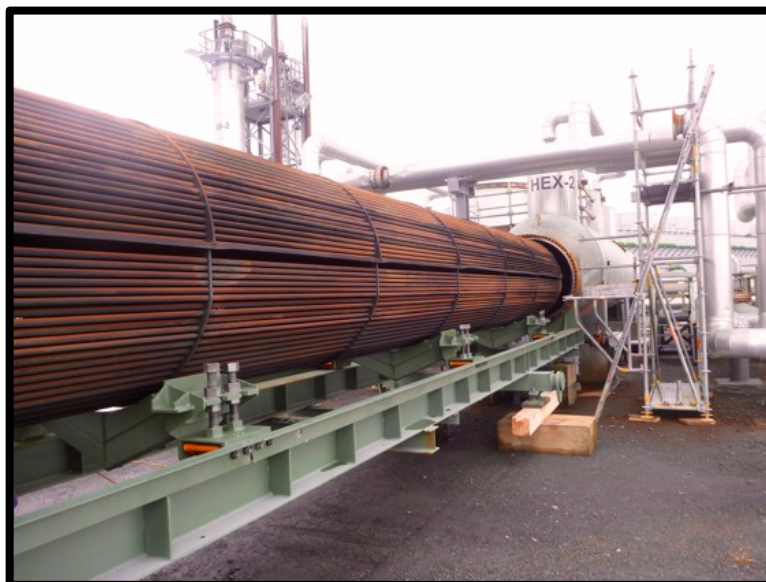
The plant was initially inspected in early August 2018 with the HEX2 reboiler out of service and the bundle extracted and visible as per Figure 4.

Figure 4: HEX 2 Tube Bundle Inspection – Late 2018 – Obvious Surface Corrosion Evident

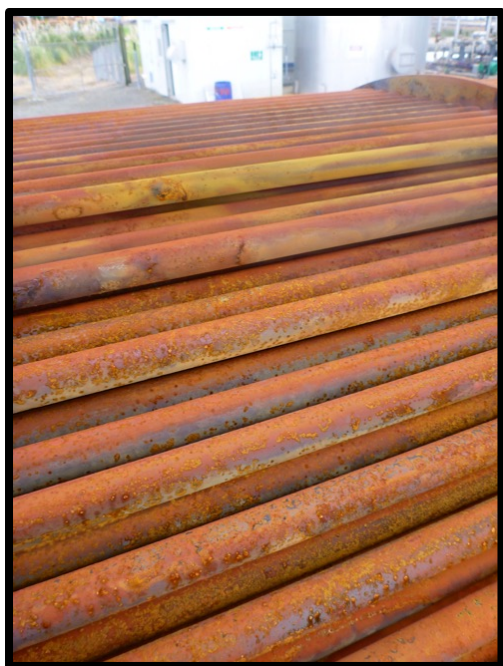
1. The bundle surface was extensively corroded, with orange, non-protective oxide or rust present along with pitting clearly visible on the surface of the tubes as per Figure 5. The rusting and pitting was most evident on the top of the bundle.
2. A significant loose crud layer of black corrosion products was present at the bottom of the bundle and inside the HEX vessel as per Figure 6.
3. Some areas of the tubes, located towards the bottom of the bundle showed partially protective oxides flaking off as per Figure 7.

Figure 5: HEX 2 Tube Bundle Inspection – Late 2018 – Rusting and Pitting Present

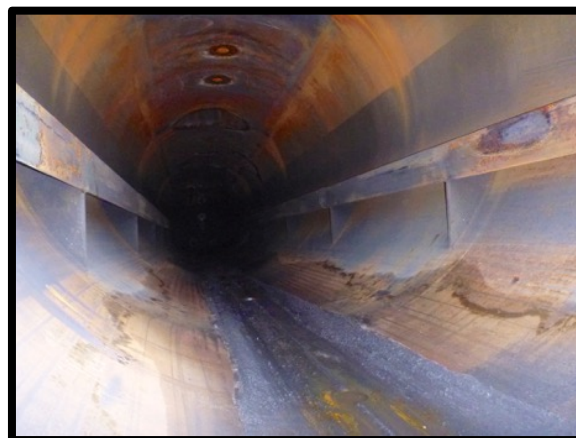
Figure 6: HEX 2 Tube Bundle Inspection – Late 2018 – HEX Shell Corrosion and Corrosion Products on Bottom

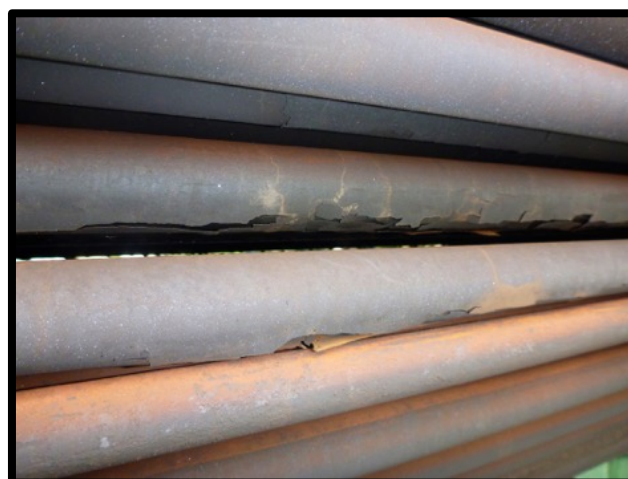
Figure 7: HEX 2 Tube Bundle Inspection – Late 2018 – Flaking Oxides

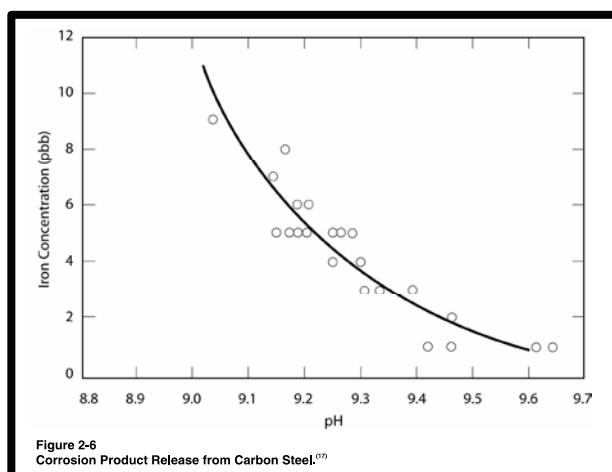
The corrosion of carbon steel is heavily influenced by pH as can be seen in Figure 8 and Figure 9, with the optimal water pH for any drum type boiler constructed from carbon steel being 9.8 to 10. This protection is due to the formation of a passive, protective iron oxide layer on carbon steel via reactions between the metal, moisture and oxygen present in the environment. The reaction is self-limiting and results in the formation of a stable oxide film, which is normally comprised of magnetite or Fe_3O_4 , and the liberation of a small amount of hydrogen gas. This is demonstrated in the following simplified reaction:

Figure 9: Influence of pH on the Corrosion of Carbon Steel – pH 8.8 to 9.7⁵

The corrosion of carbon steel is heavily influenced by pH as can be seen in Figure 8 and Figure 9. When hydrogen sulfide is present in a boiler or reboiler water and sufficient oxygen is present, there will be a rapid reaction resulting in the formation of sulfuric acid and an immediate drop in the pH of the solution with the solution becoming acidic.

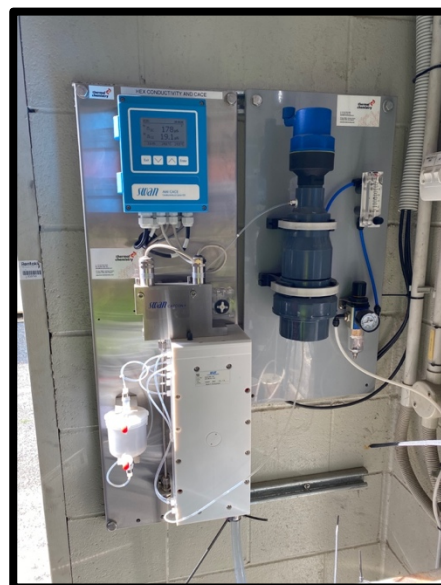
Swan Analytical¹⁰ has developed a new type of CACE analyser, as shown in Figure 10 that utilises a self-regenerating resin system based on Continuous Electrical Deionisation (CEDI) technology that does not need manual resin servicing or changing when in operation. This means that the influence of ammonia and sodium hydroxide is negated and minimal maintenance is required.

Figure 10: SWAN AMI CACE Analyser (right) with Geothermal Specific Modifications (left)

This analyser was purchased and installed for each HEX unit to base the HEX blowdown control on CACE rather than just conductivity with the final control values to be determined after further optimisation work. However, there were potential concerns related to hydrogen sulfide impacting on the CEDI regeneration unit. A factory approved field modification to prevent any residual hydrogen sulfide from interfering with the CEDI regeneration was carried out and tested prior to NTGA purchasing the unit. This unit involves air oxidation of any residual hydrogen sulfide and can be seen in Figure 10 to the left of the standard analyser

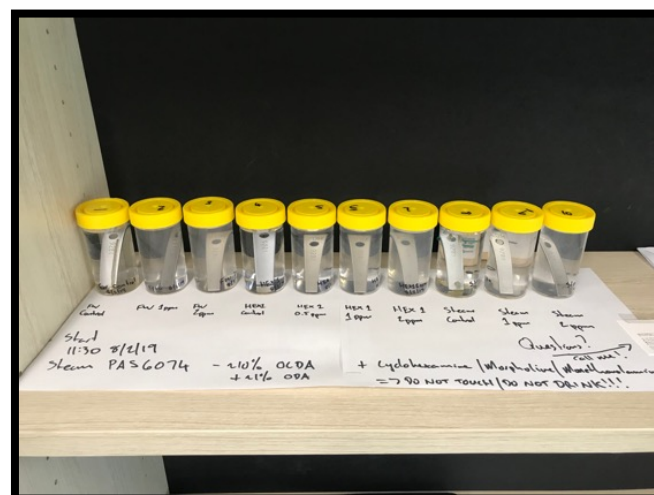
The starting condition of the coupons can be seen in Figure 11. It must also be noted that the Feedwater and Steam control (no dosing) samples immediately started corroding on exposure to oxygen which is only 1 hour after the coupons were placed into the solutions. This was not the case for the HEX control sample that had sodium hydroxide dosed into it. The coupons of 2 mg/Las product dosed immediately showed signs of “cloudiness” in the samples whilst the 0.5 and 1 mg/L samples did not.

Figure 11: Trial Start – Initial Coupon Exposure

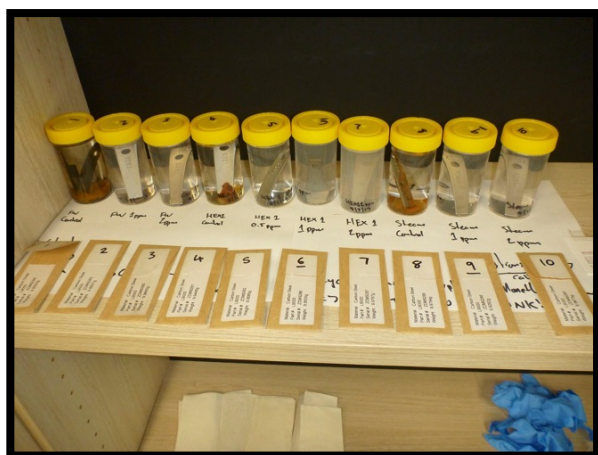
After 129 days of exposure the control coupons for feedwater and steam were showing extensive corrosion with the HEX control sample showing a lower rate. The dosed coupons showed no signs of corrosion as per Figure 12. However the 2 mg/L dosed samples showed significant cloudiness.

Figure 12: Trial End – Final Coupon Exposure

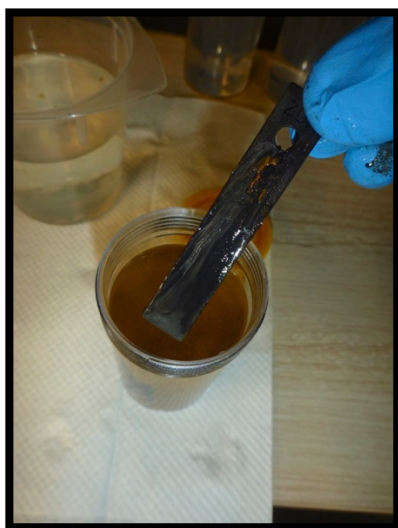
The corrosiveness of the feedwater and steam with just ammonia present when exposed to oxygen is shown in Figure 13 and Figure 18 which show significant and extensive corrosion damage. The effectiveness of sodium hydroxide dosing for lowering corrosion rates in the actual HEX water is shown in Figure 15. For the other figures (Figure 14, Figure 16, Figure 17 and Figure 19) the effectiveness of the OLDA and OLA as corrosion inhibitors is clearly evident with full effective corrosion inhibiting shown at just 0.5 mg/L dosage, which is 50% less than the suppliers' recommendation. At concentrations of 1 mg/L or higher, cloudiness was apparent and this is an indication of the OLDA and OLA starting to come out of solution and form microscopic wax like particles in suspension.

Figure 13: Trial End – Feedwater Control Coupon

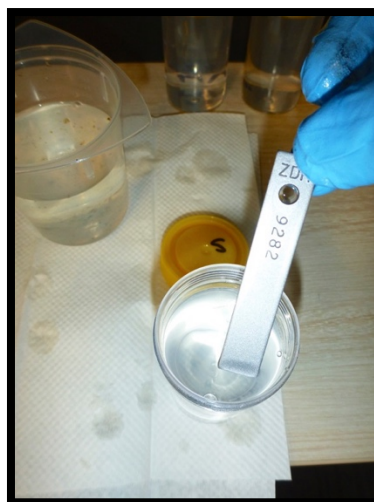
Figure 16: Trial End – HEX 0.5 mg/L Coupon

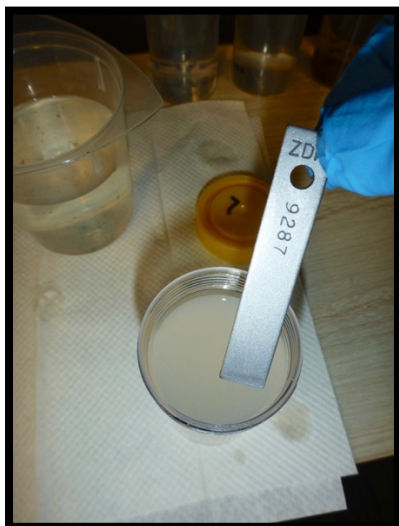
Figure 17: Trial End – HEX 2 mg/L Coupon

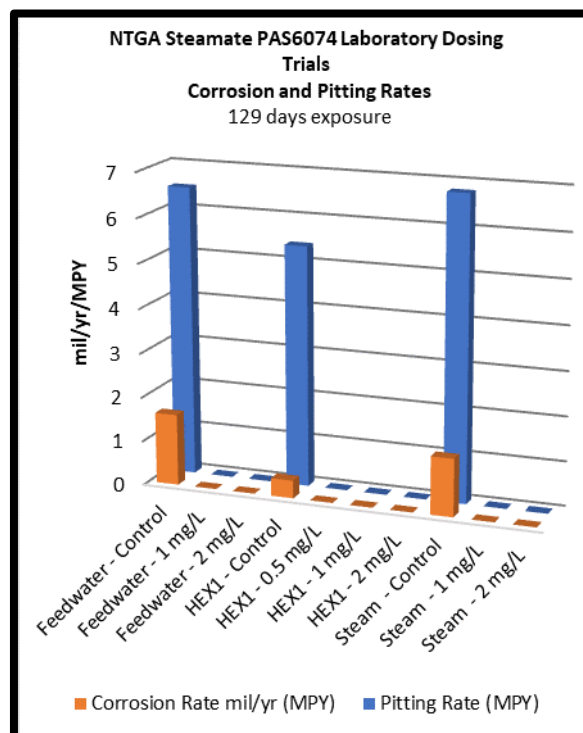
These results were extremely positive with the un-dosed control samples showing very high corrosion rates for both millimetres per year, pitting rate and pitting depth, whilst the dosed samples showed almost no corrosion at all or corrosion rates below measurable values.

Figure 20: Steamate PAS6074 Trial Corrosion Rate and Pitting Rate Results

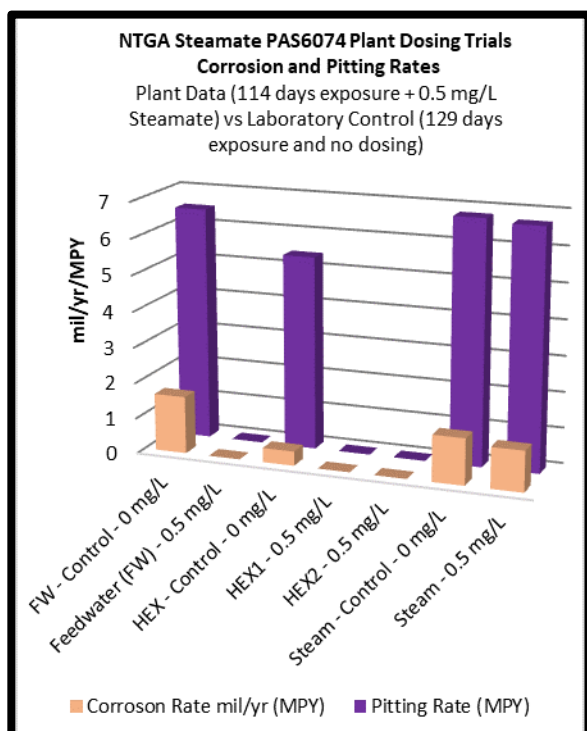
Preliminary corrosion coupons were extracted for analysis after 114 days of exposure with the key results shown in Figure 21. For the feedwater and HEX coupons both the corrosion rate and pitting rates were zero indicating complete corrosion protection compared to the control samples. For the steam coupon the result showed only a 23% decrease in weight loss rates compared to the undosed control samples which indicates a lack of Steamate PAS6074 residual in the steam possibly due to consumption and decomposition in the HEX's.

Figure 21: 114 Days Steamate PAS6074 and Sodium Hydroxide Dosing Corrosion and Pitting Rate Compared to Undosed/Dosed Lab Controls

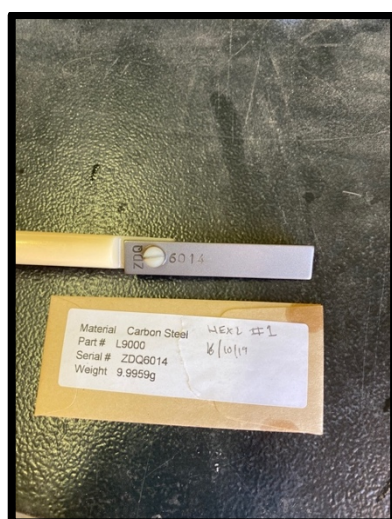
The visual appearance of one of the HEX coupons after 114 days of exposure to a flowing HEX water sample can be seen in Figure 22. Note the extremely clean and uncorroded appearance of the HEX coupons was the same for both HEX units and is consistent with the very low corrosion and pitting rate results obtained.

Figure 22: HEX1 Corrosion Coupon after 114 Days in Service Exposure with Sodium Hydroxide and Steamate PAS6074 Dosing

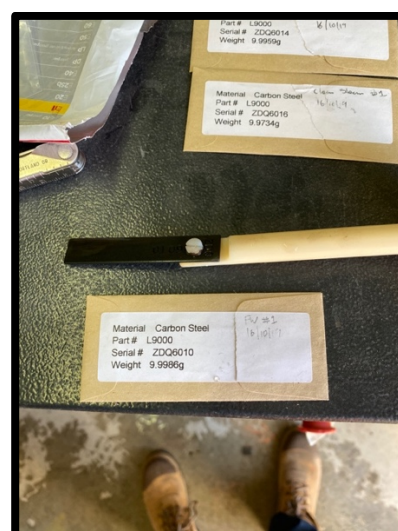
The visual appearance of the feedwater coupon can be seen in Figure 23. Whilst the corrosion and pitting rates were extremely low, the coupon shows a change in appearance which appears to be a fine, stable surface oxide layer. Further

investigations are underway to determine the composition of this surface layer.

Figure 23: Feedwater Corrosion Coupon after 114 Days In Service Exposure with Sodium Hydroxide and Steamate PAS6074 Dosing

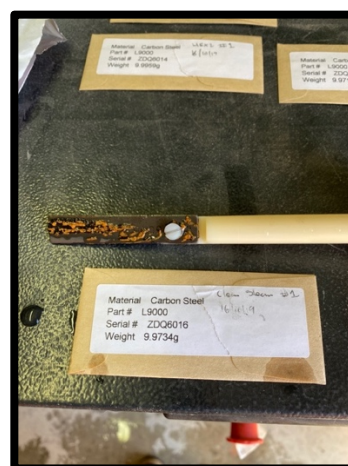
The visual appearance of the clean steam coupon can be seen in Figure 24. Active corrosion is evident on the coupon which is consistent with the slightly decreased corrosion and pitting rate compared to the control sample. Further optimisation of the dosing to impart improved protection to the steam system is required and being investigated.

Figure 24: Clean Steam Corrosion Coupon after 114 Days in Service Exposure with Sodium Hydroxide and Steamate PAS6074 Dosing

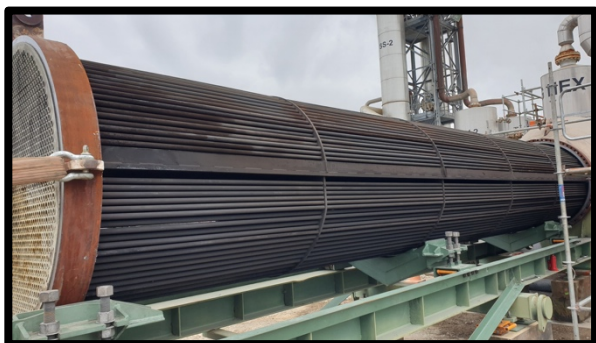
HEX1 was able to be inspected in February 2020 with the bundle extracted for routine maintenance work. The bundle was considerably different in appearance from the previous inspection in 2018 as shown in Figure 4, Figure 5, Figure 6 and Figure 7 with no active corrosion observed as rusting or pitting; a smooth, passive protective oxide layer present on the tube surfaces; and a lack of corrosion products and crud in the bottom of the HEX unit unlike what was reported for this unit at its previous inspection. Note that this bundle was replaced in 2015 with an all new bundle whilst HEX2 was the original bundle.

Figure 25: HEX1 Full Bundle with No Active Corrosion Present

Combined with the corrosion coupon results, the physical plant inspections show that the previously active corrosion and degradation of the bundle has been halted with the change in chemical dosing to include sodium hydroxide for pH control and hydrogen sulfide neutralisation and with Steamate PAS6074 for additional corrosion inhibition.

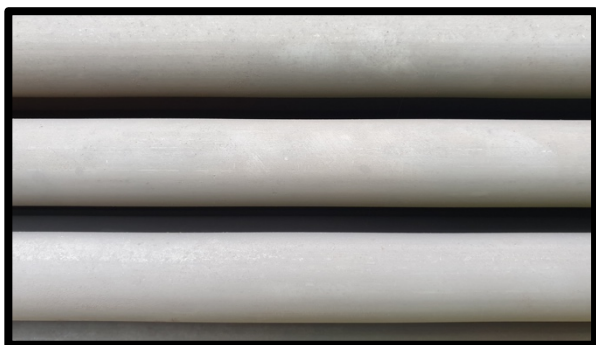
Figure 26: HEX1 Tubes with No Active Corrosion
