# USE OF SWAGES AS A TUBULAR REPAIR ALTERNATIVE FOR GEOTHERMAL WELLS

William Duran <sup>1\*</sup>, Jamie Macintosh <sup>1</sup> and Erin Doyle <sup>2</sup>

<sup>1</sup> Western Energy Services, 132 Rakaunui Road, Taupō, New Zealand

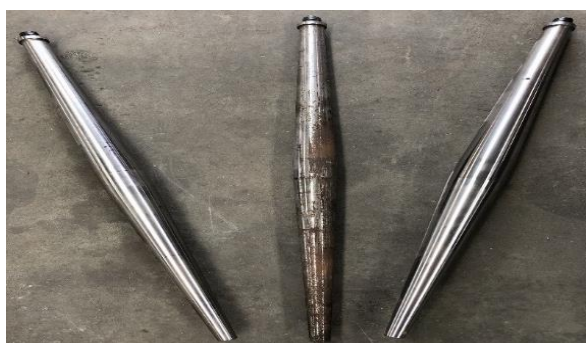
Swaging at Western Energy began by manufacturing a set of swages with an outside diameter ranging from 2.4"-3" (See Figure 2). Starting with small size swages was the most viable option as the hard steel material, and labour presented a high cost. The swage tool design was based on the following considerations:

**Figure 2: Images of fabricated swages: 2.4in, 2.6in, 2.8in (ODs Left to Right)**

In our experience, where we have been opening up restrictions predominately for geothermal well abandonment works (ranging from 2.4" – 3.25"), we have found that having swages stepping up in 0.200" increments has proved most efficient for swaging out damaged casings. This technique has also limited the work/stress being put onto the wireline while carrying out the swaging, therefore reducing the risk of fatigue on the wireline.

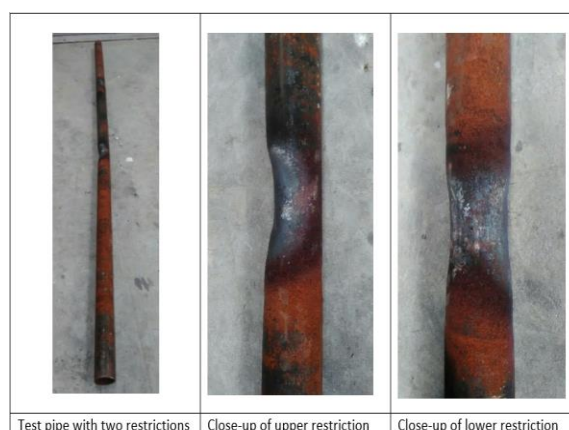
The test pipe was prepared based on the following considerations (see Figure 3):

- 3.5in OD, 3.0in ID.
- 3m long.
- Upper restriction of 2.8in OD (expected 2.3in ID).
- Lower restriction of 2.1in OD (expected 1.6in ID).
  - That is 2.1in OD at narrowest point (Restriction OD Range 2.1-2.8in OD).
- Welded to 4in 900# flange so it can be secured to the test stand and filled with water.
- A test stand is secured to the ground with 8 16mm diameter 100mm long concrete anchor screws.

**Figure 3: Test Pipe Images**

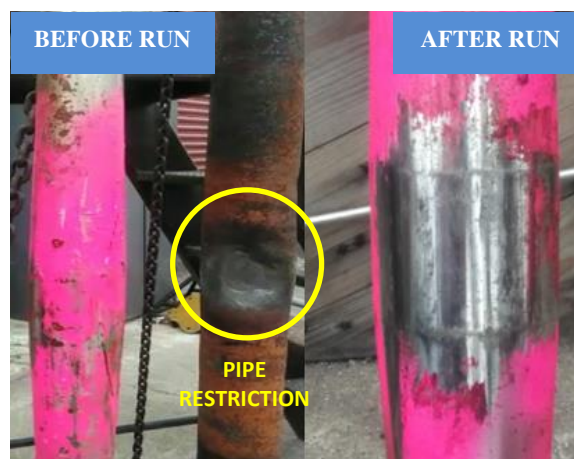
The outcome of the test is shown in Figure 4.

**Figure 4: Casing restriction and swage before and after the run**

Overall, the trial should be considered a success. The swages were able to open the two tubing restrictions to 2.8in ID. Table 1 gives the results obtained from this trial.

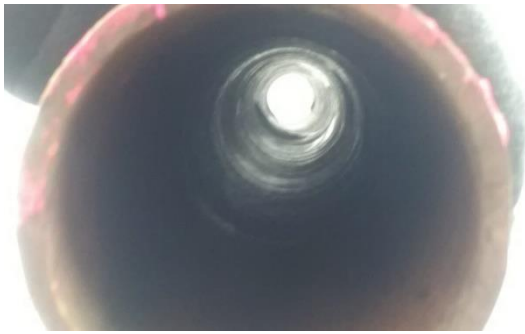
The tubular got re-shaped by incrementing the swage size after multiple passes, as shown in Figure 5.

**Figure 5: Re-shaped Tubular**

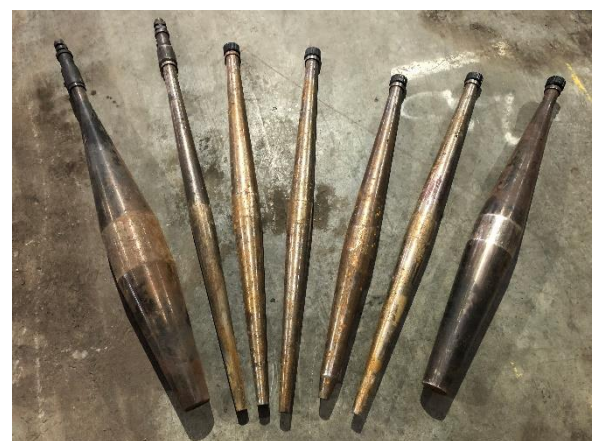
**Figure 7: Multiple OD swages**
