EROSION AND CORROSION PROBLEMS EXPERIENCED DURING THE OPERATION OF GEOTHERMAL TURBINES IN ITALY

Maurizio Bracaloni¹, Giorgio Culivicchi¹, Bruno Fornari¹

¹ENEL S.p.A. - DPT/VDT/G, Via Andrea Pisano 120, 56122 Pisa (Italy)

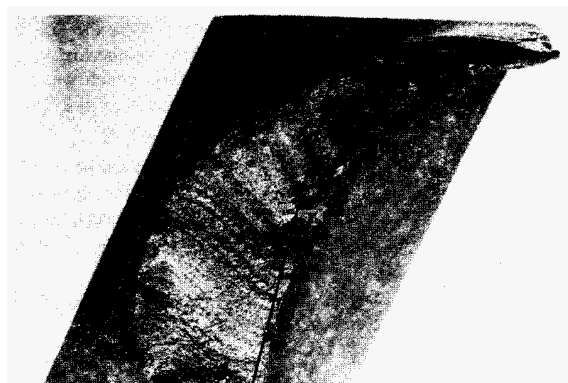
Besides the currently known phenomenon of blade failure from fatigue in some cases was caused by breakages in the binding wire (fig.7, 8), often because the more or less extended pit corrosion; a series of breaks connected with stress corrosion cracking phenomena was also detected.

Figure 8. Twenty MW turbine, Blade of eleventh row
Fatigue breakage material UNI X12CrMo13
magnification 5x
