## Mitigating the Impact of Landslide Hazards in PNOC-EDC Geothermal Fields

Winston Philip C. Pioquinto and Joeffrey A. Caranto

PNOC-Energy Development Corporation, Energy Complex, Merritt Road, Ft. Bonifacio, Taguig City, Philippines

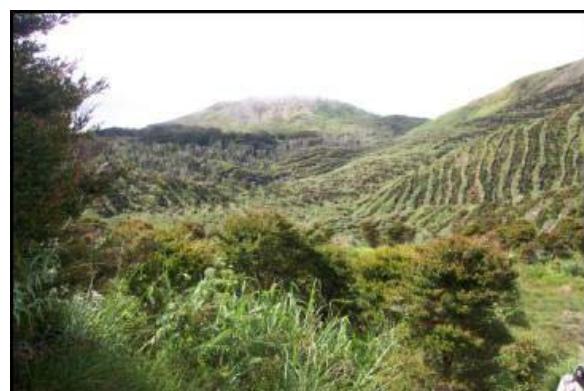
Figure 3: View of one of PNOC-EDC's reforestation project near the Mindanao Geothermal Production Field (MGPF).

The objective here is to limit the potential for slope failures rather than try to repair the damage after the event. Good land management prevents undue mass wasting. Revegetation of bare slopes and opened up areas and other soil conservation measures help in minimizing surface erosion and siltation of waterways. By declaring a specific locality as protected, all developments should cease and anthropogenic activities such as farming, slash and burn type of agriculture or kaingin should be curbed. Through the efforts of the environmental management group of PNOC-EDC, there are reforestation projects and forest protection activities being implemented within and outside the geothermal projects and even the surrounding watersheds (Fig. 3)(Pioquinto, 1999).

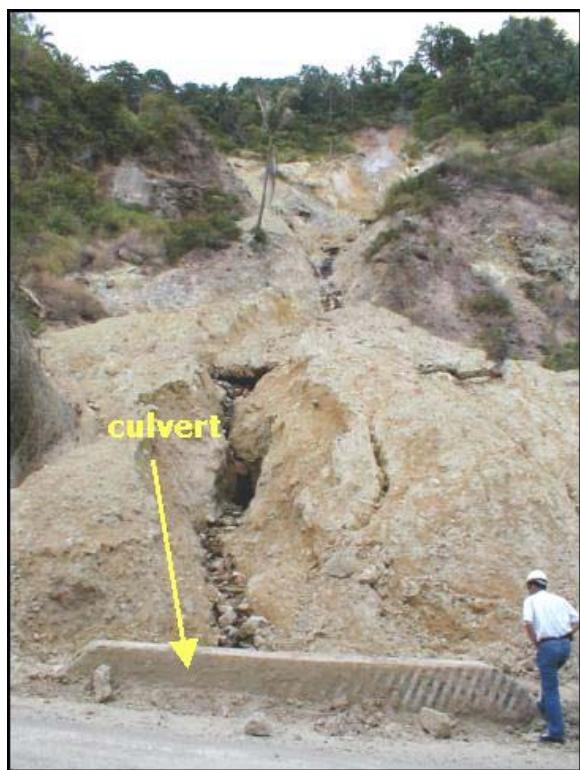
Figure 4: Photo shows the slide materials coming from the Mag-aso thermal ground in the Southern Negros geothermal field being diverted to a large culvert below the road.

The detrimental effect of slope movements could be reduced or eliminated if landslides could be induced in really susceptible areas or the sliding mass diverted to an area of least danger to decrease the effect or rightly eliminate such risk (Fig. 4). In case of rockslides and rockfalls, galleries or pipe shelters could be constructed to protect the concerned installation (Fig. 5).

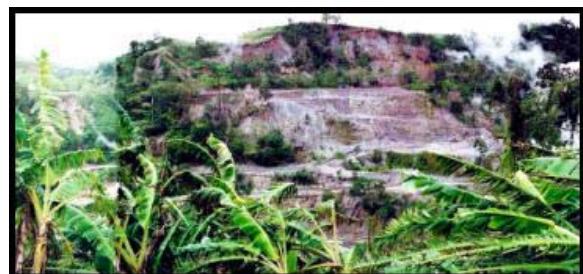
Figure 6: This is the quarry in Upper Mahiao in LGPF where the upper load was reduced and the slope face benched to prevent further slippage.

The first remediation technique was employed in the Leyte Geothermal Production Field (LGPF) at the former Mahiao quarry area. A sliding mass was detected as the toe support was removed due to quarrying. The solution therefore, was to reduce the load above the sliding mass and benching of the slope was undertaken to prevent further slippage. Figure 6 shows the removal of the upper load along the slope of the quarry face. The second scheme, control of surface water and seepage was applied in the Malitbog quarry area also in LGPF where concrete water cascades were constructed to minimize water saturation of the formation. The more common remediation technique employed at PNOC-EDC is the construction of rigid structural barriers such as rubble masonry wall and concrete retaining wall with concrete-lined canals. Figures 7 and 8 show examples of these structural barriers (Leynes et al., 2002).

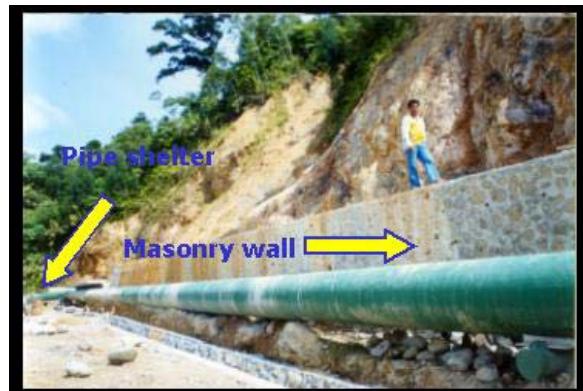
Figure 7: Picture shows a newly constructed masonry wall along the Mahanagdong-MGRD1B access road in LGPF. A pipe shelter is in the far left. These were

constructed to protect the pipeline from landslides occurring in the right side of the road.

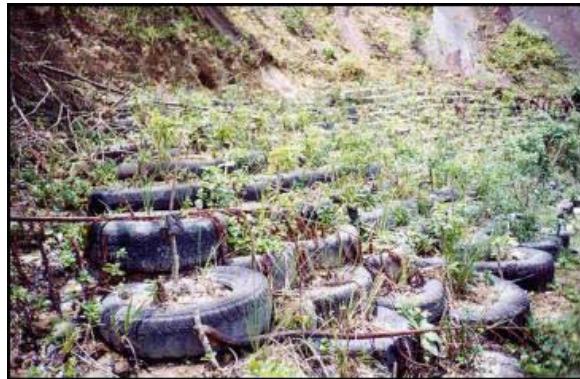
Figure 9: Old tires were overlain here in this photo near NJ-A pad periphery in SNGPF to reinforce the toe of the slope where a former landslide had occurred.

A flexible support structure is also constructed in combination with the rigid structural barriers. An example of this was implemented in the Southern Negros

Geothermal Production Field (SNGPF), Nasuji sector as shown in Figure 9. Old tires were overlain at each other to arrest a sliding mass near the pad periphery. Lastly, vegetative slope stabilization projects have been quite a common practice of PNOC-EDC. Various tree and grass species are planted to bare slopes as well as backfilled portion beside roadcuts. A Filipino technology using coco mulches, mats and fascines has been integrated along with the rigid structural barriers to mitigate a landslide prone area. Shown in Figure 10 is an example of that scheme where bare slopes are eventually revegetated as soon as enough soil accumulates along the slopes to decrease pore water pressure and seepage.
