Scaling Protection Technology for Hachijyo-Jima Geothermal Power Plant

Masaaki Shimoda, Kouichi Suzuki, Makoto Tsujita, Takashi Murakami, Shigeto Yamada and Yoshifumi Kato

Tokyo Electric Power Company / FUJI Electric Systems Co., Ltd.
4-9 Shinjuku 5-Chome Shinjuku-ku Tokyo 160-8440 Japan
1-1 Tanabeshinden, Kawasaki-ku, Kawasaki-city 210-9530 Japan

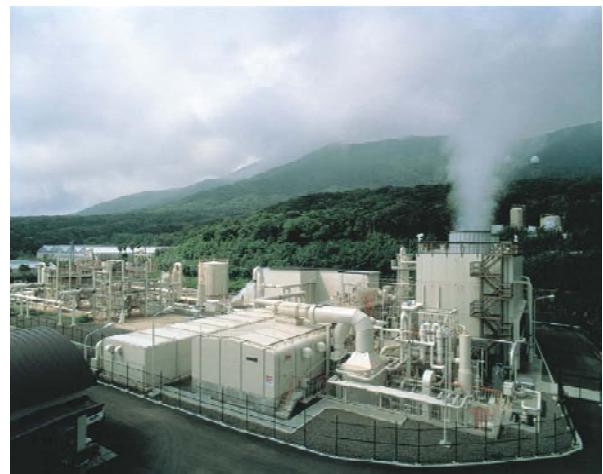
Figure 1: Hachijyo-jima geothermal power plant

Fig. 1 shows an external view of Hachijyo-Jima geothermal power plant. Fuji received the order for this plant as a turn-key project from The Tokyo Electric Power Company.

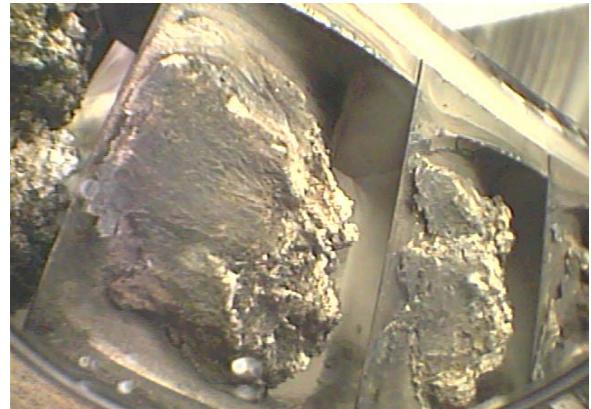
Figure 2: Scale on 1st stage stationary blade

The heavy black scaling found on the convex side of the 1st stage stationary blades consisted mainly of magnetite (Fe₃O₄), iron sulfides (FeS, FeS₂) and a trace of silica (SiO₂)(Fig.2). Scaling was not found on the concave side.

It is suspected that drain or mist carry-over from the separator may have occurred occasionally and brought impurities into the steam turbine, thereby causing the scaling problem.

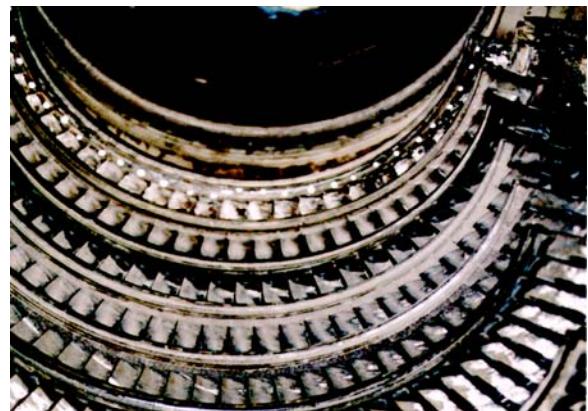
Figure 3: 1st □4th Stationary blade row

Gray-white scales were deposited on the convex side of the 1st stage stationary blades (Fig.3).

Although iron sulfides (FeS, FeS₂) were not detected in ample quantity, silica scale (SiO₂) and calcium compounds (CaCO₃) were found in significant quantities compared to levels after the 1st year of operation. Countermeasures described in the latter part of this paper, however, have been implemented to decrease the quantity of these scales.

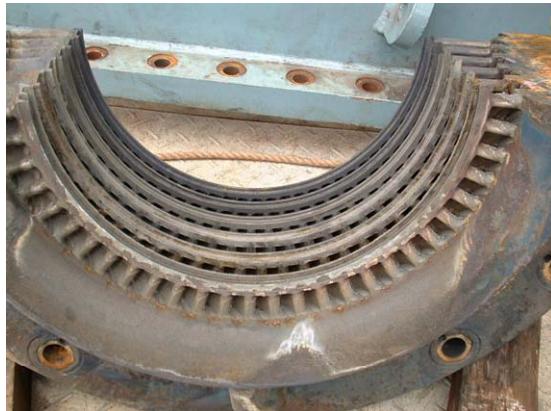
Figure 5: 1st □ 5th Stationary blade rows

The amount of scaling was quite small compared to that after the 2nd and 3rd years of operation. (Fig.5)
