Health and Safety Aspects of the Kawerau Project, Mighty River Power

Mighty River Power (MRP) has recently completed a 100MW geothermal power station in Kawerau, New Zealand.

During commissioning of the plant an incident occurred which involved the discharge of non condensable gas. This incident and the resulting investigation are reviewed and the outcomes are presented. A number of lessons have been taken forward to MRP's next project. These lessons are also pertinent for the wider geothermal industry.

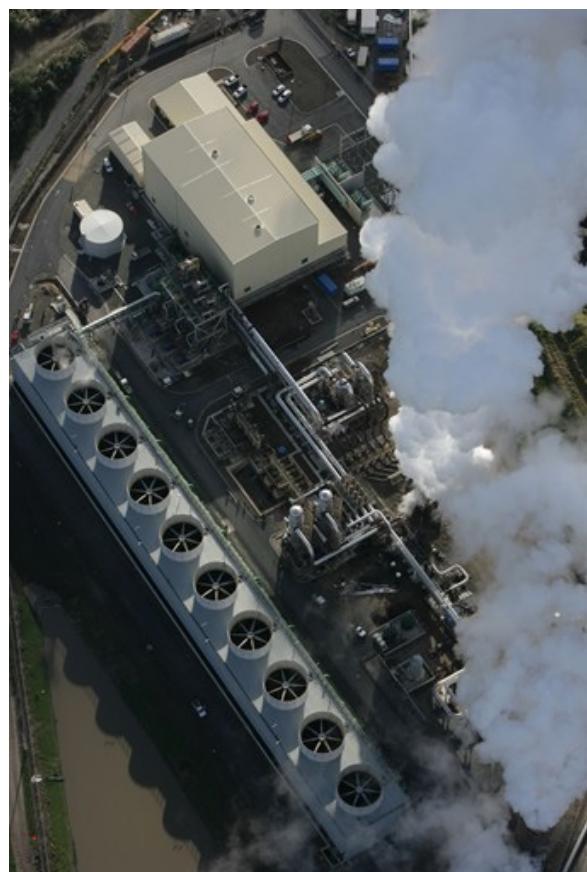
Figure 1: Kawerau Geothermal Power Plant

Figure 1 shows the Kawerau power station during commissioning.

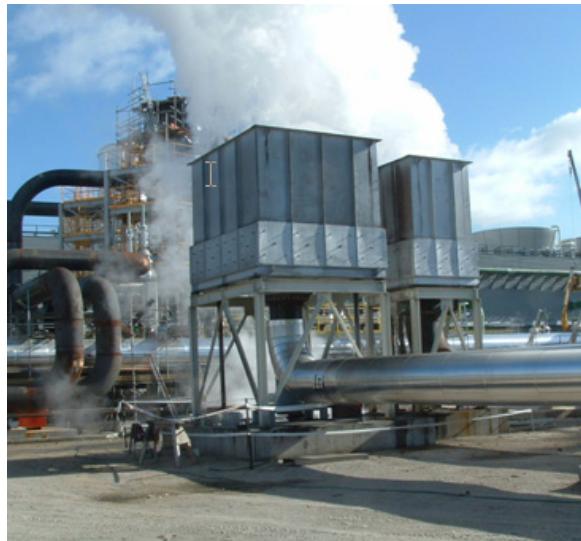
Figure 6: High Pressure and Low Pressure Silencers in Operation during plant startup.

The steam blow process occurs during the initial phase of plant warm-up during commissioning, or after a shut. During this time steam including NCGs are discharged from the high and low pressure silencers as shown in figure 6.

The Kawerau plant is constrained by the site geography and the silencers are located within the steam separation area. In other geothermal plants, if space permits, the silencers are located away from the main plant in the area of geothermal brine soak pits.

As a result of the investigation the direct cause was ascertained as follows. When the plant is shut-down the fluid in the steamfield pipelines is drained. This can leave NCGs in the pipeline which, being heavier than air, do not vent. If the NCGs remain there for a period of time some H₂S could have been converted into elemental Sulphur. This is a known phenomenon through the reaction of CO₂ to form carbonic acid and in turn a reaction with H₂S to form elemental sulphur.

The hazard was compounded due to the location of the silencers within the plant (due to site land constraints). In addition Kawerau has reasonably long production pipelines from the geothermal wellheads to the plant. This gives rise to a high “process inventory” of NCG giving rise to significant exposure time (20-30s) to high concentrations of gas.

MRP have put in place all of these recommendations for Nga Awa Purua. Gas dispersion modeling was completed. The selected solution, based on the dispersion modeling, is the same as adopted at Kawerau, where a vent pipe was installed and discharging gases over the cooling tower giving wide dispersion and avoiding unsafe concentrations of gases.
