Addressing the Problem of Decreased Capacity of an Injection Well Due to Accumulation of Debris - the Experience in Well KN1RD, Philippines

Energy Development Corp. – Mindanao Geothermal Production Field, Cotabato, Philippines 9400

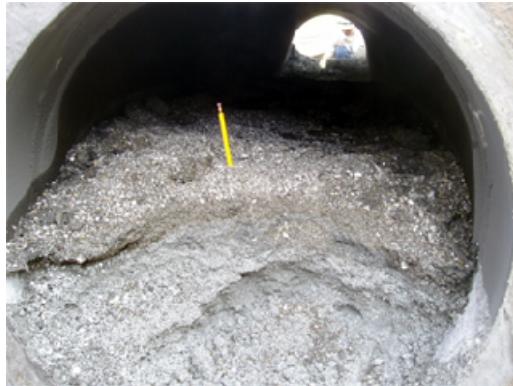
Figure 4. Solids discharged by the well and collected from the solids trap consists mostly of formation rocks with small amounts of corrosion products and silica scales. Silica forms a thin layer around the solids which binds the solids together. The petrology of the rocks gave a clue to the source production well.

A total of 24 cubic meters of debris was removed from the well composed of rock fragments, corrosion products and mineral scale components (Figure 3).

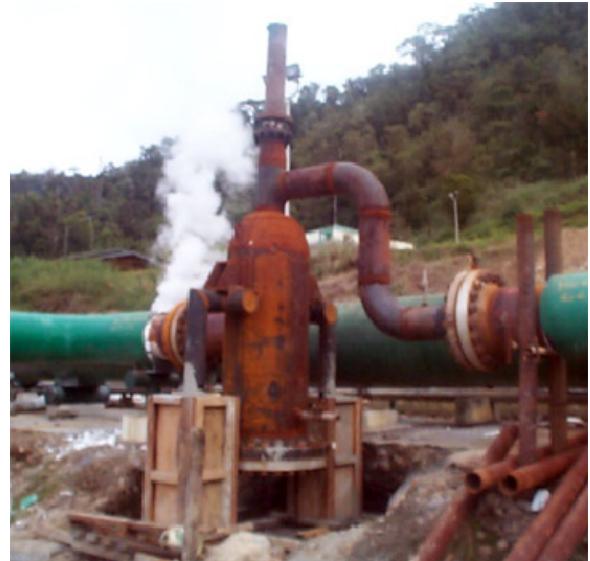
Figure 5. The two-phase strainer installed in a production well suspected of contributing solids. The strainer reduced the power output of the well by 1-2 MW and was subsequently removed.

Figure 5 shows the strainer installed along the two-phase line upstream of the separator stations in June 2003. The strainer was removed in October 10, 2005.

Installation of a two-phase strainer in KN5D used about 2 kg/s of steam equivalent to 1 MW based on flow measurements. After nearly three and a half months of continuous utilization, no debris or solids were 'captured' by the strainer. Apparently, the solids produced by KN5D are finer and are believed to be effectively scrubbed at the separator stations. The purpose of the solids strainer is to scrub solids outright from the well before the two-phase fluids are mixed and to reduce solids carry over that is not scrubbed at the separator. The finer solids debris (< 1mm) produced by the well are partially captured in the solids trap but most are carried over into KN1RD. The design of the solids strainer needs improvements to efficiently capture the solids carry over. The removal of the strainer resulted in a minimal gain in output.

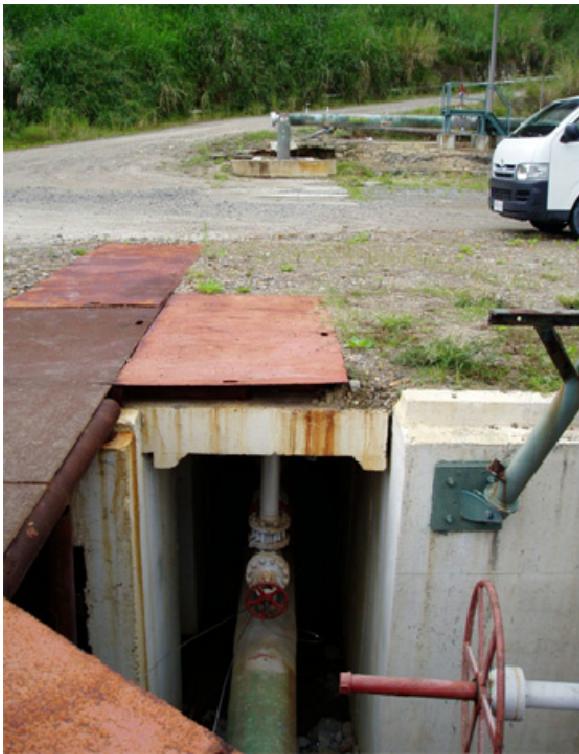
Figure 6. The original location of Pad C MBL solids trap in a deep cellar. The trap was only 18" in diameter and produced a fluid flow that was not effective in capturing large amounts of solids.

The original location of the 24-inch diameter solids trap in pad C was at the pipe trench leading to well KN1RD (Figure 6). The solids trap was relocated to the surface upstream of the main brine line (Figure 7). The relocation was completed in July 2003. Initial inspection of the ST after four months of continuous utilization found more accumulation of solids debris compared to its original location at the pipe trench. However, the debris profile inside the pipe suggested two-phase flow or high velocity failing to efficiently capture more solids entrained in the brine. To address this occurrence a provisional solution was implemented where the 6-inch diameter level control valve (LCV) found downstream of the separators was replaced with an 8-inch diameter pipe spool. Inspection thereafter showed debris profile inside the ST with a "smoother, laminar" (lower velocity) flow being attained. Finer solids debris was observed to be captured by the solids trap. However, subsequent inspections indicated again two-phase flow conditions. To reduce fluid flow velocity and control occurrence of two-phase flow, the pipe size of the ST was increased from 24-inch to 30-inch diameter. This proved to be efficient based on the subsequent inspections where debris profile suggested fluid flow velocity has been significantly reduced thereby increasing solids capture.

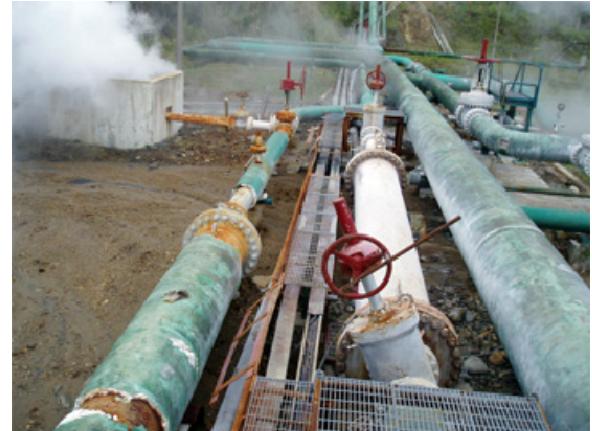
Figure 7. Above shows the location at pad surface of the two 30"-diameter solids trap modification from the original set-up. Adding a redundant solids trap allows cleaning of one solids trap at a time without affecting continuous brine injection.

Apart from the foregoing changes implemented, a redundant line was constructed parallel to the main brine line (MBL2) and installed with a 20-inch diameter ST (Figure 7). In the same manner as the main ST, the 20-inch diameter pipe was later replaced with the 24-inch diameter pipe installed previously in the MBL2. The redundant line was commissioned in November 2003. The redundant line is primarily utilized as a bypass brine line during inspection/clean out of the main brine line solids trap. On inspection of the redundant ST, debris profile almost always shows two-phase flow profile. The flow profile is

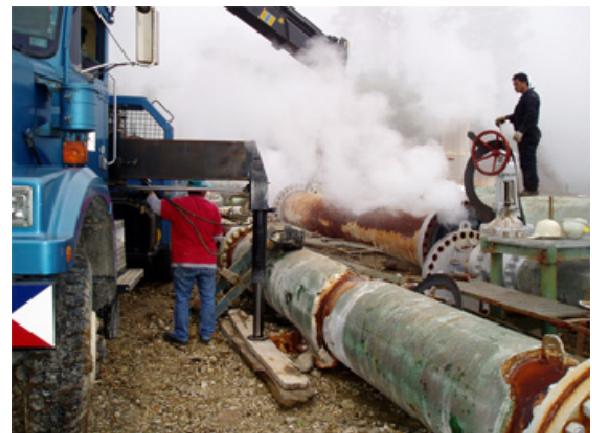
Figure 8. Maintenance crews conduct regular monthly cleaning and inspection of the traps to maintain its efficiency.

The regular cleanout of solids trap began May 2004 (Figure 8). Figure 2 shows the trend of debris collected during inspection of the solids trap. As much as 1930 kg of debris was accumulated in the solids trap after the Mindanao-2 Power Plant shutdown in February 2005 (Figure 4). Correlation with the injection flow to KN1RD indicated a significant decline. Injection flow decreased to 30 kg/s although the well showed some recovery but not to its initial acceptance. The huge volume of debris apparently reduced the capacity of the STs. After nearly blocking the STs, solids carry over into KN1RD increased thus reducing its flow acceptance based on the tracer flow measurements conducted. The debris collected is characterized as 50-80% rock fragments, 15-40 % corrosion products and <10 % amorphous silica (Dulce, 2003). As mentioned earlier, debris removed from KN1RD in the 2004 workover is characterized as sand-sized fragments which are easily

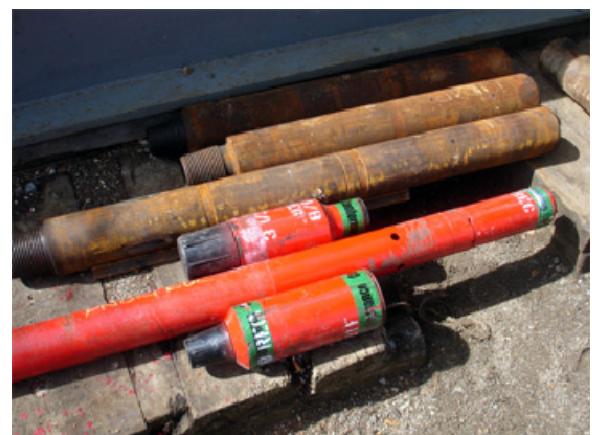
Figure 11. The venturi jet assembly was used during the last workover in KN1RD to remove the solids fill at the bottom of the well which cannot be circulated out by the rig.

The rig attempted to drill out the obstruction but experienced high torque and over pull (Javier, 2005). As planned, a venturi jet with 5-3/4" core type junk basket assembly was run-in and tagged the obstruction. The venturi assembly was able to recover fills composed of sandy materials composed of rock debris consistent with those recovered from the MBL solids traps. A further three washing of liner passes were conducted by the rig before the workover was completed.

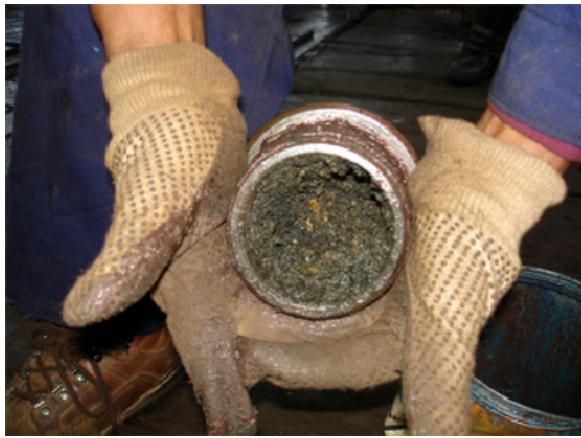
Figure 12. Sand sized rocks collected by the venturi jet from KN1RD. Although the tool was successful in capturing a large amount of solids, the limited volume of the tool requires multiple run-ins which were considered impractical.

Because the workover / venturi jet was largely unable to extract a large volume of the solids debris at the bottom of KN1RD, a sustained discharge of the well was programmed to eject the fill. The well was heat-up for 35 days and discharged on April 18, 2008. The well sustained discharge for five days and afterwards shut for subsequent use of the well for injection. Dumping immediately ceased after cut-in of KN1RD indicating full acceptance of brine.
