Improved Efficiency of Solid Trap Installed in Brine Injection Pipeline of Leyte Geothermal Production Field, Philippines

Ruperto R. Villa, Jr., Ellen Grace C. Corona, Erlindo C. Angcoy, Jr., Jose Rufino S. Peñaranda, Ulysses Rex P. Bontia and Edwin H. Alcober

Energy Development Corporation, PNPC Complex, Merritt Road, Fort Bonifacio, Makati City, Philippines

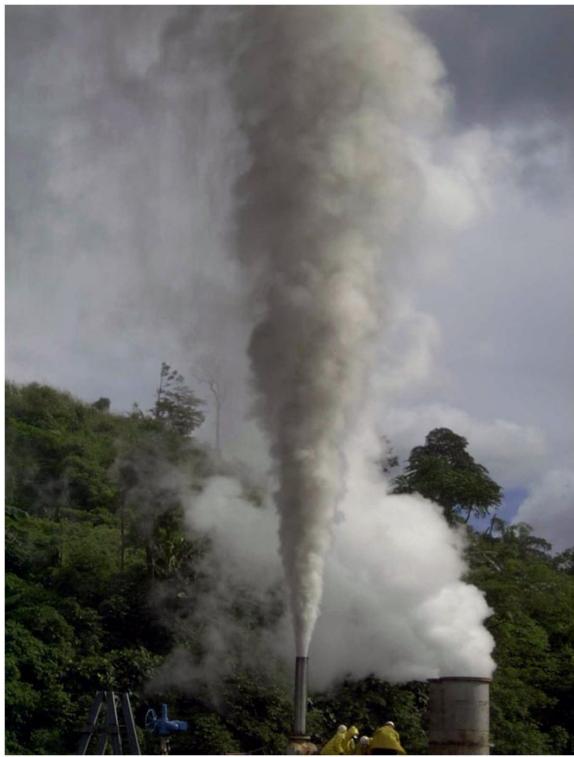
Figure 2: Well 1R3D clearing discharge showing some dark debris being ejected.

trap installed was able to collect only a small amount of solids. But when it was vertically discharged in October 23, 2001, significant volume of tiny particles of solids were ejected (Fig. 2). indicating that the solids were not captured by the original solid trap and were deposited inside the well bore that eventually blocked the well and dropped its injection capacity (Villa, 2002).

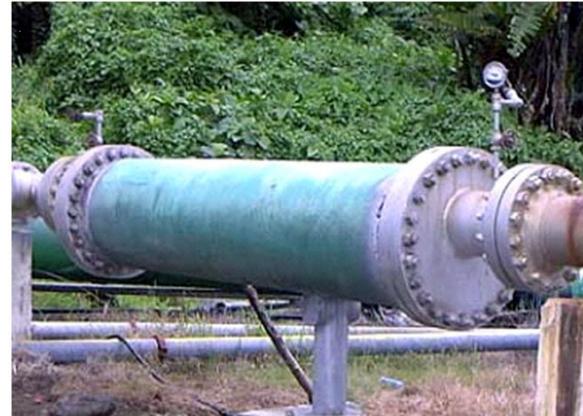
Figure 3: The original 1R8D solid trap installed.

The original solid trap installed in 1R8D is a single, 20-inch diameter pipe around 6 meters in length (Fig. 3). Due to minute size of the solids captured by the brine and the high velocity and turbulent nature of the brine (Reynold's number = $>4,500$) flowing along the brine line, this solid trap was ineffective because when it was opened, only a small amount of solids were collected. This was contrary to the observation upstream in the separator and flash vessels, that significant amount of solids were deposited.

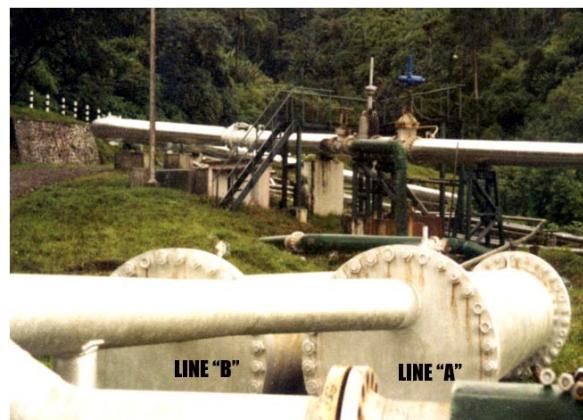
Figure 4: The new 1R8D modified solid trap installed.

The characteristic of the solids captured by the wash fluid is that it has a sandy texture and with a particulate size that tends to be lighter and remains suspended in the brine if the velocity is high enough to carry it. But if the velocity is significantly reduced and the flow is laminar, these solids will have enough time to settle. This was noted from the solids deposition mechanism at the bottom of the FV-100 brine drum. The modified solid trap was designed to significantly reduce the brine velocity. It allowed sufficient time for the captured solids to settle down before the brine exits the solid trap and injected into the well. It consists of two 36-inch pipe by 7.5 meters in length installed parallel to each other (Figs. 4). The velocity of the brine inside the solid trap is significantly reduced due to the increase in the

diameter of the pipe from 10 inches to 36 inches aided further by dividing the total flow into two lines. Furthermore, double-baffle plates were installed inside the solid trap to serve two purposes: (1) to reduce further the velocity of both brine and solids inside the large-diameter pipe (Reynold's number = ~ 1200); and (2) deflect the settling solids at the bottom of the slow moving brine, allowing only the cleaner upper portion layer to overflow to the next chamber. The outlet of the solid trap was located near the top to allow the solids carried to the second chamber to settle further and allow the upper layer brine that is relatively free of solids to pass through.

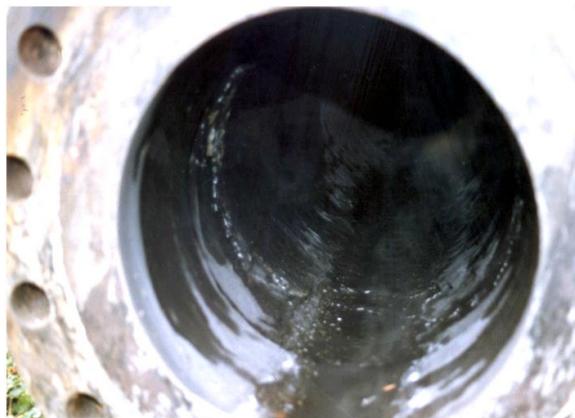
Figure 6: Minimal debris collected at the main brine line even after the installation of the new modified solid trap.

To determine its efficiency, it was decided to visually inspect the internals of the modified solid trap. It was opened and inspected on July 2-3, 2003. Both ends of the two parallel 36-inch solid traps were opened. Upon inspection, there was no observed deposition at the main brine line (Fig. 6). However, there was a significant amount of deposits inside the modified solid trap. It was noted that significant amount of solids were collected inside the solid trap near the end section (Figs. 7 to 8). The total weight of the debris collected was 3,445 kg, for an estimated deposition rate of 20.6 kg/day (Villa, 2002).

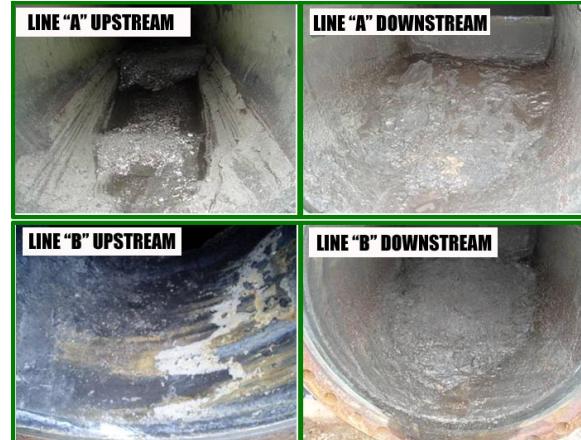
Figure 7: Photos inside the modified solid trap inlet and outlet during first inspection.

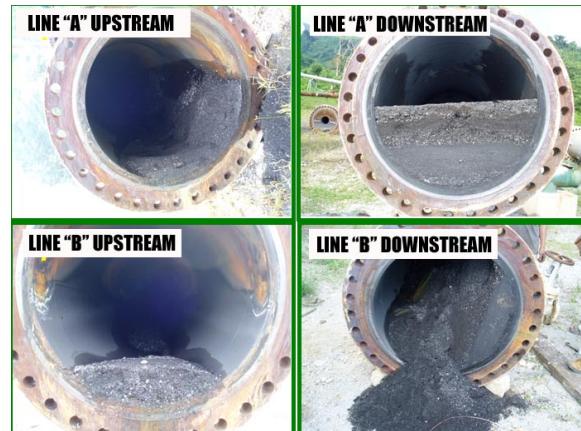
Figure 8: Photos inside the modified solid trap inlet and outlet during the succeeding inspection.

Well 1R8D modified solid trap was almost totally filled near the top of the baffle plates when opened (Fig. 8). In fact, it is suspected that some of the solids were partly

carried over by the brine into the wellbore based on the profile of the solids that was deposited. Deposition was significant since the utilization of the solid trap until it was opened is 167 days from commissioning. With the 3,445 kg of solids collected, it translated to 20.6 kg/day of debris retained in the solid trap. If this amount was not removed from the brine, it is likely that the capacity of well 1R8D would have eventually declined much earlier. These solids will fill the wellbore permeable zones similar to 1R3 and eventually drop the capacity of the well to accept the injected brine.

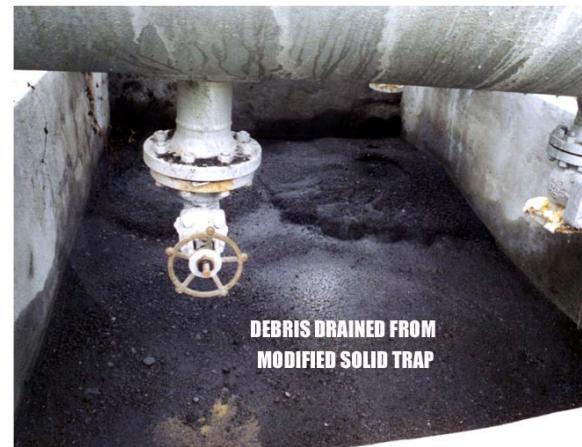
Figure 9: Debris discharged from the Modified Solid Trap drain box.

However, based on observation during inspection there is a limit in the capacity of the modified solid trap to capture the solids. Its efficiency to trap the solids would be reduced when the solids start to build up and begin filling the chambers near the baffle plates at the end section of the solid trap. It is, thus, proper to prevent the captured solids from accumulating inside the solid trap through regular

draining of the drains installed near the baffle plates (Fig. 9). Also, a bi-annual inspection and cleaning should be conducted.
