## Design and Construction of the Kawerau Steam Field

KC Foong<sup>1</sup>, Jay Valaval<sup>2</sup>, Michael Rock

**Keywords:** Steam field, Design, Construction

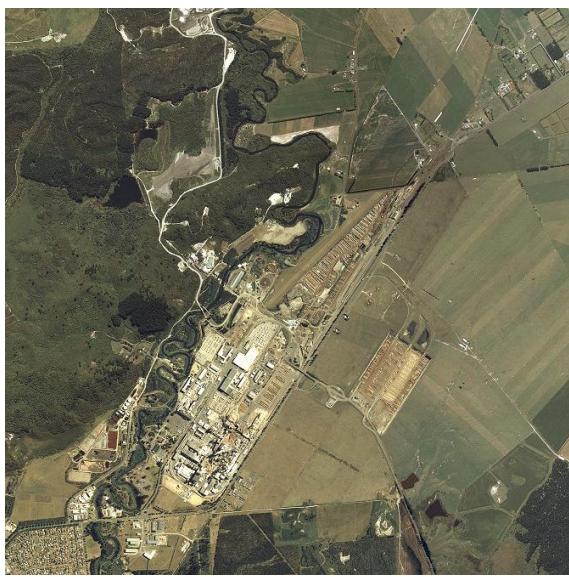
**Figure 1A: The steam field site**

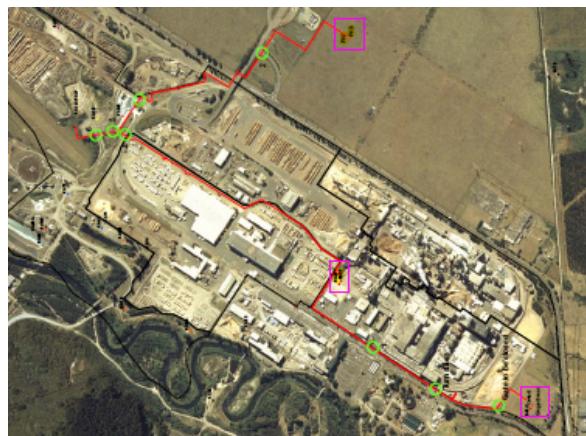
There are only three well pads in the steam field. Each well pad has two production wells. The first well pad is located in the Putauaki Farm. The two phase fluid from this well pad flow inside a single header pipe to the industrial plant site. It goes through several road culverts, crosses over a state highway on a bridge and runs through a log yard area.

**Figure 3: The two-phase lines from the three well pads**

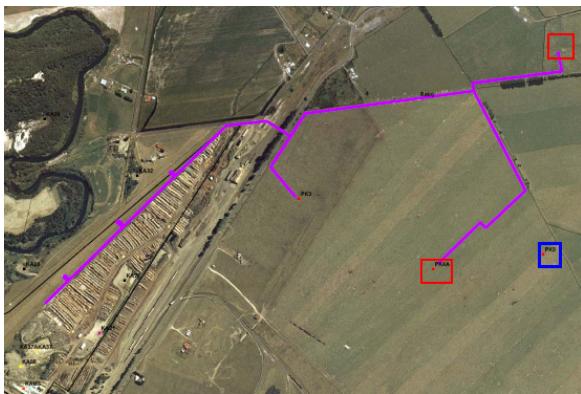
**Figure 4: The Brine and Condensate Reinjection Lines**

The brine line from the power plant runs along an airfield, crosses underneath a couple of access roads to other industrial plants and Ontrack rail yard. It then crosses underneath the railway yard and the state highway inside an 80 meter long tunnel. After the under road crossing it enters the farm and then runs on for another 1.5 kilometer avoiding the natural gas line and power pylons. The brine is then reinjected into three wells located on two well pads on the farm.

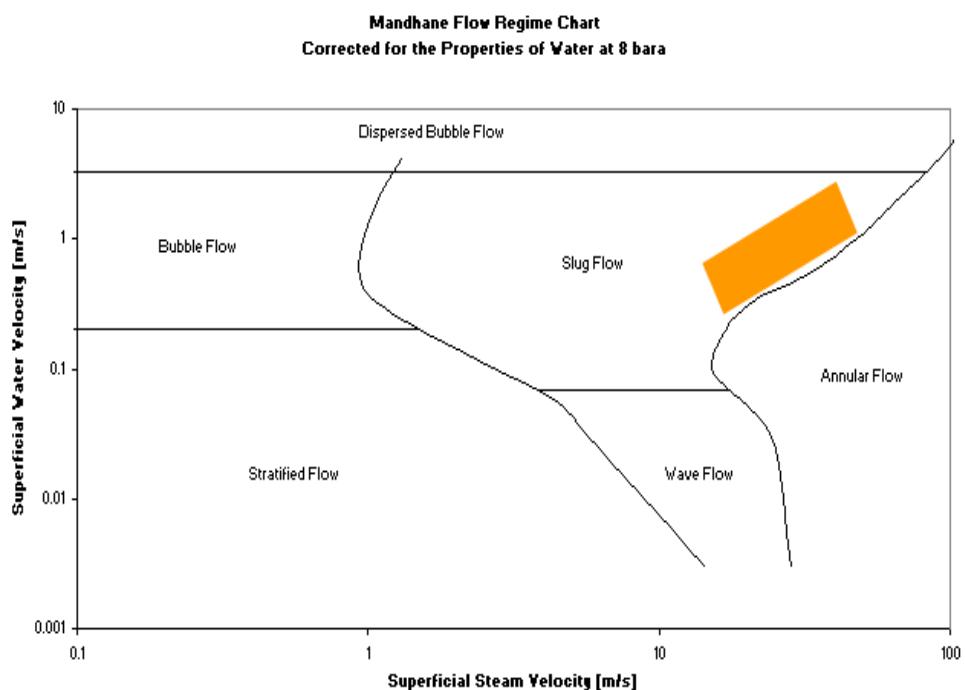
The theoretical flow regime for the design conditions would place it near the boundary of slug and annular flow regime of the Mandhane diagram. There is uncertainty in that area as most of the research on two-phase flow was carried out on small diameter pipes of less than 12". The steam field cross country pipe diameter is normally larger. Some literature suggested that it is unlikely that a slug can form in a large diameter pipe because the waves that initiate it cannot bridge the diameter of the pipe. MRP have many years of experience in running two-phase fluid up hill and had experienced the occasional slug. Due to the uncertainty of slug formation, the designers were required to consider slug flow in their analysis.

**Figure 5: The two-phase flow regime is close to the slug-annular flow boundary**

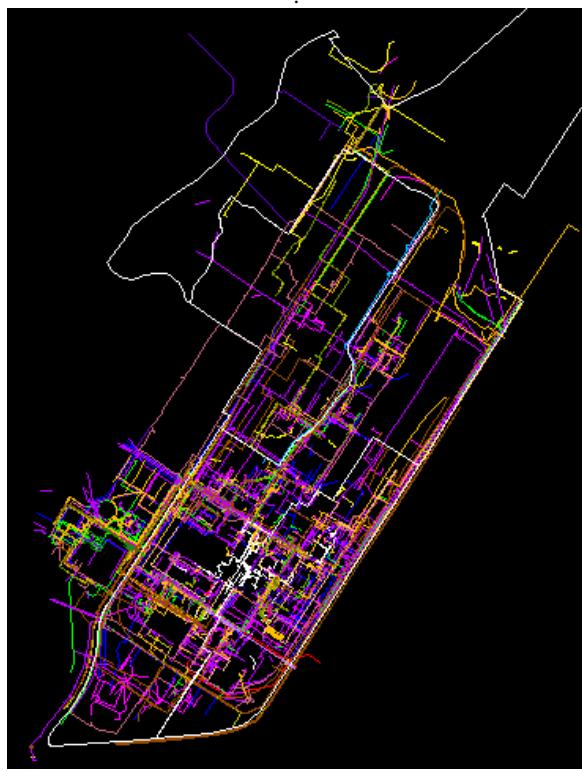
**Figure 6: The known underground services in the industrial complex**

The designs took the known underground services into account but many of these services were not indicated in the service drawings and were only discovered during the digging for the foundations. Minor changes were made to the location of the supports along the pipe where possible. Where this could not overcome the problem, the foundation was redesigned or the pipe route was changed. In one location underground cavities formed by an old plant room or similar was unearthed.

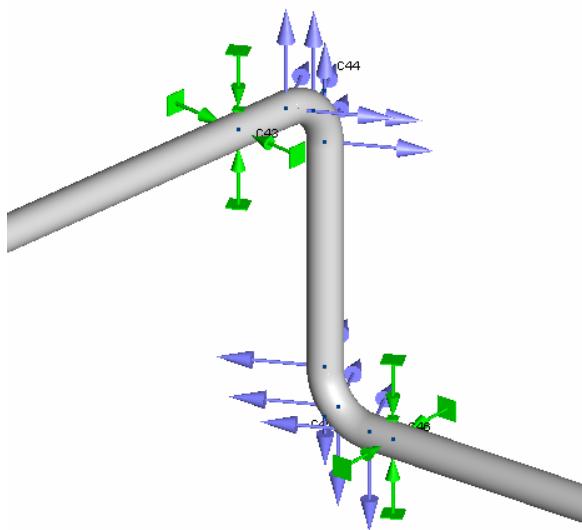
The pipe stress analysis for the Steam field was done to ASME B31.1 code for Power Piping using the AutoPipe software. The slug load was entered as random occasional load acting on the bends in the pipeline to make use of the higher allowable load margins permitted by the code. In the analysis, the addition of slug loads increased the stresses in the pipe and the pipe support system was tightened up to resist the slug load.

**Figure 7: Slug loads modeled on the bends of a pipe**

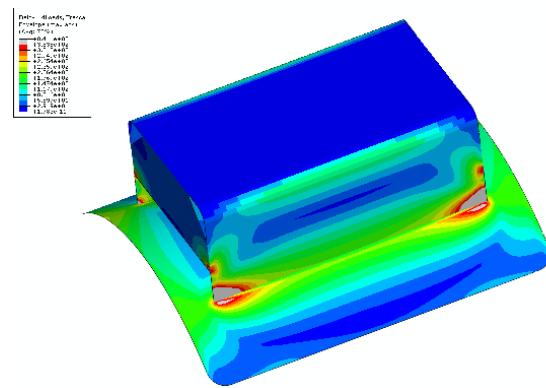
The pipe support local stresses were checked using finite element analysis (FEA) on sample supports to ensure that the stresses were not too high. The results were peer reviewed by several engineers. Figure 8 shows a sample of the analysis.

**Figure 8: Finite Element Analysis on pipe support saddle**

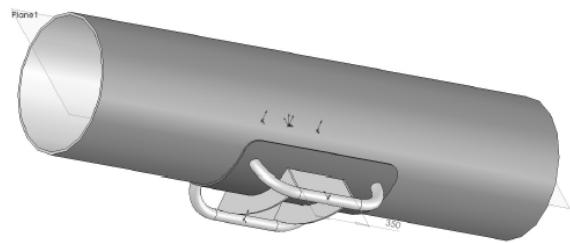
The construction team was consulted on the location and the design of the supports used to thread the pipe through the culverts. Special supports were also designed for the installation of the pipe on the bridge. These supports were designed to reduce the installation time which minimize the interruption to the traffic on the State Highway. The support system allowed the 55m pipe to be lifted in one piece onto the supports.

**Figure 9: Support designed to skid pipe into the pipe culverts**

The piping installed through the culverts was pre-insulated and 100% of radiography was carried out on the welds before they were skidded into place.

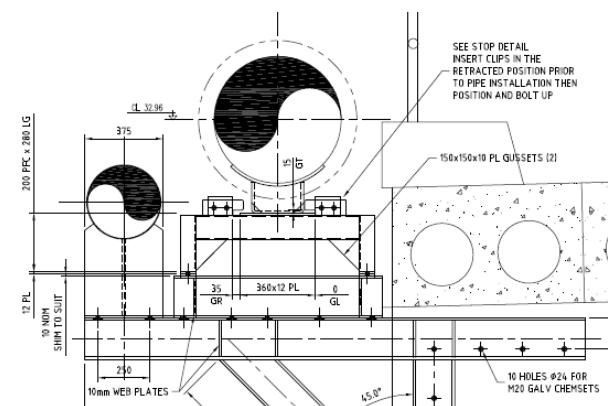
**Figure 10: Removal support clips to allow for lifting the pipe straight onto the bridge support**

The bridge supports took some time to work through as several parties had vested interests. The loading on the bridge was re-calculated and a risk assessment on the installation of the high pressure hot pipe across the bridge was performed. The high pressure hot pipe was subsequently required to be installed with a single lift. Methodical planning was required as this was a one-chance-one-off operation.

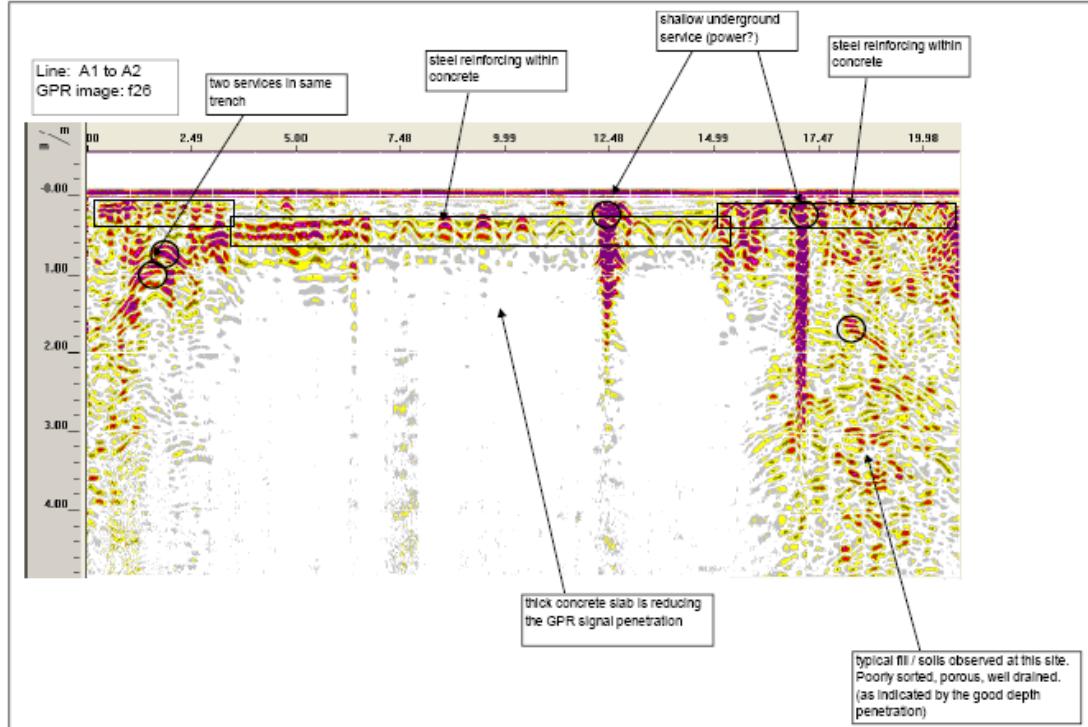
Figure 11: Ground Penetrating Radar results

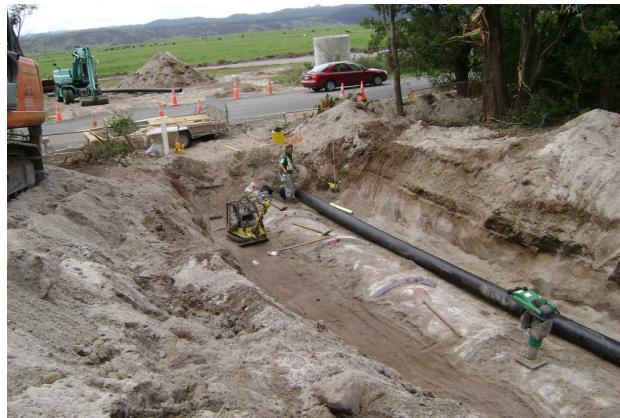
The construction of the tunnel underneath the railway yard and the state highway presented a different challenge. The minimum over burden requirement and the water table level needed to be considered. The tunnel had to be installed between these two limits.

**Figure 12: The 80m tunnel underneath the State Highway and the railway line**

Similarly, the construction of the 80m long tunnel needed to be timed to suit the railway operation in the yard.

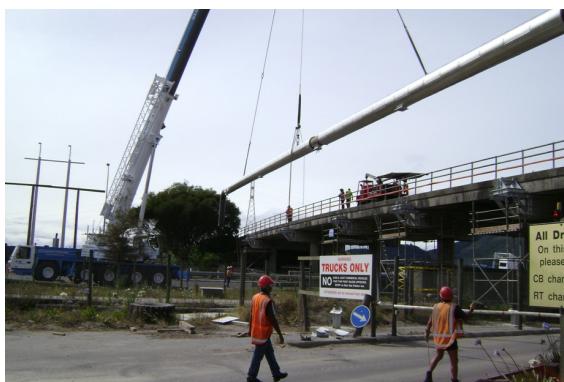
**Figure 13: Lifting the 55m pipe onto the bridge over the State Highway**

The State Highway could only be closed for a short period of time. Discussions were carried out with the crane operators, welders and fitters to work out a plan for the single one-chance-one-lift operation. The operation went smoothly with limited disruption to traffic.

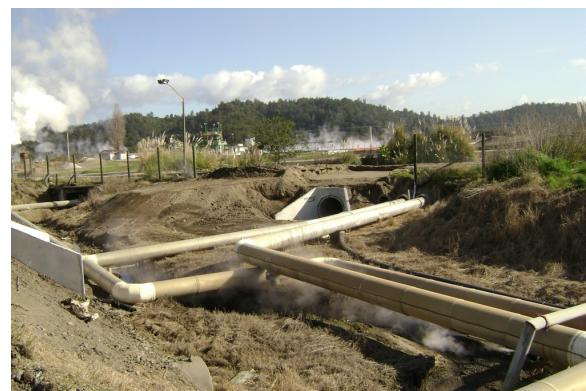
**Figure 14: Running new pipes over old in a tight spot**

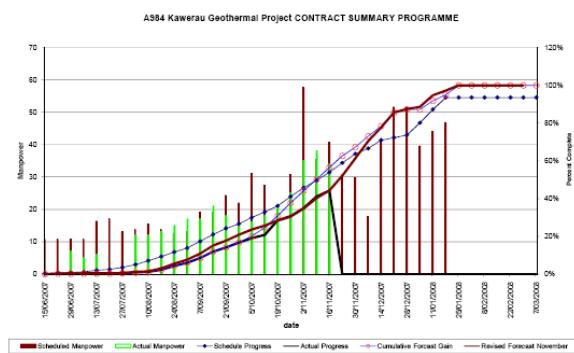
The S curve was used to monitor the progress of the work. Initially the project was running behind schedule and additional resources were employed. These quick corrective actions brought the project back on schedule.

**Figure 15: The S Curve used to monitor progress**

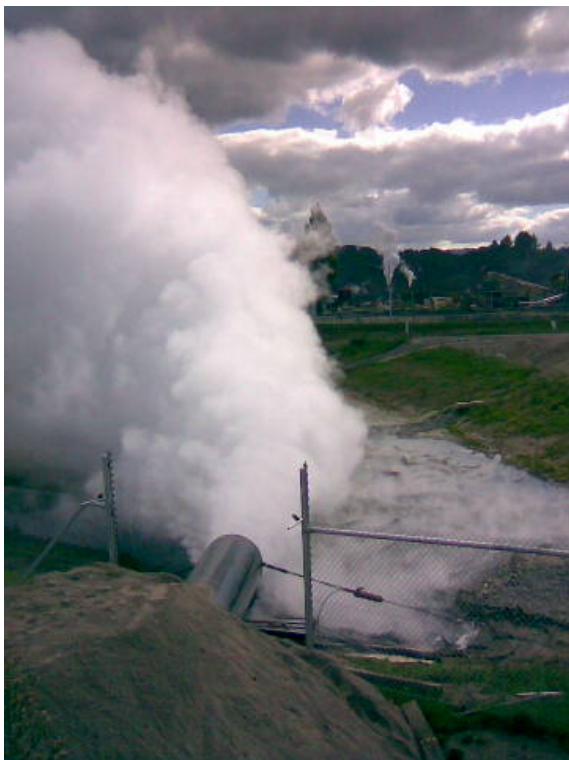
Mighty River Power operators from another geothermal power plant carried out the steam blow and commissioned the steam field. Although there were initial concerns regarding slug flow during start up, slug flow did not occur. However, a few plant items were worn out during the commissioning.

**Figure 16: Commissioning – Steam Blow**
