## Laboratory Results of Corrosion Tests for EGS Soultz Geothermal Wells

Jiri Muller<sup>1</sup>, Katerina Bilkova<sup>2</sup>, Albert Genter<sup>3</sup>, Marion Seiersten<sup>4</sup>

IFE, Norway; IFE, Norway; GEIE EMC, France; IFE Norway

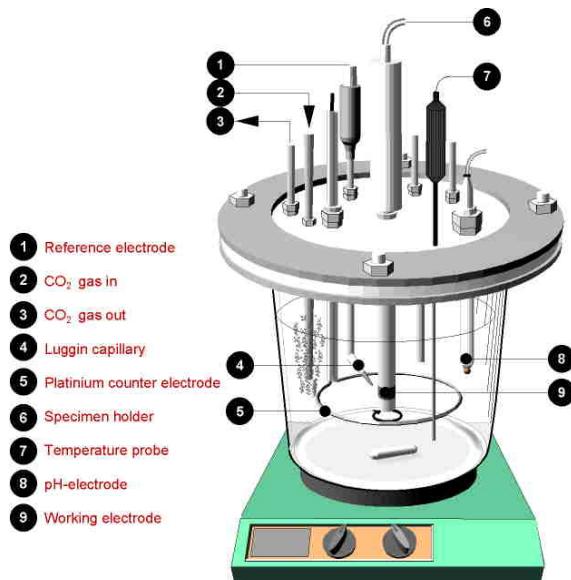
**Figure 2: Schematic illustration of a glass cell with accessories**

One glass cell test was carried out to determine the effect of the Mexel corrosion inhibitor at moderate temperature (60°C). The reason was that the inhibitor did not give any effect in test EGS\_03 at 200°C. The glass cell test was carried out in glass cells with a volume of 3 litres. Electrodes for electrochemical corrosion monitoring and pH measurements, temperature probes and gas inlets/outlets were inserted through stainless steel lids. The glass cell with accessories is schematically represented in Figure 2. A

heating plate heated the cell. Magnetic stirring provided convection. The test was carried out at 60°C, with CO<sub>2</sub> partial pressure of 0.8 bar (1.01 bar total pressure and 0.2 water vapour pressure). The test solution was the same as for the previous tests; the composition is given in Table 3. The inhibitor concentration was 10 ppm. Two specimens were immersed in the cell. The specimens were cleaned and prepared before the test in the same way as the specimens for the autoclave tests. The inhibitor was added after 4 hours of pre-corrosion. The corrosion rate measurement was the same as for the autoclave tests.

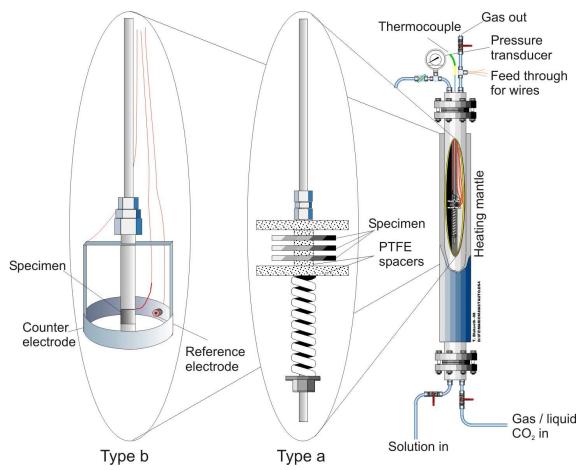
**Figure 1: Schematic drawing of the autoclave**

The corrosion tests were carried out in a Hastelloy C autoclave. The schematic drawing is shown in Figure 1. The autoclave was equipped to house specimens of various geometries and to allow electrochemical measurements. Two tests were carried out, one without and one with Mexel inhibitor. The test matrix is given in Table 1. Three types of steel were tested: carbon steel TU42BT, low carbon steels P110, and N80. Steels P110, and N80 were tested only in the second test, EGS\_03. The non-coated steel specimens were ground with series of SiC papers up to 1000 mesh wetted with isopropanol, cleaned in an ultrasonic bath with technical acetone and flushed with ethanol. The specimens were blow dried, weighed and mounted on the specimen holders. The chemical composition of the steels is given in Table 2. Detailed chemical composition for the P110 and N80 steels was not available. In the first test, EGS\_02, three organic coatings were tested along with TU42BT steel, the coatings were: Sakaphen synthetic coating, and two types of Teflon coating. The Teflon coatings were named after the colour of the coating: Teflon green, and Teflon red. These coatings have never been tested at high temperatures with saline fluid. All experiments were carried out in artificial brine with the same ionic composition as the produced brine from the well. The chemical composition of the brine is given in Table 3. The solution was purged continuously with carbon dioxide to avoid oxygen ingress prior to the test. The carbon dioxide partial pressure was 0.5 bar. The tests were carried out at 200°C, where the total pressure was 15 bar. The concentration of Mexel inhibitor was 10 ppm. The pH was 4.6 at the start, and it increased to 5 during the test. The pH was measured at room temperature. The iron content at the end of the tests was 15 ppm in the first test, EGS\_02, and 60 ppm in the second test, EGS\_03.

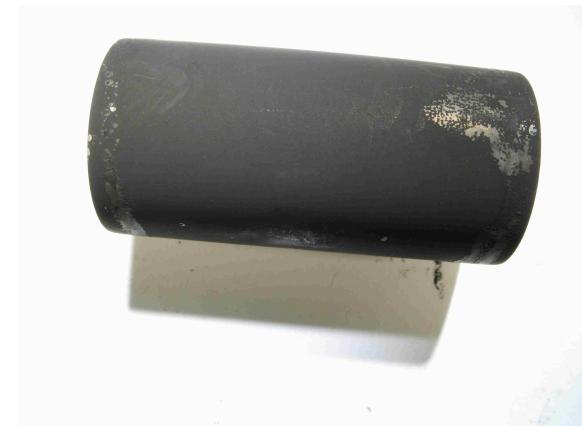
**Figure 4: Photograph of the non-coated TU42BT steel specimen after test EGS\_02. Test conditions: 200 °C, 0.5 bar CO2, pH 4.6-5, brine (see Table 3)**

The development of the corrosion rate measured by LPR for the non-coated steel specimen in the course of the test is given in Figure 3. The corrosion rate stabilized at about 1.9 mm/y after 70 hours of exposure and was stable for the rest of the test. Inspection of the specimen after the test showed that the specimen was covered with black corrosion products (Fig. 4). The corrosion product layer consisted of fine crystals of iron oxide and it was quite porous and from 6 to 35 µm thick (Fig. 5). EDS analysis gave iron/oxygen ratio about 0.4 in the film (Fig. 6). (The carbon content (4 wt%) is apparent; it is due to the carbon film applied on the samples to make them conductive for the SEM and EDS analyses). The ratio was lower than for either magnetite or ferrous oxide. The corrosion product layer was thus probably a hydrated iron oxide. The corrosion product layer was not protective, because the corrosion was not effectively reduced by the deposition of the layer.

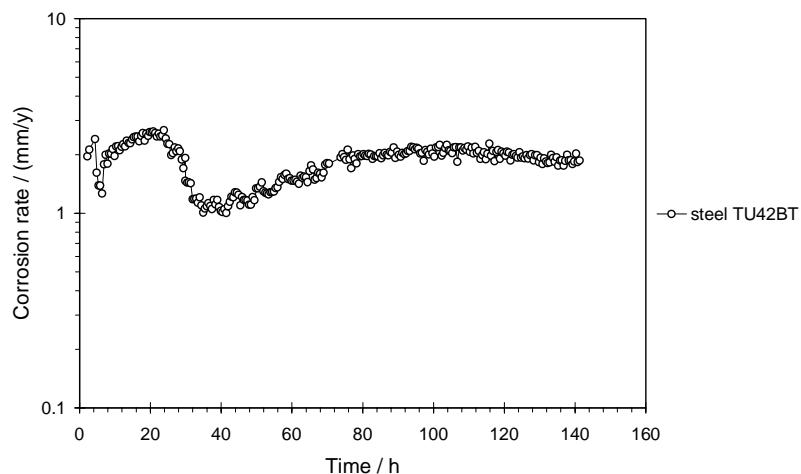
**Figure 3: Corrosion rate versus time for the non-coated TU42BT steel specimen, test EGS\_02. Test conditions: 200 °C, 0.5 bar CO2, pH 4.6-5, brine (see Table 3)**

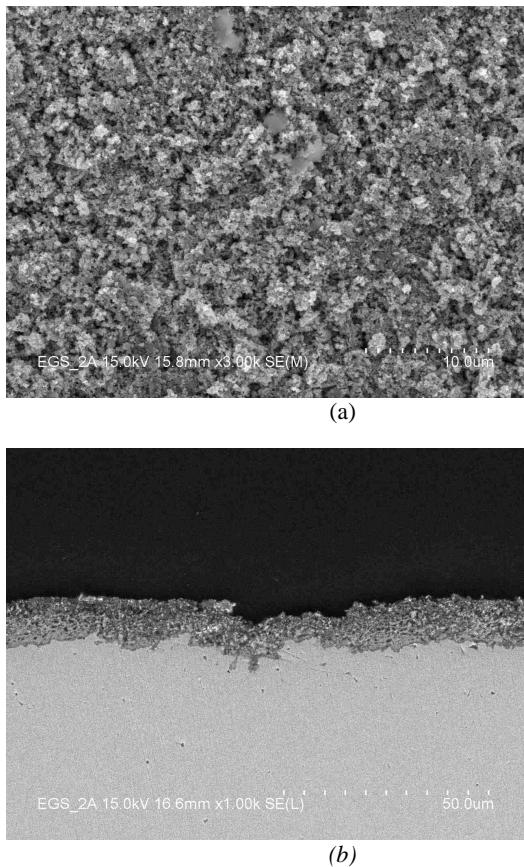
**Figure 5:** SEM images of the non-coated TU42BT steel specimen after test EGS\_02 (a) specimen surface, (b) cross-section of the specimen. Test conditions: 200 °C, 0.5 bar CO<sub>2</sub>, pH 4.6-5, brine (see Table 3)

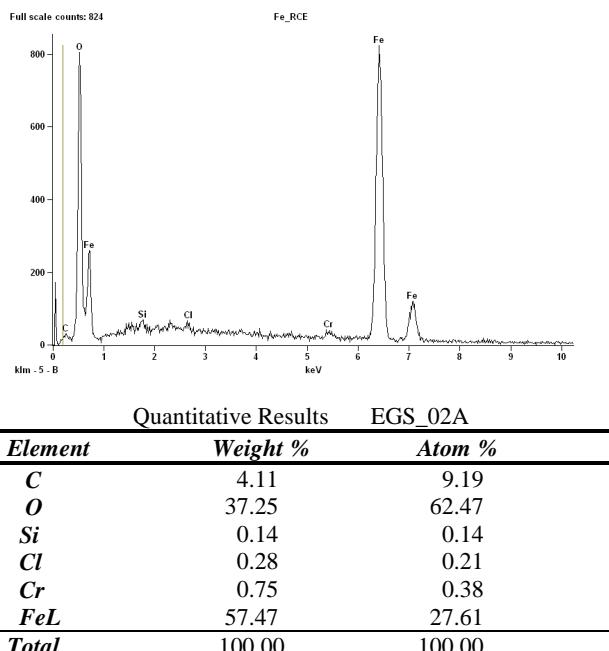
**Figure 6: EDS analysis of the corrosion product layer on the non-coated TU42BT steel specimen, test EGS\_02. Test conditions: 200 °C, 0.5 bar CO<sub>2</sub>, pH 4.6-5 brine (see Table 3).**

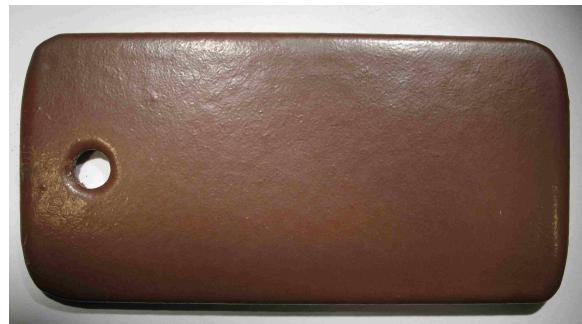
**Figure 7:** Photograph of the specimen coated with Sakaphen synthetic coating after test EGS\_02. Test conditions: 200 °C, 0.5 bar CO<sub>2</sub>, pH 4.6-5, brine (see Table 3)

The photographs of the specimens with coatings are given in Figures 7-9. SEM images of the cross sections of the specimens with coatings are given in Figures 10-12. None of the coatings seemed to deteriorate during the test. No blisters or detachment of the coatings were observed. The inclusions in the metal near the interface to the Sakaphen coating come from the manufacturing of the coating (Fig. 10), they are not corrosion products; EDS analysis showed that they contain silica. The origin of the silica is most probably that the specimens are sand blasted prior to coating.

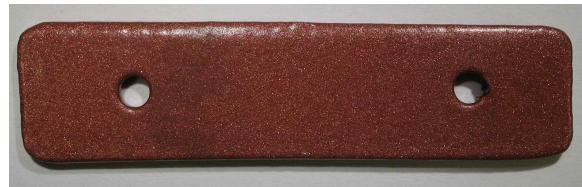
**Figure 8: Photograph of the specimen coated with the red Teflon coating after test EGS\_02. Test conditions: 200 °C, 0.5 bar CO<sub>2</sub>, pH 4.6-5, brine (see Table 3)**

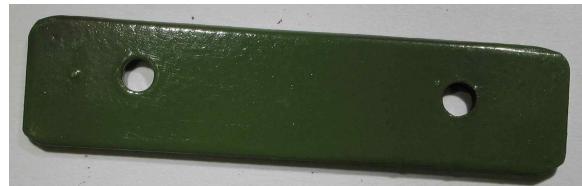
**Figure 9: Photograph of the specimen coated with the green Teflon coating after test EGS\_02. conditions: 200 °C, 0.5 bar CO<sub>2</sub>, pH 4.6-5, brine (see Table 3)**

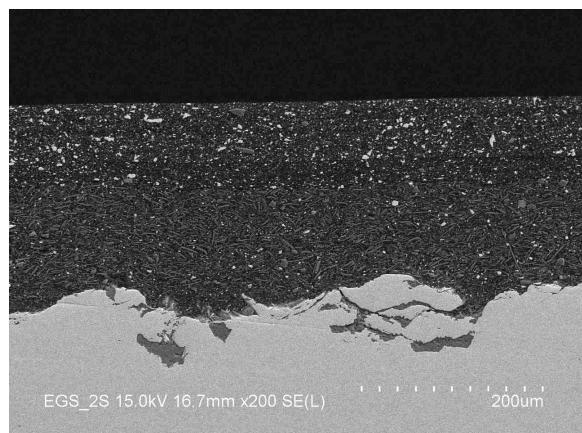
**Figure 10:** SEM image of a cross section of the specimen with Sakaphen synthetic coating, test EGS\_02. Test conditions: 200 °C, 0.5 bar CO<sub>2</sub>, pH 4.6-5, brine (see Table 3)

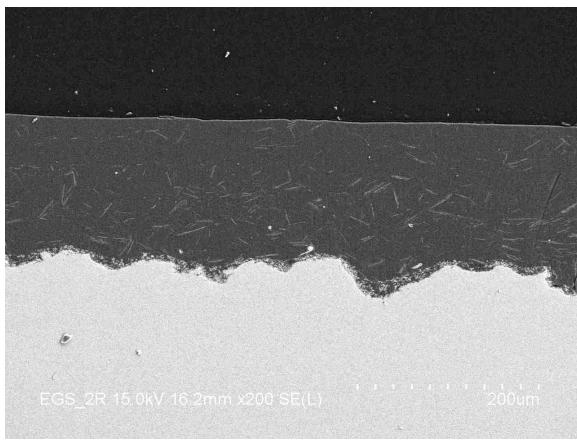
**Figure 11:** SEM image of a cross section of the specimen with the red Teflon coating, test EGS\_02. Test conditions: 200 °C, 0.5 bar CO<sub>2</sub>, pH 4.6-5, brine (see Table 3)

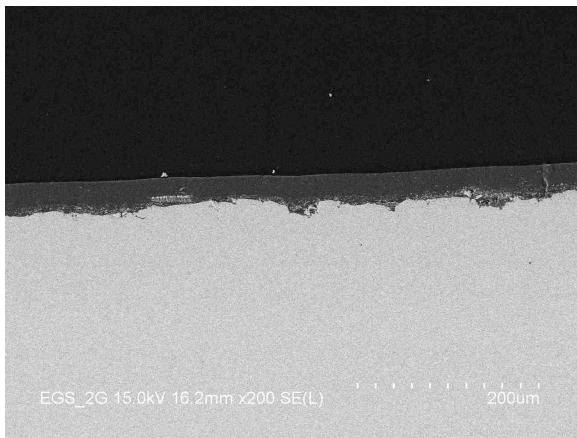
**Figure 12:** SEM image of a cross section of the specimen with the green Teflon coating, test EGS\_02. Test conditions: 200 °C, 0.5 bar CO<sub>2</sub>, pH 4.6-5, brine (see Table 3)

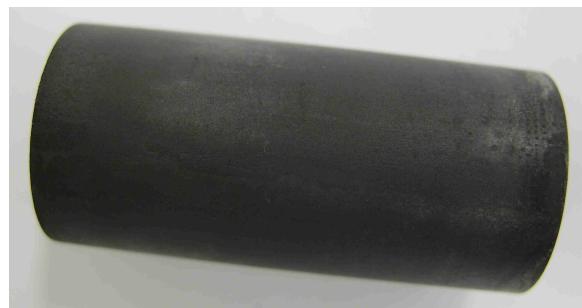
**Figure 14:** Photograph of the non-coated TU42BT steel specimen after test EGS\_03. Test conditions: 200 °C, 0.5 bar CO<sub>2</sub>, pH 4.6-5, brine (see Table 3), 10 ppm Mexel inhibitor

**Figure 15:** Photograph of the non-coated P110 steel specimen after test EGS\_03. Test conditions: 200 °C, 0.5 bar CO<sub>2</sub>, pH 4.6-5, brine (see Table 3), 10 ppm Mexel inhibitor

**Figure 16:** Photograph of the non-coated N80 steel specimen after test EGS\_03. Test conditions: 200 °C, 0.5 bar CO<sub>2</sub>, pH 4.6-5, brine (see Table 3), 10 ppm Mexel inhibitor

Inspection of the specimens after the test showed that all the specimens were covered with black corrosion products (Figs. 14-16). Inspection of cross sections of the specimens showed that the corrosion products consisted of several layers (Figs. 17b-c, 18b-c, 19b). The layer on the surface mainly consisted of cubic crystals as is clear from the SEM images of the specimen surface (Figs. 17a, 18a, 19a). EDS analysis is given in Figures 20-22. The iron/oxygen ratio was in the range 0.2-0.3, which indicates carbonate and is too low for magnetite and for ferrous oxide. Iron carbonate is, however, not expected to form at 200°C (Gérard et al., 2006) and the corrosion products thus probably consisted of mixed iron carbonate, calcium carbonate and hydrated ferrous oxide. It cannot be excluded that some FeCO<sub>3</sub> has precipitated on the surface during cooling after the test (the specimens could not be removed at 200°C; hence the specimens were cooled to room in the test solution before removing).

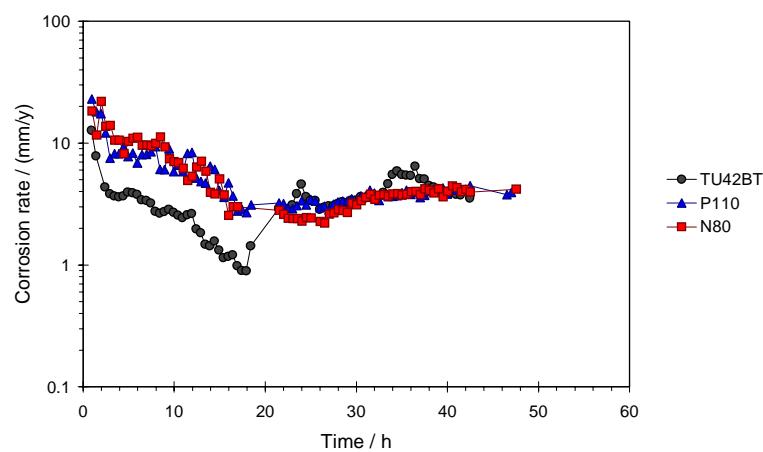
**Figure 13:** Corrosion rate versus time for the non-coated steel specimens, test EGS\_03. Test conditions: 200 °C, 0.5 bar CO<sub>2</sub>, pH 4.6-5, brine (see Table 3), 10 ppm Mexel inhibitor

The development of the corrosion rate measured by LPR for the non-coated steel specimens in the course of the test is

given in Figure 13. Unfortunately a contact with the reference electrode was lost after 50 hours, so no more LPR data were obtained after that. But the experiment was continued for one more week. The corrosion rate after 50 hours was about 4 mm/y for all the specimens. This is, however, not corrected by weight loss measurements and as these give a lower average rate, the corrosion rates must either have been much lower towards the end of the experiment or lower throughout the test.

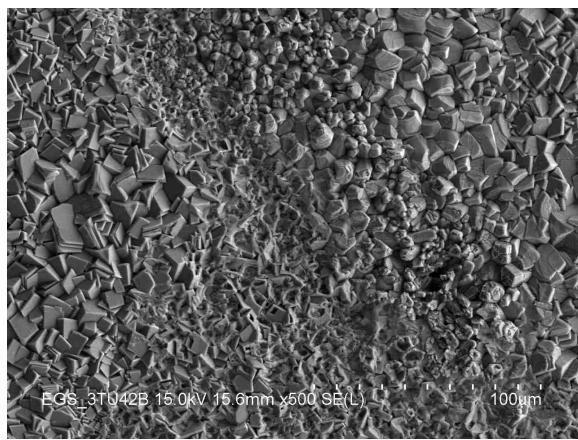
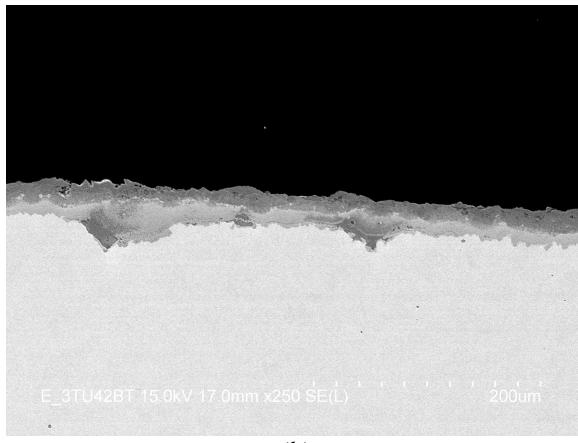
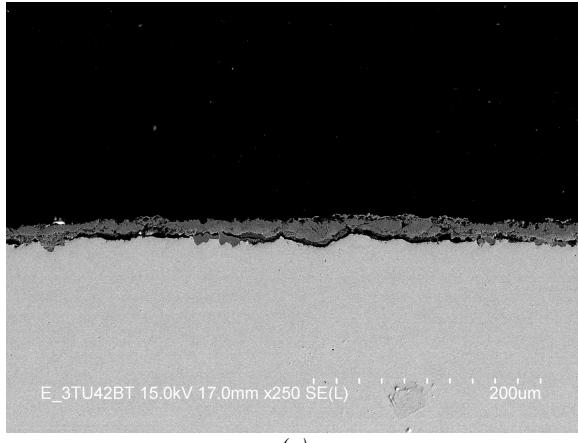
**Figure 17:** SEM images of the non-coated TU42BT steel specimen after test EGS\_03 (a) specimen surface (b-c) cross sections of the specimen. Test conditions: 200 °C, 0.5 bar CO<sub>2</sub>, pH 4.6-5, brine (see Table 3), 10 ppm Mexel inhibitor

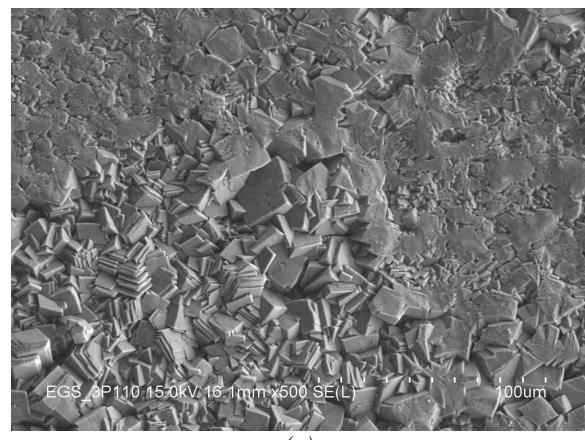
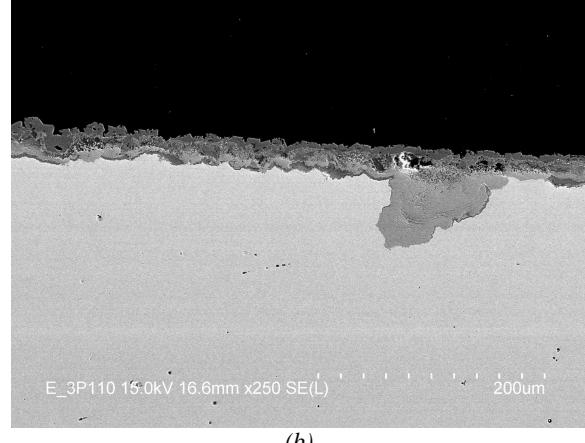
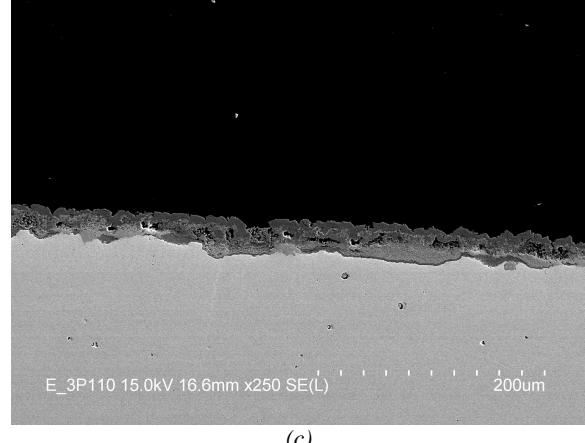
**Figure 18:** SEM images of the non-coated P110 steel specimen after test EGS\_03 (a) specimen surface (b-c) cross sections of the specimen. Test conditions: 200 °C, 0.5 bar CO<sub>2</sub>, pH 4.6-5, brine (see Table 3), 10 ppm Mexel inhibitor

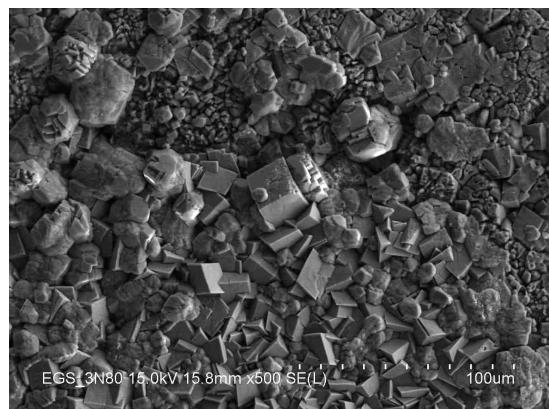
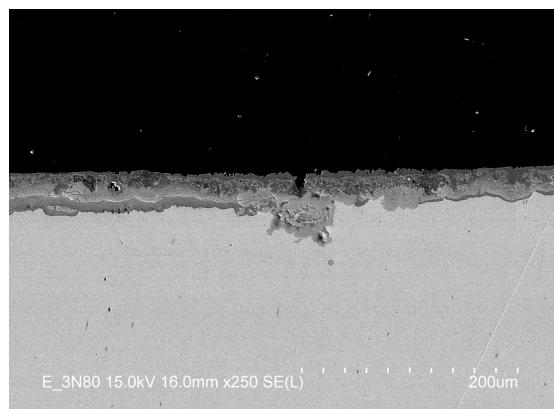
**Figure 19: SEM images of the non-coated N80 steel specimen after test EGS\_03 (a) specimen surface (b) cross section of the specimen. Test conditions: 200 °C, 0.5 bar CO<sub>2</sub>, pH 4.6-5, brine (see Table 3), 10 ppm Mexel inhibitor**

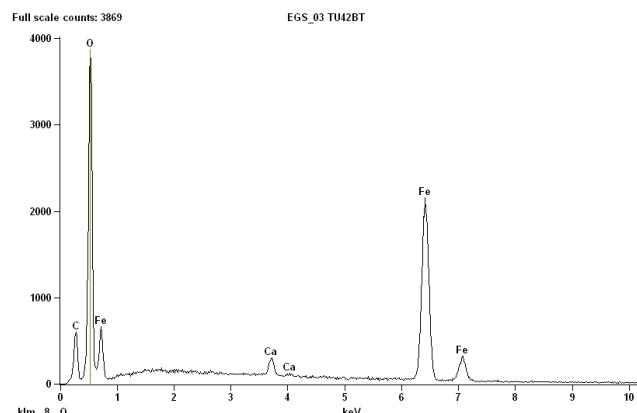
Element	Weight %	Atom %
C	13.11	23.49
O	44.62	60.05
Ca	1.08	0.58
Fe	41.19	15.88
<b>Total</b>	<b>100.00</b>	<b>100.00</b>

**Figure 20:** EDS analysis of the corrosion product layer on the non-coated TU42BT steel specimen, test EGS\_03. Test conditions: 200 °C, 0.5 bar CO<sub>2</sub>, pH 4.6-5, brine (see Table 3), 10 ppm Mexel inhibitor

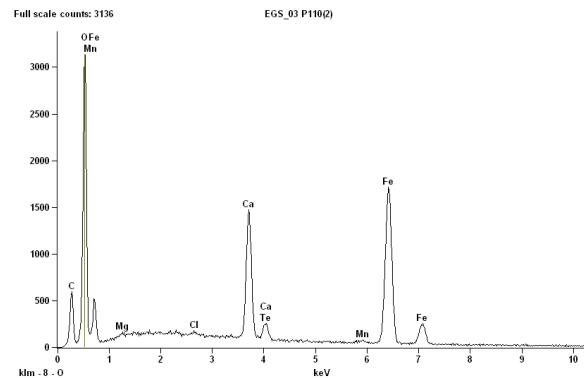
Element	Weight%	Atom%
C	12.14	21.49
O	46.24	61.44
Mg	0.12	0.11
Ca	7.89	4.19
Fe	33.55	12.77
<b>Total</b>	<b>99.94</b>	<b>99.99</b>

**Figure 21: EDS analysis of the corrosion product layer on the non-coated P110 steel specimen, test EGS\_03. Test conditions: 200 °C, 0.5 bar CO<sub>2</sub>, pH 4.6-5, brine (see Table 3), 10 ppm Mexel inhibitor**

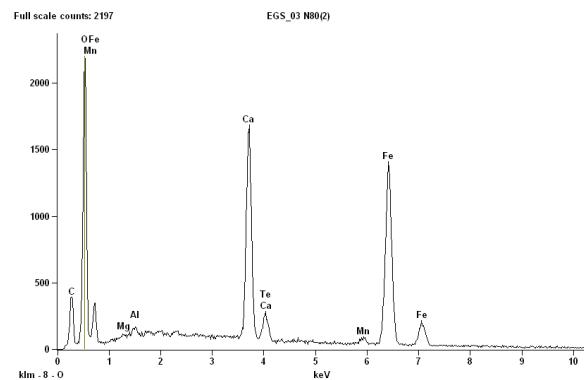
<i>Element</i>	<i>Weight %</i>	<i>Atom %</i>
<i>CK</i>	10.96	19.55
<i>OK</i>	46.54	62.29
<i>MgK</i>	0.09	0.08
<i>AlK</i>	0.24	0.19
<i>CaK</i>	11.71	6.26
<i>FeL</i>	30.24	11.60
<i>Total</i>	99.78	99.96

**Figure 22: EDS analysis of the corrosion product layer on the non-coated N80 steel specimen, test EGS\_03. Test conditions: 200 °C, 0.5 bar CO<sub>2</sub>, pH 4.6-5, brine (see Table 3), 10 ppm MexelL inhibitor**

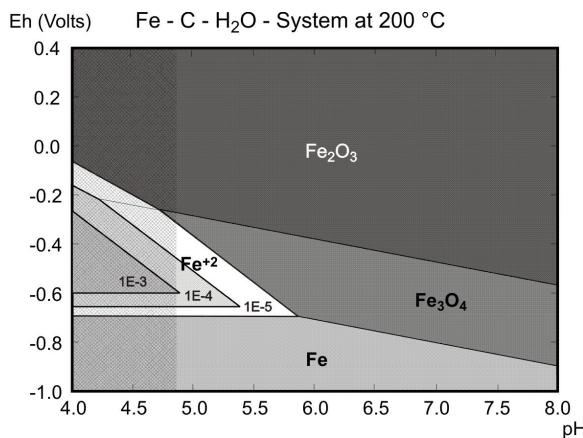
**Figure 24: Eh-pH diagram (Pourbaix diagram) for Fe-C-O at 200°C in the pH range 4-8. The diagram is for 20bar, 0.03 m carbonate species and a Fe2+ concentration of 10-3, 10-4 and 10-5M. The hatched area indicates the pH range for the experiments. (Constructed with HSC Chemistry 6.1. Outotec Research Oy Information Center, P.O. Box 69, FIN - 28101 PORI, FINLAND)**

The Eh-pH diagram (Poubaix diagram) in Figure 24 shows that it is magnetite (Fe<sub>3</sub>O<sub>4</sub>) rather than siderite (FeCO<sub>3</sub>) that is stable at 200°C (the metastable hydroxides and oxy-hydroxides are not shown in the figure). Its stability depends on pH and ferrous (Fe<sup>2+</sup>) concentration in the solution. The pH range in the experiment is indicated by an overlay in the figure. It was measured to 4.5-4 at room temperature. The actual value at 200°C is uncertain. It is probably lower as the dissociation constant of water is only 11.3 at 200°C and the solution will contain carbonic acid as it is in equilibrium with 0.5 bar CO<sub>2</sub>. The diagram in Figure 24 thus indicates that an iron concentration of more than 1E-5 m (56 ppm) is needed before Fe<sub>3</sub>O<sub>4</sub> starts to form and more will be needed to form a stable film. The iron concentration at the end of the autoclave tests was 15 ppm in EGS\_02 and 60 ppm in EGS\_03 which implies that Fe<sub>3</sub>O<sub>4</sub> might form in EGS\_03. The difference in iron concentration at the end of the two tests is due to three corroding samples in EGS\_03 and only one in EGS\_02.

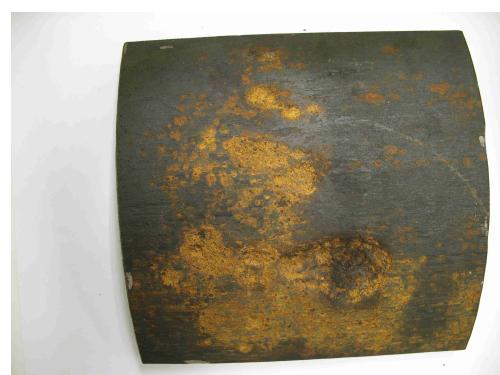
**Figure 26: Photograph of the corroded part of the pack-off assembly of casing in the injection well GPK3 suspected for microbiological corrosion**

During pack-off maintenance job on the injection well GPK3 of the Soultz-sous-Forêts project, important traces of corrosion products were found on the outside top part of the casing (Figure 24). It was found that the corrosion took place 2 meters below the casing top end, on the outside part of the pack-off assembly. Because the temperature of the geothermal brine was quite low, 70°C, it was suspected that the pitting corrosion might be microbiologically induced. Photograph of the corroded part is shown in Figure 25. The corroded specimen was analysed for bacteria by means of two methods: ATP measurement and by cultivation in SRB medium. The first method, ATP measurement, is based on

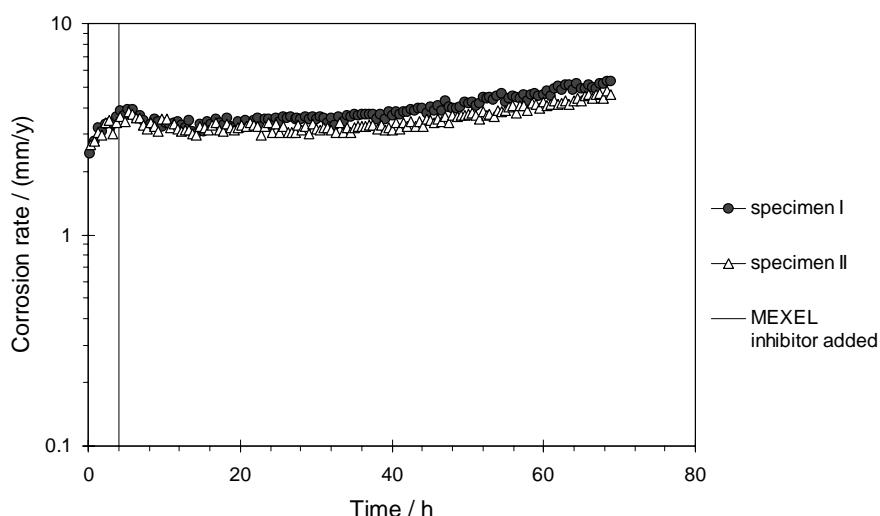
**Figure 23: Corrosion rate versus time for the non-coated steel specimen, test EGS\_04. Test conditions: 60 °C, 0.75 bar CO2, pH 4.8-5, brine (see Table 3), 10 ppm Mexel inhibitor**

The development of the corrosion rate measured by LPR is given in Figure 23. 10 ppm Mexel inhibitor was added after 4 hours. Addition of the inhibitor did not have any effect on the corrosion rate. The inhibitor thus did not give any inhibitor effect at 60°C at this concentration.

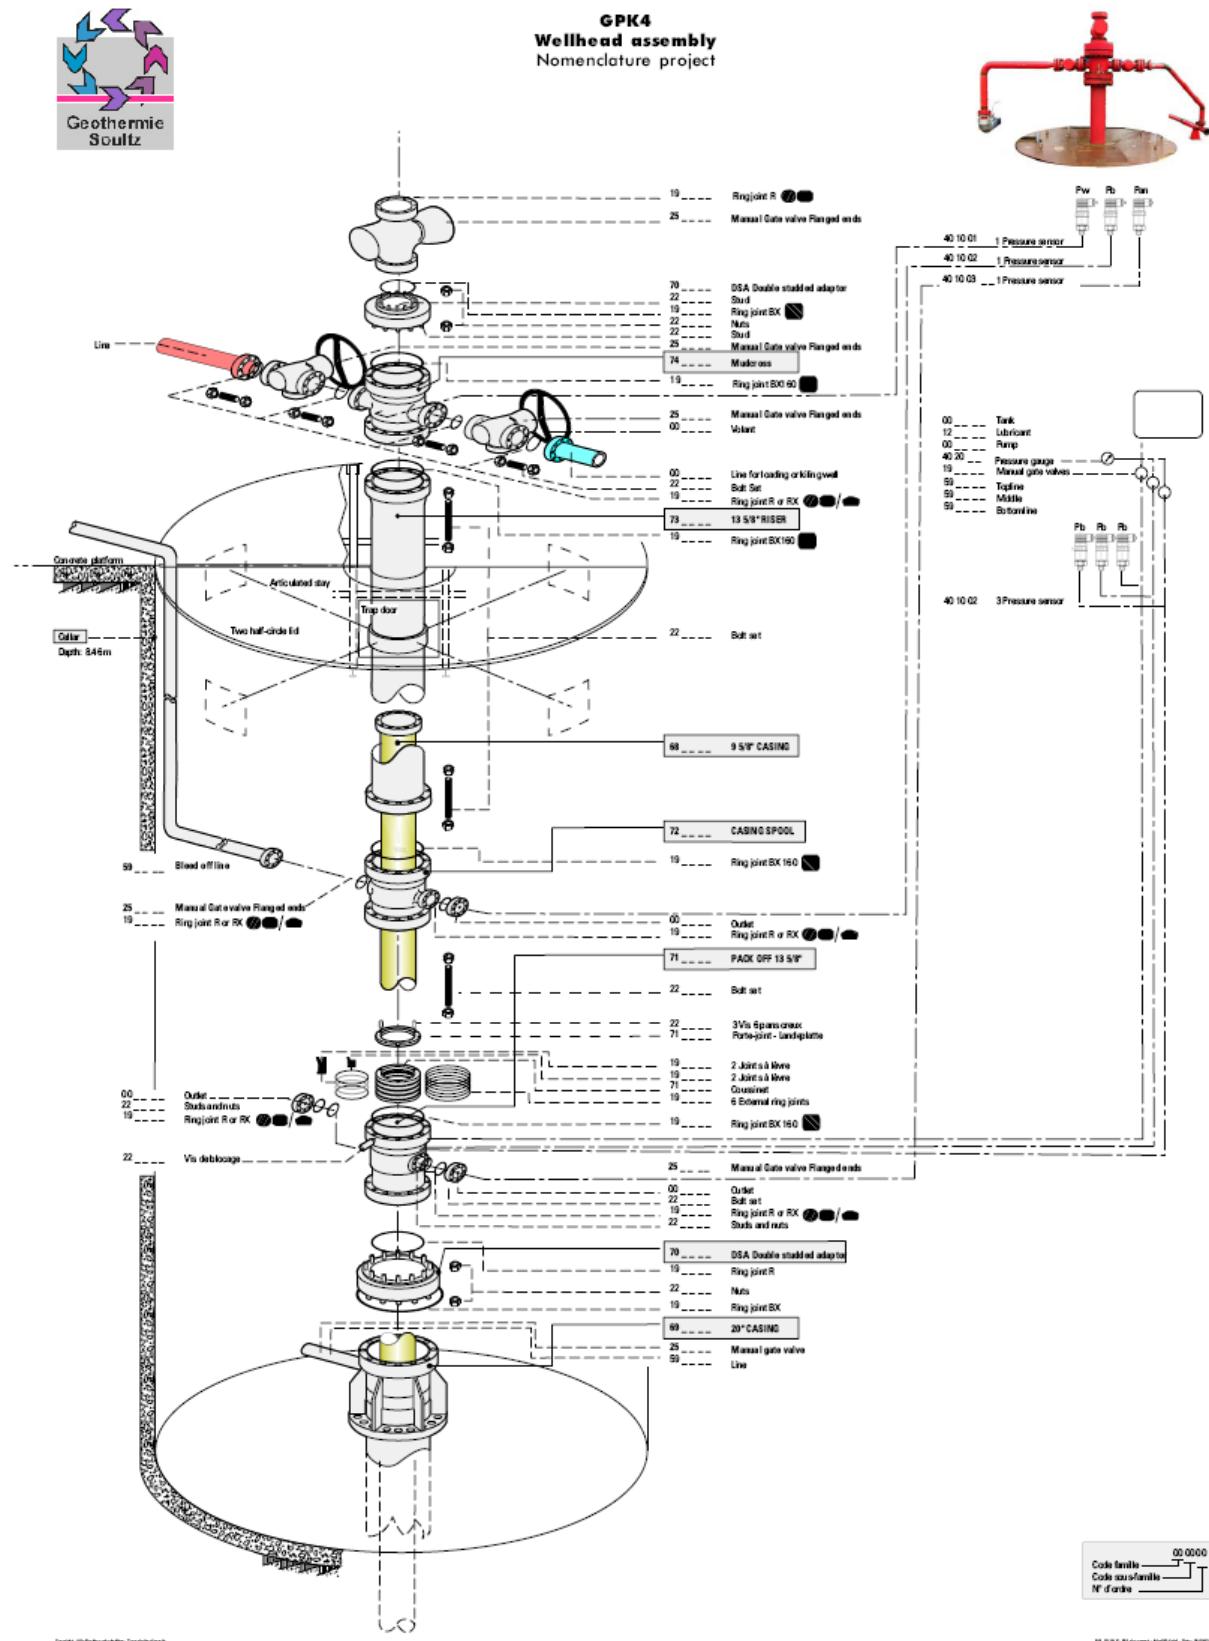
**Figure 25: Well head assembly where the suspected microbiologically induced pitting corrosion was found**
