## Engineering Challenges for the Innamincka Hot Fractured Rock Geothermal Development

### ABSTRACT

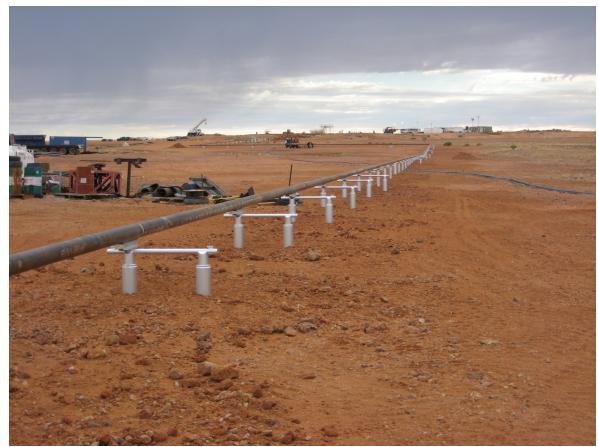
**Figure 3: Pipeline under construction.**

pipeline stresses within the code requirements and keep support reactions at a comparatively low level. The final design incorporated four pipe anchors and the balance of the supports being either guides or vertical stops. Figure 3 shows part of the pipeline during construction.

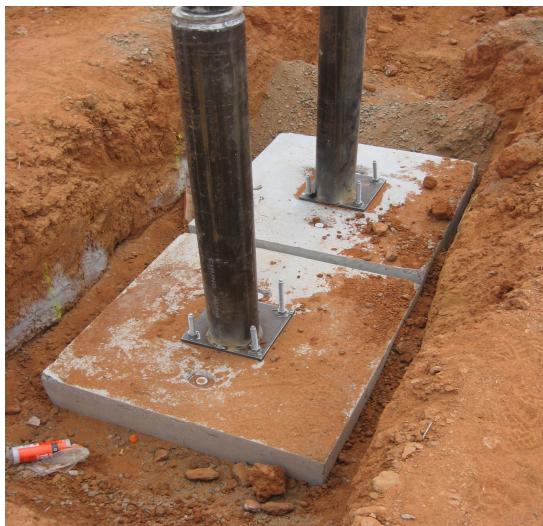
**Figure 4: Typical pipe support footing.**

The remoteness of the location and the soil conditions made conventional bored pile supports unattractive. The soil consists of about 1-1.5m of comparatively loose stony clays above a deep layer of hard calcrete, which is a naturally occurring concrete-like material. The site is also about 360km away, over very poor roads, from the nearest concrete batching facility and hence it is very expensive to site pour concrete footings. Our solution was to excavate down to the calcrete layer and use pre-cast concrete slabs as spread footings for the pipe supports. Figure 4 shows a typical footing.

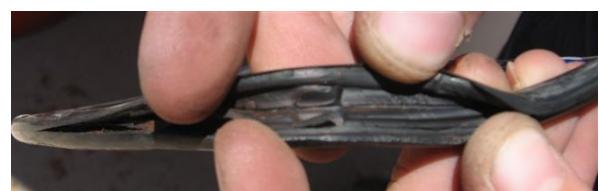
Multiple failures of elastomers occurred due to explosive decompression. This is a process where gases dissolved in solution, at high pressure, percolate into the elastomer and will blow the elastomer apart if the seal is de-pressurised. This process can be mitigated by using harder grades of elastomer and more exotic compounds such as perfluoroelastomers and also by depressurising the seal over a very long time to allow the gases to escape from the seal. Figure 5 shows one of the O-rings that has suffered explosive decompression.

**Figure 5: Seal failure due to explosive decompression.**

There are problems with both mitigation strategies. The obvious issue with a slow decompression (possibly over many hours) is that this does not accommodate the operational need to promptly shut down the pump if there are any safety issues. Using harder elastomers can work for static seals but is problematic for dynamic seals such as are found in a typical mechanical seal assembly where the ceramic must be allowed to float axially. In this case, retrofitting a harder elastomer into existing seal grooves provides too high a radial force on the shaft and is likely to cause the floating ceramic to stick. This almost certainly happened in one instance where disassembly of the seal assembly at the seal company's workshop could find no damage to either the ceramics or the elastomers, even though the seal had been leaking badly.

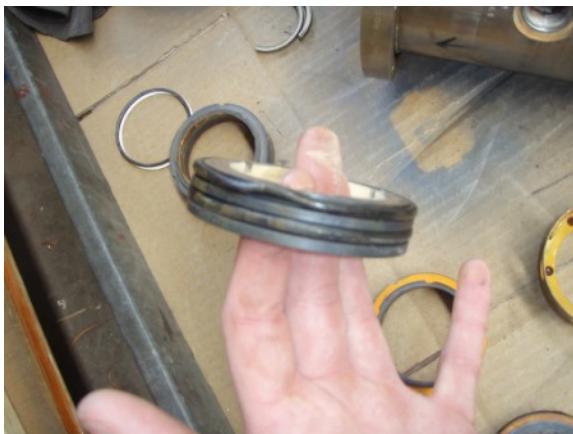
Multiple failures of elastomers also occurred due to extrusion. This problem was overcome by using harder grades of elastomers and seal back up rings. Seal extrusion at high pressures is very hard to avoid with radial seals as the required minimum radial clearance is very hard to achieve. We believe that the correct solution for all static seals is to use non-elastomer face seals. Figure 6 shows an O-ring that has failed by extrusion.

**Figure 6: Seal failure due to extrusion.**

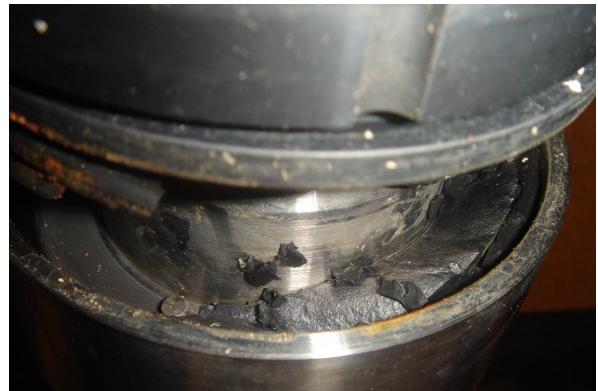
There also been failures in the seal ceramics without there being any satisfactory explanation of what has caused the failures. It is clear, however, that the existing design is unsatisfactory for the duty. Various remedial measures have been installed by the seal and pump suppliers. These include: fitting of filters on the seal flush water line to reduce the dirt in the assembly and using a manually set pressure reducing valve to achieve an inter-seal pressure at approximately half of the pump inlet pressure. It is not at all clear how the seal supplier expected the inter-seal pressure was going to be maintained in the original design and a manual set pressure reducing valve is a very poor solution as it requires operator adjustment both during start up and

shutting down of the pump. It should be noted that SiC/SiC mechanical seal pairs are a common choice for abrasive duties, but are not normally used at pressures above 2 MPa; our duty requires an 18 MPa differential per seal. Figure 7 shows a failed seal ceramic.

**Figure 7: Mechanical seal ceramic failure.**
