## **Restoration from a Large Scale Steam Explosion at the Well Site of the Onikobe Geothermal Power Station**

Chitoshi Akasaka, Kengo Takizawa, Norifumi Todaka, Osamu Iwasaki, Shigeo Tezuka, Shigetaka Nakanishi, Isao Shimizu and Naoki Kumazaki

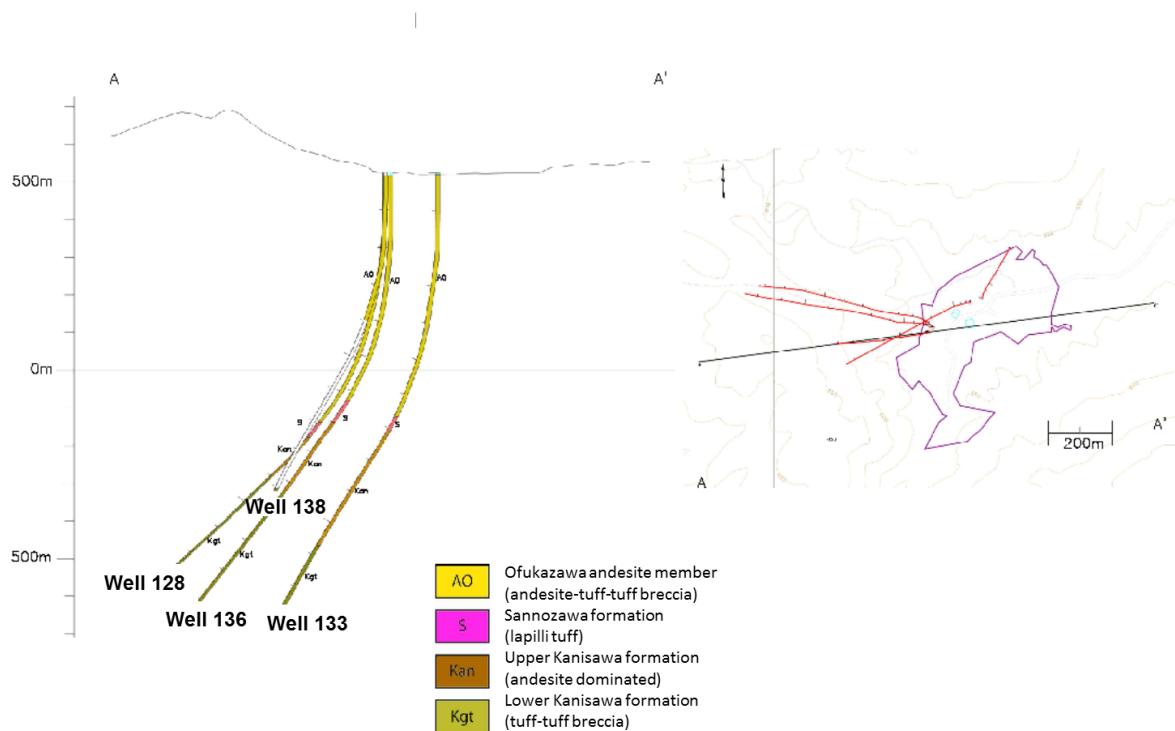
**Figure 2: Geological column of Well 128, 136 and 138.**

Well 128 produced neutral fluids at first, but over time the discharge became more and more acidic (Figure 2). The well has multiple feedpoints, and the shallowest feedpoint is in acidic alteration zones. The stable shut-in temperature profile suggests boiling in the reservoir at shallow depths near the well.

Well 136 was deviation-drilled in 2001 to a total depth of 1334 m into the neutral-fluid part of the reservoir. Well 138 (drilled in 2006; to a total depth 915 m) was also deviated, but encountered acid fluids. Therefore duplex stainless steel was used in the upper part of the production casing of Well 138 to resist corrosion.

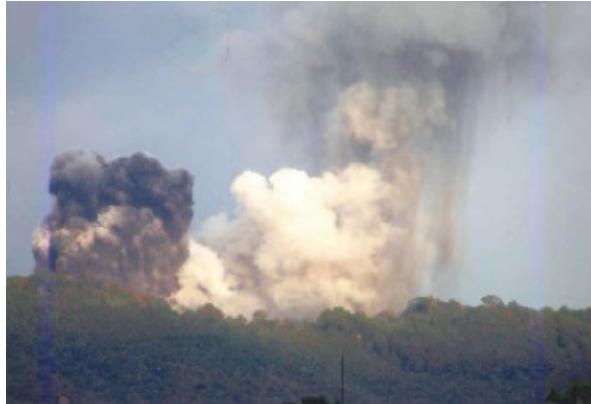
**Figure 3: Photograph of the moment of steam explosion taken from 5 km west of the wellfield. A mountain ridge hides center of the explosion (Akasaka et al., 2011).**

Fortunately, a photograph was taken from 5 km west of the Onikobe power station at the moment of the explosion (Figure 3). Analysis of the photograph indicates that the dark-colored eruptive materials to the north rose about 250 m above the crater. The grey-colored materials to the south rose more than 400 m.

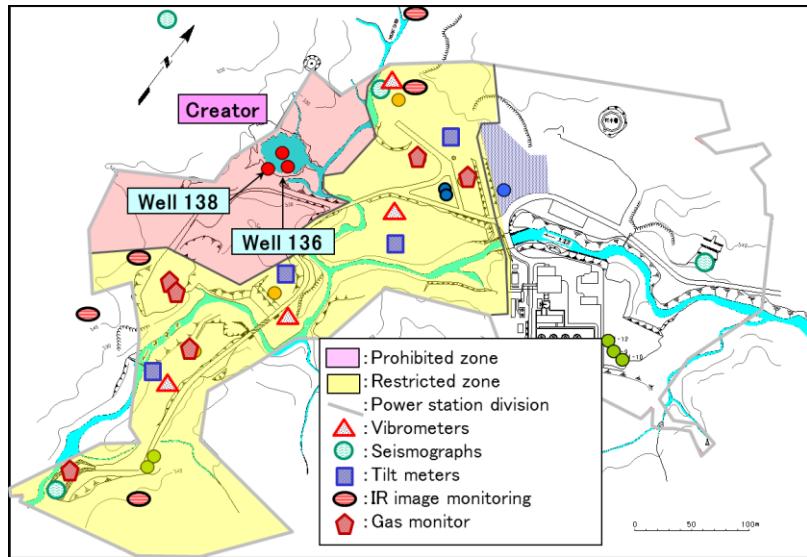
**Figure 4: Distribution of monitoring points with classification of working area.**

Based on experts' recommendations a surface and subsurface monitoring program was begun after the steam explosion occurred. Also, discharging fluid samples are being acquired and analyzed chemically to detect any changes in water origins. In order to observed vary of tremor phenomenon which is related to evolution of steam explosion, vivrometers, three-component seismographs and tilt meters were chosen. Location of monitoring stations were indicated in Figure 4.

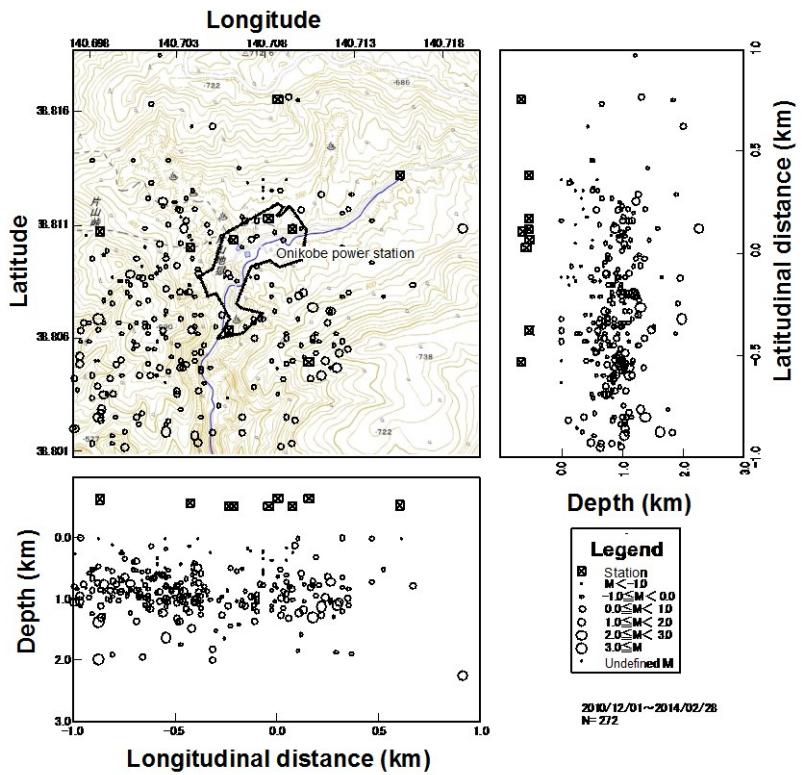
**Figure 5: Location of seismic network stations and distribution of hypocenters from December 2010 to February 2014 within 1km distance and 3km depth.**

Location of seismic network consisted of nine seismographs and estimated hypocenter locations are indicated in Figure 5. Indicated result was estimated automatically but after seismic event. The real time automatic seismic system is able to provide rapid estimation of hypocenter location and magnitude. If forming of pressure chamber progress near subsurface, seismic event might be detected by this system real time.

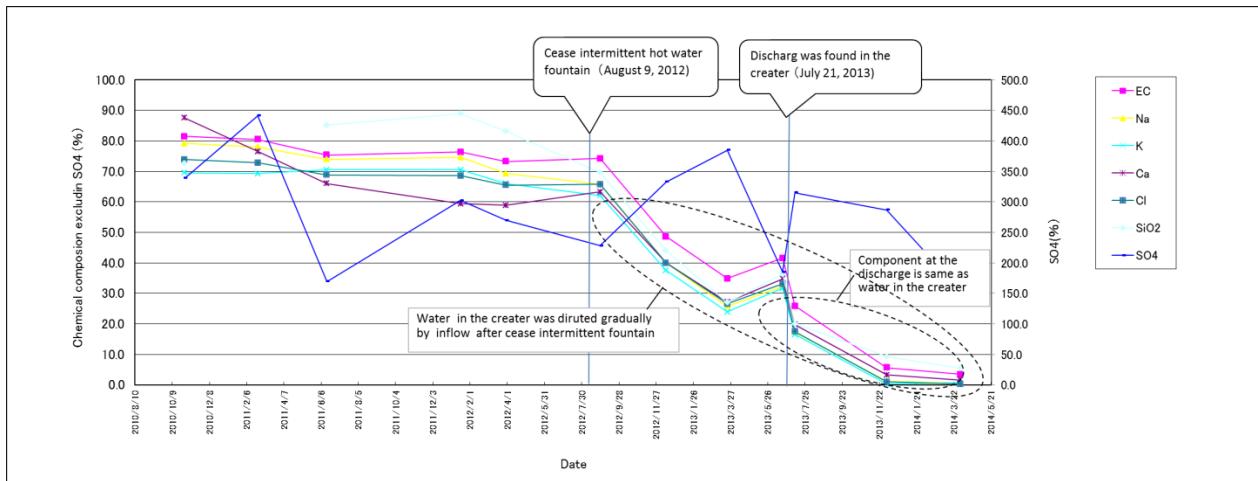
**Figure 6: Change in chemical concentration of water in the crater-lake.**

Self-contained navigation helicopters were used to chemical sampling, aerial photographs and laser mapping. The result of chemical sampling of water in the crater-lake is indicated in Figure 6. Photographs and result of laser mapping indicated that there is no remarkable change in local topography around the crater.

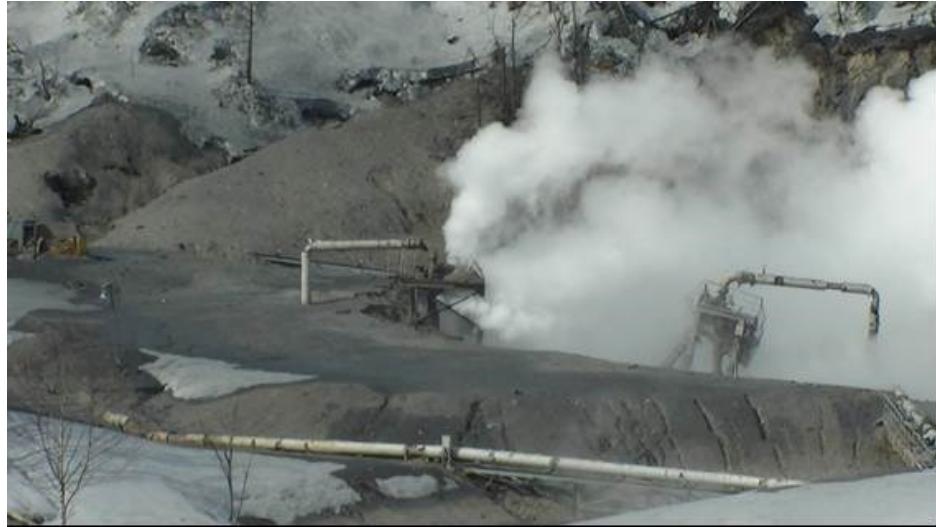
Steam began to leak through near casing head of Well 138 on 9 March 2012. Amount of leakage was observed about several tons/hour by the eye. It was thought that strong acid fluid weekend casing until crack occurred. Because of an apprehension of cutting off wellhead of Well 138, protection cover was constructed for preventing for worst situation, that is fall of well head and blowing out. Because Well 138 located in “prohibited” working area, operator-less construction machines were used to make flat ground surface and to install the protection cover.

**Figure 7: Steam leaking through casing head just under the closed well head valve of the Well 138 (on 9 March 2012)**

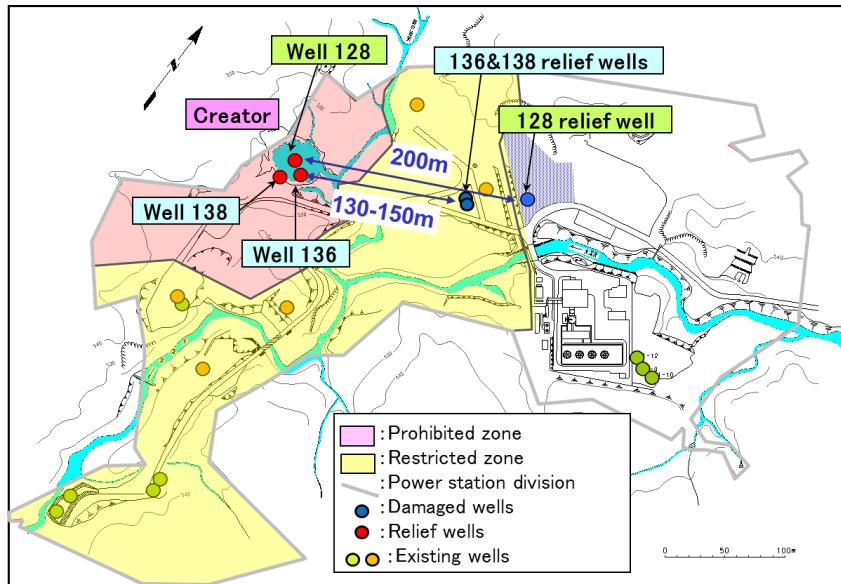
**Figure 8: Location map of the damaged wells by steam explosion (red circles) and relief wells (blue circles).**

Just after steam eruption, “restricted” and “prohibited” areas were designated within the wellfield from the point of view of preventing workers from victims (Figure 8). For the first step to returning project operations to normal was clearly to regain control over Well 128 and to shut it in permanently.

Since the “restricted” and “prohibited” safety zones within the site must be respected. Therefore the relief well was spudded near the power station outside the controlled area approximately 200 meters to the east of the Well 128 wellhead (see Figure 8).

Steam leak from the Well 138 continued after intermittent fountain ceased by 128 relief well. The 138 relief well was spudded in the restricted area approximately 150 meters to the east of the Well 138 wellhead (see Figure 8). About 5 hours after partial loss of circulation occurred at 673 m depth during drilling sidetrack D1c, form like material appeared on the water table of the crater-lake. Amount of leaked steam became low obviously one day after (Figure 10). Form like material was thought from mud component. Decrease of steam leak caused reservoir cooled by low temperature mud water of loss circulation.

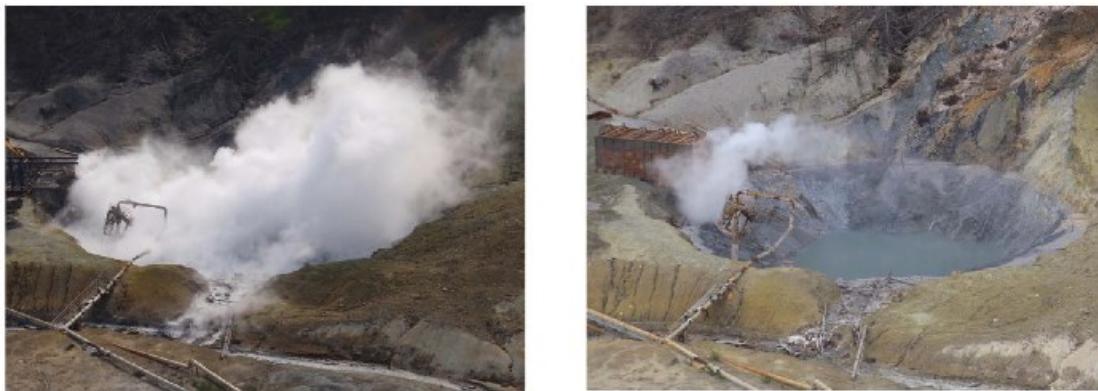
As soon as the total loss of circulation occurred at 896 m depth during drilling, the intermittent hydrothermal eruptions at the surface ceased (Figure 9). After that, there were a number of changes in the water level in the crater-lake, masked to some extent by varying amounts of rainfall. When Well 128 was occluded by sidetrack D-4 (after cementation), the crater-lake water level fell to 4.5 m below maximum. This was a major factor that convinced us to drill sidetrack D-5. Since Well 128 was plugged by

**Figure 9: Change of steam discharge from crater (left; 2 June 2012) and after first plugging of Well 128 (right; 18 September 2012), after Takizawa et al. (2013).**

After Well 128 was successfully plugged by the second cement injection through the relief well, discharge from the crater-lake ceased. Also after loss circulation of the relief Well 138 during drilling, steam leakage near wellhead of the Well 138 decreased remarkably. Relief wells contribute to cease the damaged wells by large scale steam explosion and to make safe working circumstances in the wellfield of the Onikobe geothermal power station.

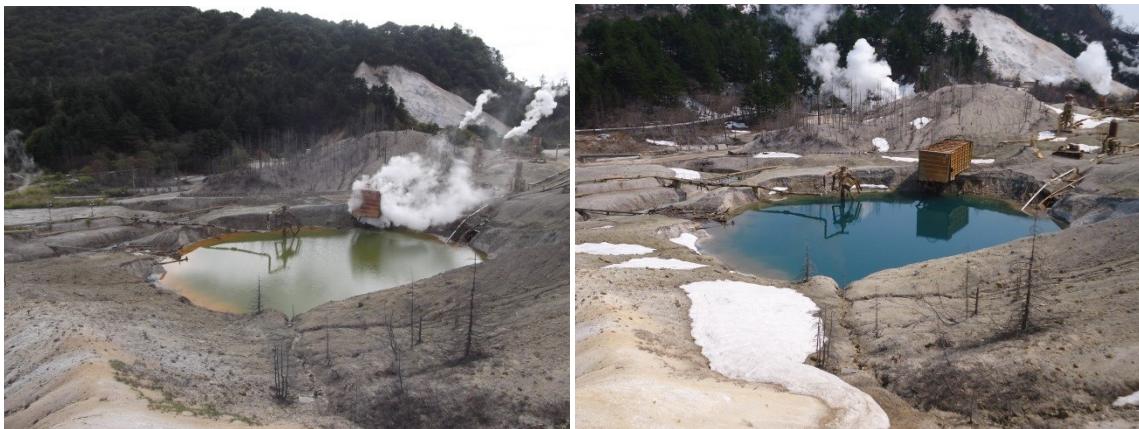
**Figure 10: Change of steam leakage from Well 138 before relief well affected (left; 26 September 2013) and after (right; 18 April 2014)**
