Operating a Lineshaft Production Pump in a Small Pump Chamber Under Highly Aggressive Geothermal Fluid Conditions: Results from the Soultz EGS Site

Keywords: Soultz-sous-Forêts, EGS project, downhole water-lubricated lineshaft pump, corrosion, abrasion

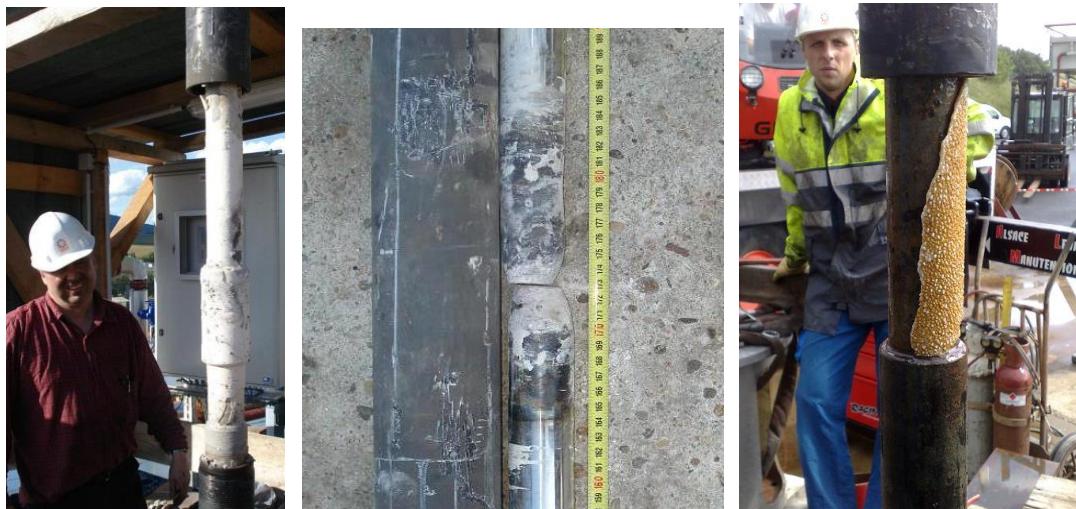
Figure 2: View of the carbonate scaling observed in August 2008 with drinking water lubrication (on the left), lineshaft break (in the middle) and scaling observed in June 2009 with softened water lubrication (on the right)

The first LSP was installed in Soultz in May 2008 and operating from June 2008. First failure in August 2008 was caused by carbonate scaling inside the enclosing tube due to the use of drinking water for lineshaft bearing lubrication (Genter et al., 2010). Carbonate scaling inside the enclosing tube heated the shaft by friction, leading to a breakdown of the top shaft. Domestic drinking water was first replaced by softened water, but this measure did not eliminate completely the scaling inside enclosing tube. For this reason, since 2009, Soultz LSP has been lubricated with water purified by reverse osmosis and with sulphite treatment against

oxygen. The modification has increased operating cost compared with operational experience in Iceland, where LSP's are lubricated directly with the geothermal brine. Since that change in 2009, no more carbonate scaling has been observed.

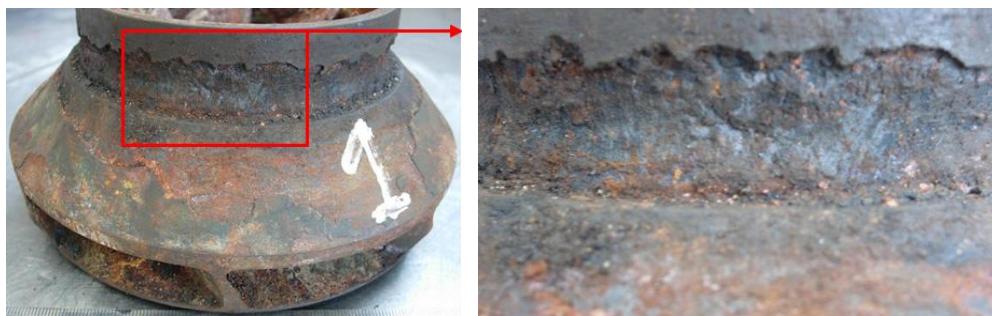
Figure 3: Views of wear caused by "sand-cutting" of impeller No.1 of the pump removed in May 2012

Unfortunately, Soultz operation conditions are more aggressive than Icelandic conditions: high content of chlorine in the brine, high gas-liquid-ratio, high dissolved carbon dioxide in the brine, and carry-over of cuttings from the reservoir and deviated well. The following failures are all mostly related to damages to pump assembly components due to abrasion and corrosion. Each time the pump assembly was removed from the production well, considerable signs of wear and damage could be observed on both rotary and stationary parts. The impellers and bowls were also highly corroded. Investigation with environmental scanning electron microscopy revealed an embrittlement of iron oxide with a soft layer of iron arsenide (geothermal brine contains 4-6 mg/L of As) (Scheiber et al., 2015). Some impellers and stator bowls were damaged seriously by being effectively sandblasted. Sand, scaling or debris trapped by centrifugal force had abraded impellers' necks or the stator bowls. These kinds of abrasion-corrosion damages reduced step-by-step the hydraulic performances of the pump.

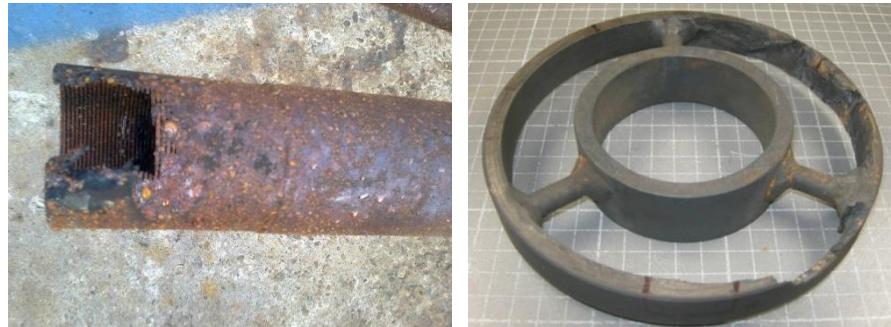
Figure 4: View of the leaking driveshaft-enclosing tube and of one centraliser damaged by stress corrosion and removed in November 2011

In November 2011, the pump was stopped and removed because of a leakage inside the enclosing tube (Genter et al., 2012). The thread of one of the driveshaft's enclosing tube elements and various centralisers were seriously damaged. Investigations with CETIM CERMAT in Mulhouse, France, concluded that the origin of these damages was stress corrosion due to high vibration of the pump. The vibrations were the result of insufficient tensioning of the enclosing tube. This bad experience showed up the importance of the LSP adjustments before start-up. In Figure 4, a view is presented of the damaged enclosing tube and of one damaged centraliser.

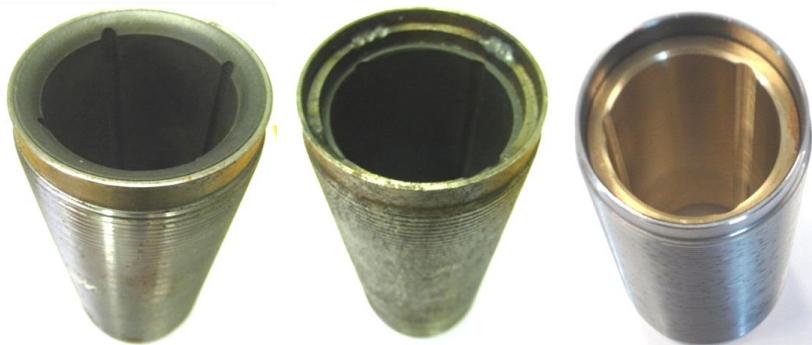
Figure 5: View of the different lineshaft bearings tested in Soultz: standard Icelandic (on the left), with welded rings and carbon-graphite Teflon insert (middle) and bronze bearing insert (on the right)

Between 2009 and 2012, several attempts were made to improve the lineshaft bearing firstly with new Teflon insert fastening with welded rings instead of pins, and then by replacing Teflon with bronze. Teflon fastening with welded rings was not really successful because the axial thermal expansion of the Teflon, which was not taken into account leading to radial expansion and high shaft friction. Bronze material, commonly used with oil lubrication, was not a success with water lubrication: after 5 days of operating, the pump was stopped due to high vibration level. After pump withdrawal, it could be observed that all the bronze bearings were ovalised and some of them had gained 2 mm in their diameter. In Figure 5 the different lineshaft bearings tested during this period are shown.

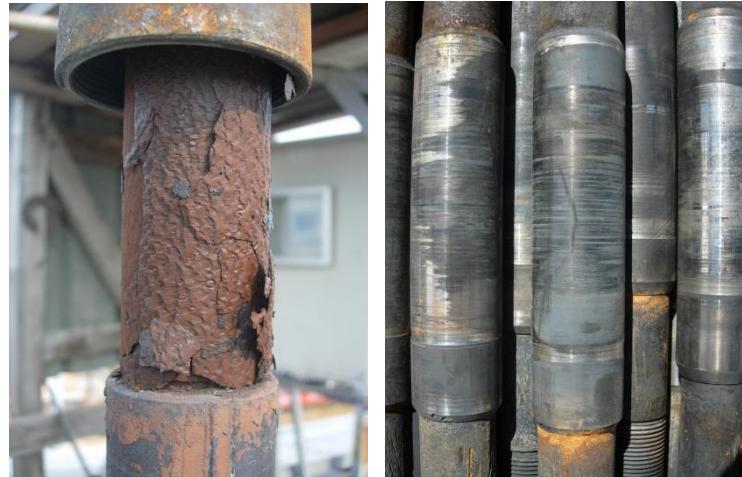
Figure 9: View of oxide and carbonate layer on the shaft (left) and of wear observed on several drive shaft bearing sleeves (right)

Pump withdrawal and lineshaft disassembly were very informative. First, a fine layer of iron oxide was observed at the surface of the lineshaft. This layer was particularly present on the shaft elements closest to the surface. The accumulations of these deposits at the top of Teflon bearings created significant wear, sometimes rather severe, on the shaft sleeves. On the left side of Figure 9 is a view of the iron oxide and particle layer on the lineshaft and on the right side can be seen examples of the wear on the shaft bearing sleeves. This confirms that the lubrication water treatment needs to be improved in order to remove more effectively the dissolved gases such as oxygen or carbon dioxide.

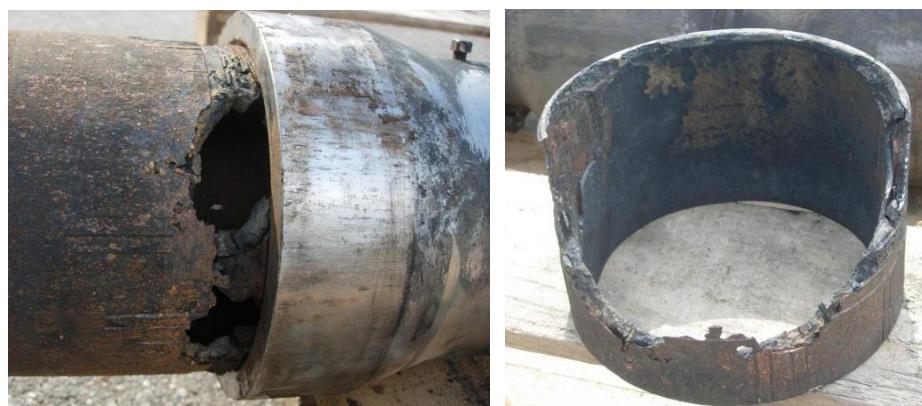
Figure 10: View of the production tube connected to the pump assembly before dismantling (left) and after (right)

The leakage in the production column was finally found at the end of the pump withdrawal: two holes of between 3 and 4 cm diameter were observed on the production tube, where it was connected to the top of the pump assembly. Figure 10 contains a view of the leaking production column connected to the pump and another after pipe cutting and separation. Investigation of the carbon steel pipe in contact with the Duplex alloy has revealed severe mass loss corrosion. This corrosion is thought to be galvanic corrosion induced by the high electrode potential difference between the Duplex material and the carbon steel and probably the use of inappropriate grease for high temperature brine. In such a saline environment, a galvanic isolation between the pump assembly and the column assembly seems to be required. A further possibility is to make the discharge casing of the pump assembly from an intermediate material to reduce the effect of a high electro-potential difference between carbon steel and Duplex alloy in direct contact. This change is to be discussed with the pump manufacturer and their metallurgy experts.

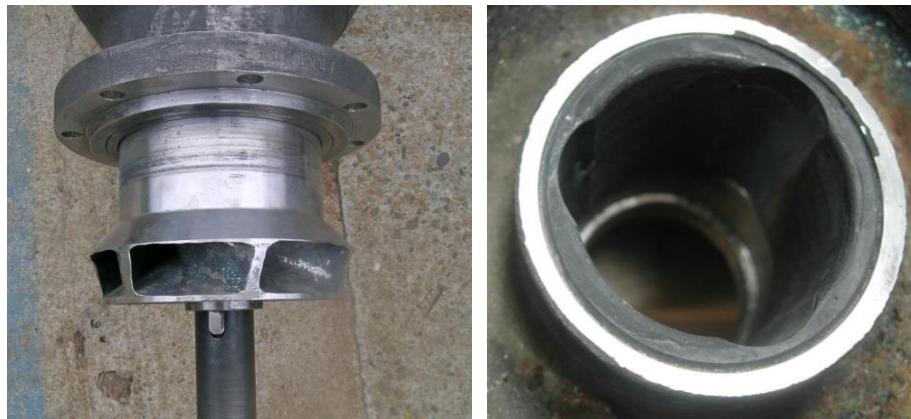
Figure 11: View of the top impeller after cleaning (left) and of the top stator bowl bearing (right)

Once pump withdrawal was achieved, the bottom stage (suction) and top (discharge) impellers were water cleaned and could be inspected. No visible corrosion was observed on these impellers, thus confirming the results of corrosion tests made with the Soultz high temperature skid. Moreover no wear could be felt by hand on the impeller necks. In addition, their external diameters were measured and compared with the nominal value. Measurement gave 116.6 mm for the top impeller and 116.7 mm for the suction impeller, strictly in agreement with the nominal value of 116.5 +/- 0.5 mm. The Duplex alloy used for casting the pump

components seems to be suitable for the highly corrosive brine of Soultz and for standing up to abrasion due to cuttings carried up from the deep reservoir. The top stator bowl was also inspected carefully, especially since the tin bronze bearings had shown strong corrosion during the corrosion tests. A black layer of general corrosion was found covering the bearing surface and further investigation is required to confirm the material choice (see Figure 11).
