Kinetics of Galvanic Corrosion of Carbon Steel to Arsenic and Antimony Couples

Keith A. Lichti¹, Lily Wallis¹, Monika Ko¹ and John Kennedy²

¹Quest Integrity Group, PO Box 38096, Lower Hutt, New Zealand

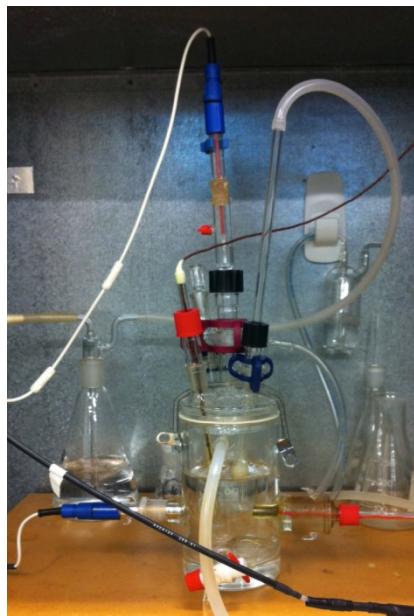
Figure 1: Photo of the experimental set up for Polarisation Experiments.

All electrochemical measurements were obtained by using a PGZ 100 potentiostat (Radiometer Analytical) and EG&G Model 273A potentiostat (Princeton Applied Research). Measurements were conducted using a typical three-electrode electrochemical cell with a double-wall arrangement. Such a custom-made design allowed for a hydronic heating of the experimental electrolyte, with both the heating mantle (Electrothermal, UK) and the peristaltic pump (Watson-Marlow 505S, UK) located outside a Faraday cage to minimize electromagnetic interference (see Figure 1 for experimental set up).

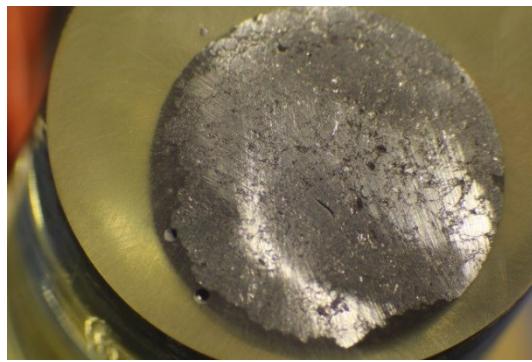
Figure 2: Photo of the surface of the arsenic electrode

A calomel electrode with saturated KCl (SCE) was used as the reference (all potentials reported were referred to SCE) and a platinum electrode as the auxiliary. Antimony and carbon steel electrodes were prepared using rods of high purity antimony (Goodfellow Materials, England) and AISI 1018 carbon steel with a diameter of 6 mm. A copper-tin wire was soldered to one end to provide electrical connection then degreased with ethanol and cleaned with acetone. The arsenic electrode was prepared using sintered arsenic with a diameter of 10 mm and had a degree of porosity. Arsenic was attached to a metal holder by silver epoxy resin which was soldered to a copper-tin wire. The metal was mounted in K36 coating and laminating epoxy resin (Nuplex Industried Ltd. New Zealand). Electrode surfaces were ground to 1200 grit with SiC-Paper and rinsed with distilled water and cleaned with ethanol. Figure 2 displays the very porous structure of the arsenic surface. All electrodes were stored with silica desiccant when not in use.

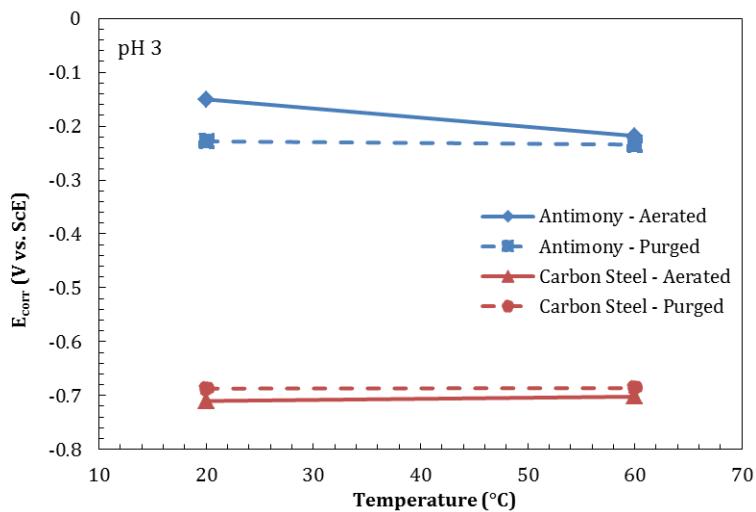
Figure 3: Free corrosion potential, E_{corr} for carbon steel and antimony (pH 3) as a function of temperature for the aerated and purged environment.

A summary of free corrosion potential (E_{corr}) measurements of antimony, arsenic and carbon steel in varying test conditions (temperature, pH and aeration) are given in Figure 3 to Figure 5. Figure 3 shows that the E_{corr} value of antimony at pH 3 shifts to more active values with increasing temperature in the aerated solution, however, E_{corr} remained constant when exposed to de-aerated solution achieved by N_2 purging. For carbon steel at the same conditions, there were small differences for changes in aeration and temperature.

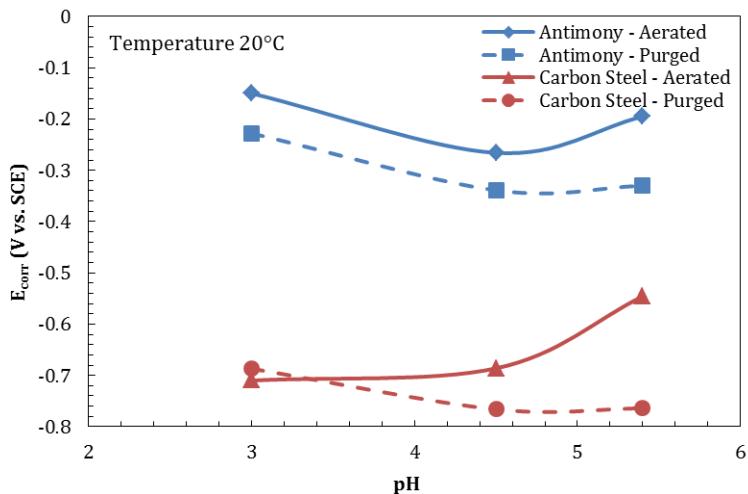
Figure 4: Free corrosion potential, E_{corr} for carbon steel and antimony as a function of pH for the aerated and purged environment at 20°C.

Figure 4 shows the change in potential value with pH levels. Antimony in both environments follows a similar trend, potential decreases for the pH 3 vs. pH 4.5 solution with a slight increase in potential for pH 5.4. Carbon steel also follows a similar trend however aeration has a more drastic change for pH 5.4. Figure 5 shows free corrosion potential of arsenic and carbon steel at pH 5.4 and temperatures between 20°C to 80°C. The E_{corr} of arsenic decreases with increasing temperatures and with de-aeration by N_2 purging. Aeration showed significant effect on the E_{corr} of carbon steel at 20°C, however little difference was observed at higher temperatures of 60 and 80°C, presumed due to lower oxygen solubility at higher temperatures. The free corrosion potential of carbon steel in the de-aerated solution remained more or less constant at all temperatures.

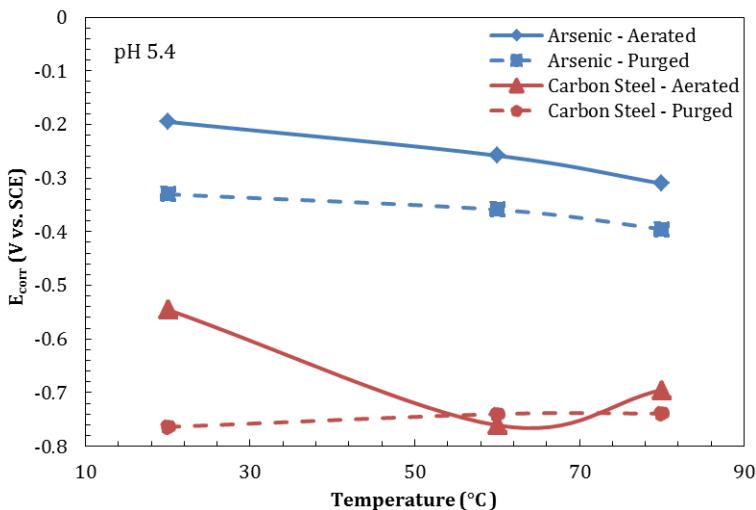
Figure 5: Free corrosion potential, E_{corr} for carbon steel and arsenic (pH 5.4) as a function of temperature for the aerated and purged environment.

These graphs show that antimony and arsenic are less electronegative (cathodic) compared to carbon steel under all experimental conditions.

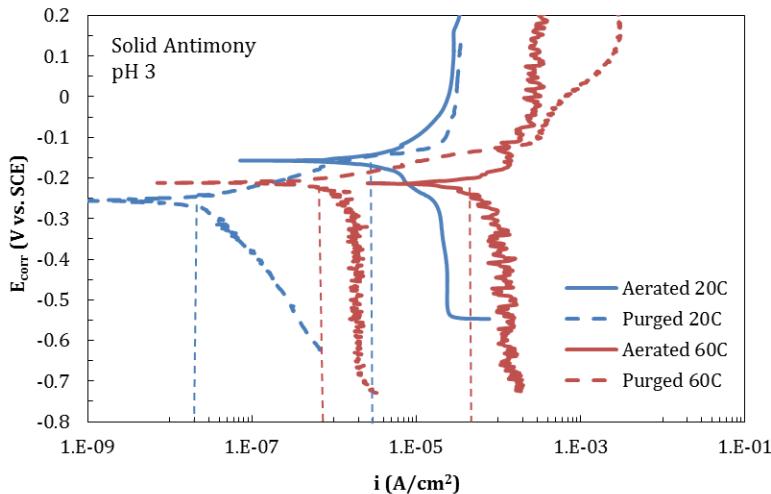
Figure 6: Potentiodynamic curve for solid antimony electrode exposed to aerated and purged environments at pH 3, 20°C and 60°C

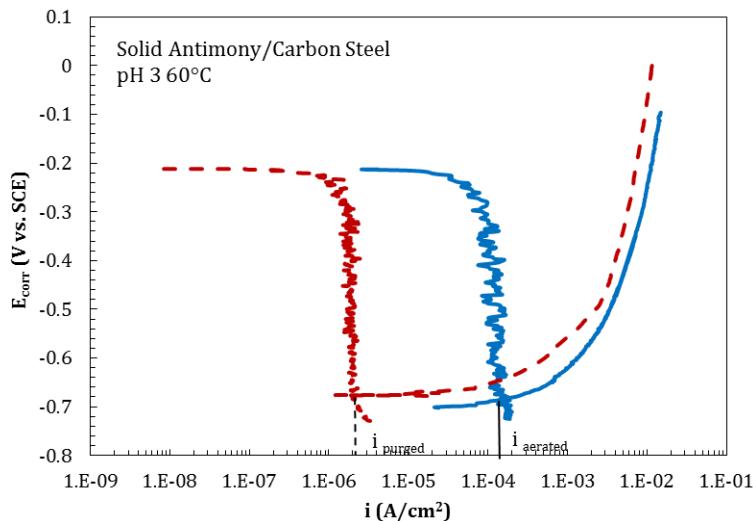
**Figure 7: Super-imposed anodic and cathodic curves for carbon steel and solid antimony electrodes exposed to purged environment at pH 3 and 60°C.**

Galvanic corrosion current can be roughly predicted by super-imposing polarization curves of the anode and the cathode materials, for example see Figure 7 and Figure 8 for antimony/carbon steel and arsenic/carbon steel couples respectively. The approximate corrosion current densities are summarised in Table 3. The solid antimony to carbon steel super imposing results (Figure 7) were consistent with previously published results [Soltis and Lichti, 2013] and show a significant decrease in coupled current due to purging.

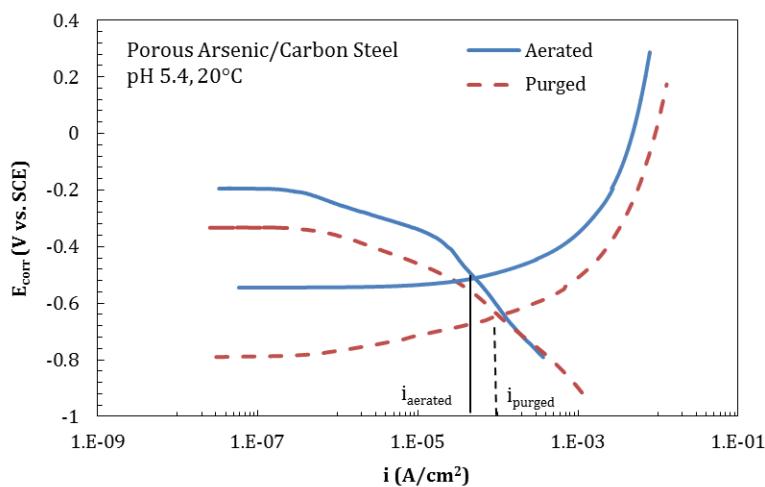
**Figure 8: Super-imposed anodic and cathodic curves for carbon steel and porous arsenic electrodes exposed to aerated and purged environment at pH 5.4 and 60°C**

The porous arsenic to carbon steel super imposed results at pH 5.4 and 20°C gave a lower current for aeration than the purged experiment, Figure 8. This again suggests the porous electrode is less than ideal for this work, possibly giving an error in the results due to the high surface area and retained gas (oxygen) within the electrode. In spite of this unexpected result with the porous arsenic electrode, the proposed matrix of electrochemical testing was progressed.

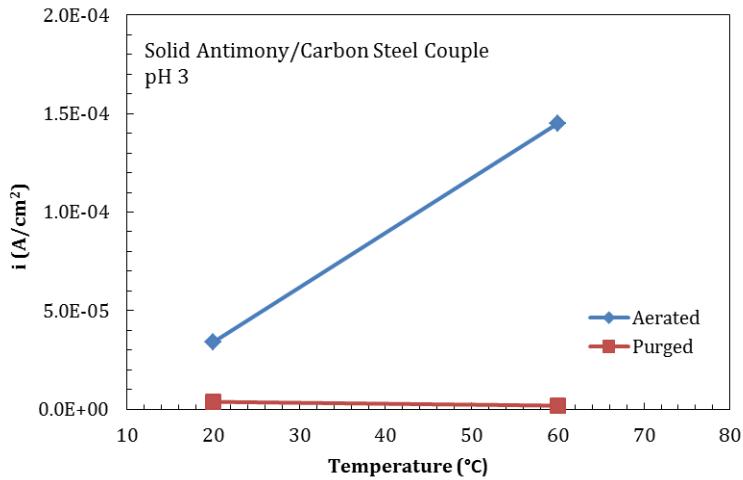
Figure 9: Corrosion current, i_{corr} of solid antimony/carbon steel coupling plotted as a function of temperature for aerated and purged environments, pH 3.

Figure 9 shows how influential the temperature is on the corrosion current of solid antimony in an aerated and a purged environment. In the acidic environment with aeration, increasing the temperature increased the corrosion current. However the same effect was not observed in de-aerated conditions. Figure 10 shows the observed effect of temperature on the corrosion current of the porous arsenic electrode. Both aerated and N_2 -purged conditions gave an increase in corrosion rate as temperature was increased. Again, the purged solution had a higher corrosion current than aerated at 20°C.

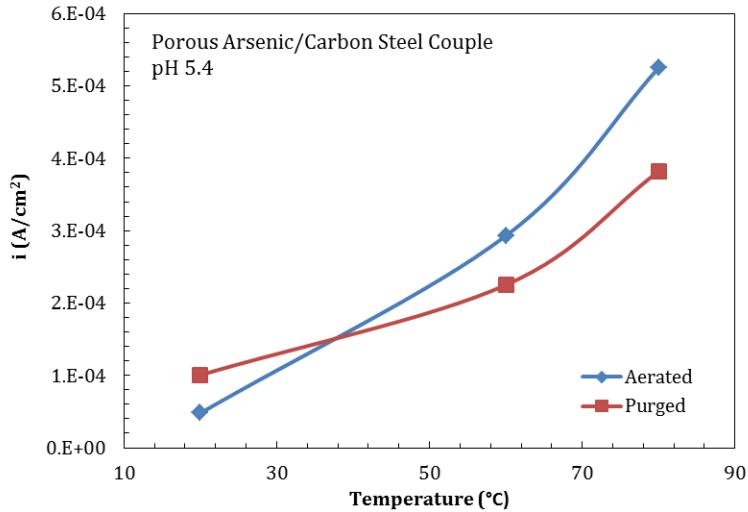
Figure 10: Corrosion current, i_{corr} of porous arsenic/carbon steel coupling plotted as a function of temperature for aerated and purged environments, pH 5.4.

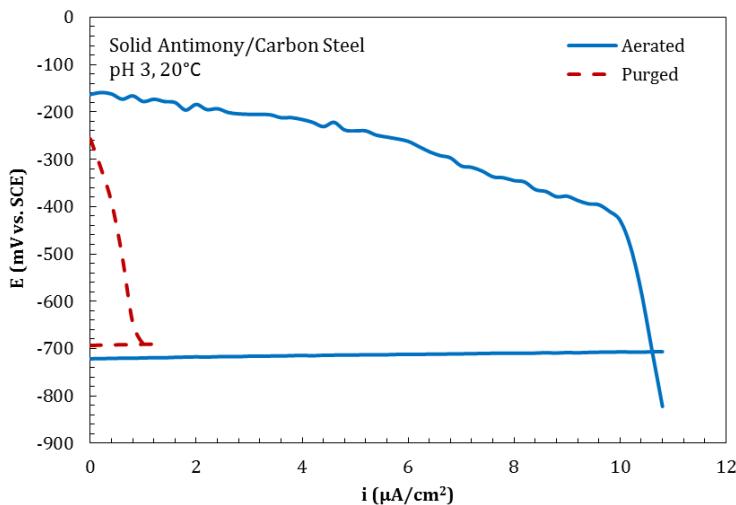
Figure 11. Evans experiment in aerated and purged environment in at pH 3 and 20°C. Intersection of graph indicates i_{corr} .

Evans experiments provide a corrosion current value from the intersection of the working and auxiliary potentials. Table 4 displays the values of the corrosion current obtained in this work. Figure 11 illustrates the results for corrosion current (i_{corr}) of solid antimony and carbon steel in pH 3 and at 20°C under aerated and N₂-purged environments. As expected, the corrosion current of the antimony and carbon steel coupling obtained under aerated condition was higher compared to the N₂-purged condition. At the higher temperature of 60°C, experiments conducted under aerated pH 3 conditions did not produce a mixed potential as the measured potentials of the antimony electrodes were unstable.

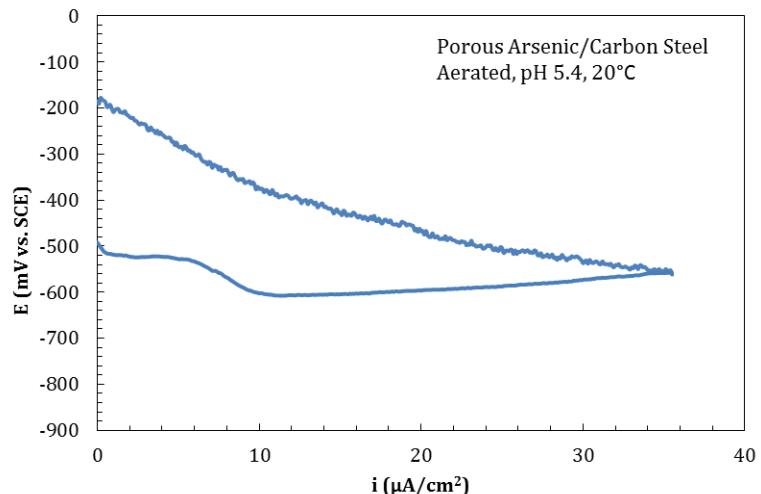
Figure 12: Evans experiment in an aerated environment at pH 5.4 and 20°C. Intersection of graph indicates i_{corr} .

Figure 12 shows the corrosion current for arsenic in pH 5.4, aerated solution at 20°C. Evans experiments of arsenic and carbon steel coupling conducted under N₂-purged condition and also at higher temperatures were inconclusive. The potential readings for the arsenic electrodes were unstable, possibly due to the porous nature of the arsenic electrode. I_{corr} values between Evans experiments and the super-imposed method were roughly comparable.

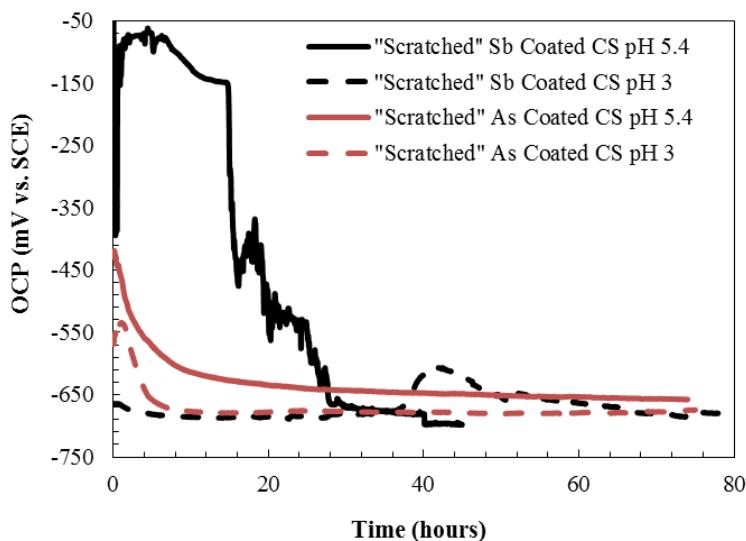
Figure 13: Open circuit monitoring for “scratched” antimony and arsenic coated carbon steel at pH 5.4 (Test 1) and pH 3 (Test 2), aerated and at 20°C.

Figure 13 presents the free corrosion potential (E_{corr}) measurement for ‘scratched’ antimony and arsenic coated carbon steel coupons exposed to aerated pH 5.4 and pH 3 solutions at 20°C. With the exception of antimony coated carbon steel at pH 3, the E_{corr} results indicate that antimony and arsenic metal dominated initially and held the potential more positive, being the larger area and the less electronegative material compared to carbon steel in the galvanic series. After some time a more negative mixed potential, close to that expected for carbon steel in this environment was observed. The free corrosion potential for antimony coated carbon steel exposed to pH 5.4 solution showed instability but followed a similar trend. However, antimony coated carbon steel at pH 3 solution showed a different trend as at the start of the test, E_{corr} was dominated by the carbon steel potential, presumably due to the effect of the strong acid on the antimony layer at the antimony to carbon steel interface.

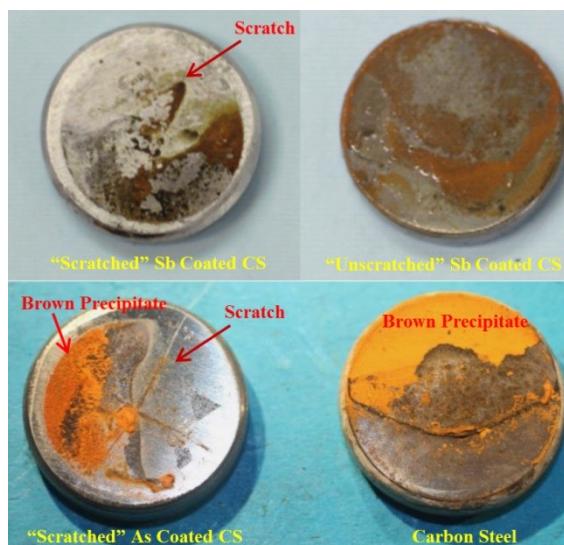
Figure 14: View of the as-exposed coupons from test 1, conditions: pH 5.4, 20°C, aerated.

Test one was for arsenic and antimony coated CS coupons exposed to aerated pH 5.4 solution at 20°C. A plain carbon steel coupon was also exposed for comparison. Following the exposure, all of the exposed coupons were partially covered in brown deposit (Figure 14). For the antimony and arsenic coated coupons, areas of spalled/damaged coating were observed on both the scratched and unscratched coupon surfaces. The unscratched coupon had a similar appearance. A brown precipitate formed as a result of dissolved iron leaching from corrosion below the coatings was observed for all coated coupons.

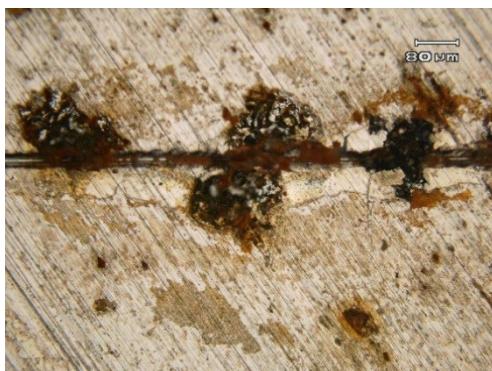
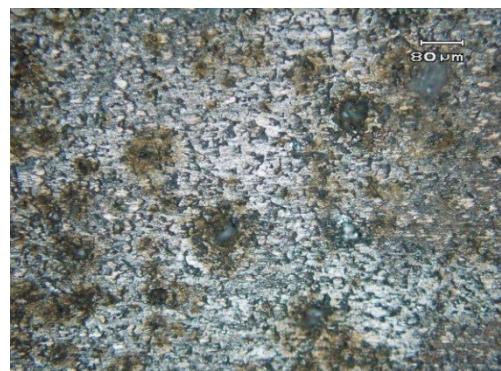
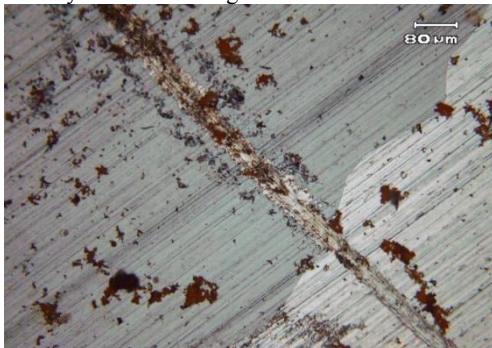
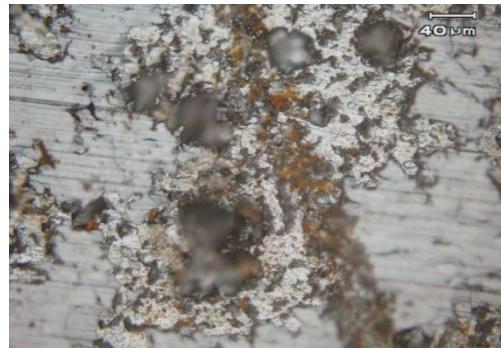
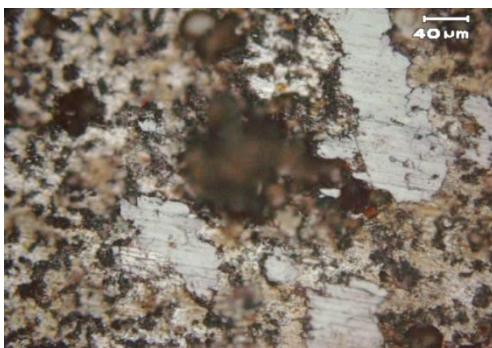
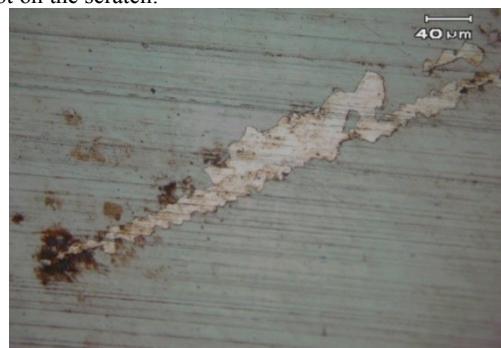
Figure 15: Optical images “scratched” antimony coated and arsenic coated carbon steel coupons from Test 1, pH 5.4, as-exposed and after clean.

a) View of cleaned ‘scratched’ antimony coated coupon surface showing pitting corrosion next to and on the scratched area, surrounded by retained coating.

b) View of cleaned ‘unscratched’ antimony coated coupon surface showing several large pits.

c) As-exposed surface showing non-corroded “scratched” surface and area of spalled coating.

d) View of the coupon after cleaning showing pitting corrosion next to the scratched area surrounded by retained coating areas but not on the scratch.

e) View of coupon after cleaning showing pitting under brown area with retained coating areas.

f) View of un-corroded carbon steel surface with pre-existing coating damage.

The coupons were subsequently chemically cleaned to reveal the extent of surface corrosion under the deposit. The cleaned antimony coated coupons showed localised corrosion damage near the scratch area as well as at locations away from the scratch area, see Figure 15a and Figure 15b. Similarly, the arsenic coated coupon surface had large areas of removed or spalled coating surrounded by discrete islands of intact coating. Where the coating was absent, the underlying steel surface had an ‘etched’ appearance, typical of acid attack, and in some instances deep pitting corrosion was observed, see Figure 15c to Figure 15f. It should be noted that some of the areas of the “scratched” surface where carbon steel was exposed remained un-corroded, see Figure 15f.

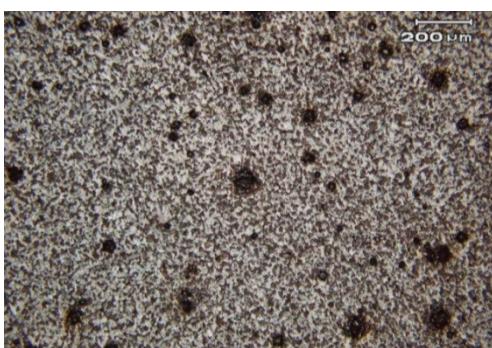
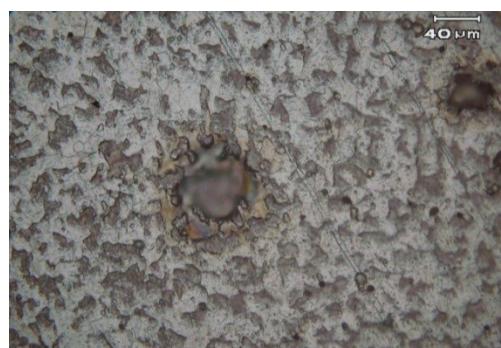
Figure 16: Optical images of cleaned carbon steel coupon from Test 1, pH 5.4, 20°C aerated.

a) Optical image of general surface corrosion and localised pitting corrosion under brown precipitate.

b) Close up view of pitting corrosion and ‘etched’ general corrosion appearance of carbon steel surface.

The cleaned CS coupon had an ‘etched’ appearance, typical of acid attack revealing individual grain facets and grain boundaries, Figure 16. Extensive pitting corrosion was observed under the brown deposit with a maximum measured pit depth of 39 µm. In the area free of brown deposit, general corrosion was observed with surface roughness of around 10 µm.

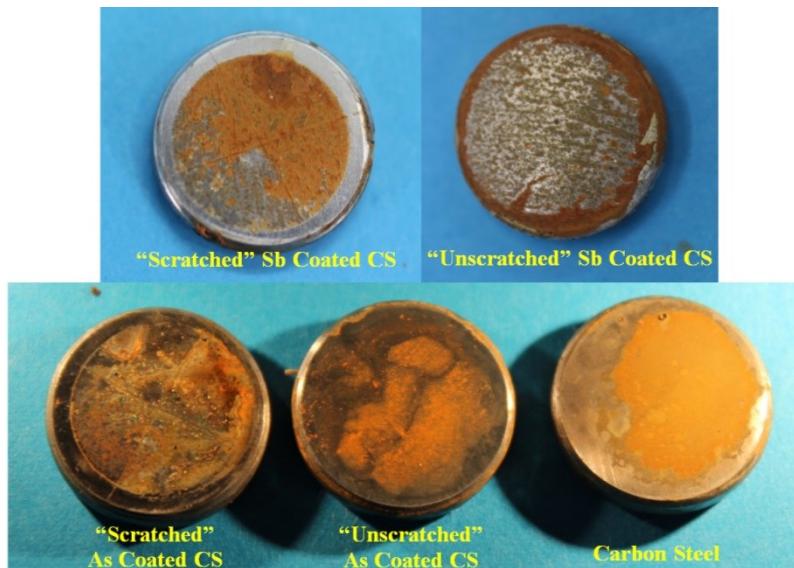
**Figure 17: View of as-exposed coupons from Test 2, conditions: pH 3, 20°C, aerated.**

Test 2 was for antimony and arsenic coated carbon steel coupons exposed to aerated pH 3 solution at 20°C. A plain carbon steel coupon was also exposed for comparison. All of the exposed coupons had a significant amount of brown precipitate on the surface after testing. The unscratched coupons had brown precipitate that was readily removed by rinsing with distilled water. This brown precipitate indicates that the underlying carbon steel had corroded and damage to the coatings layer had occurred.

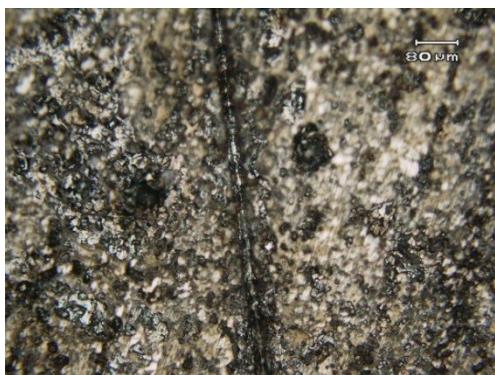
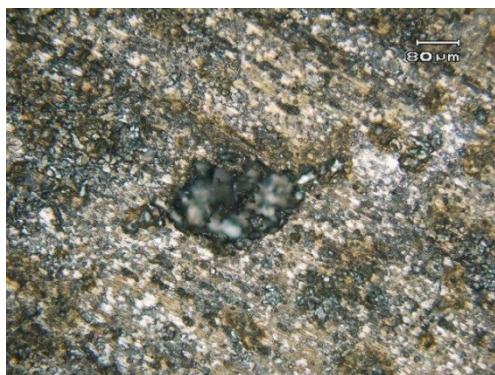
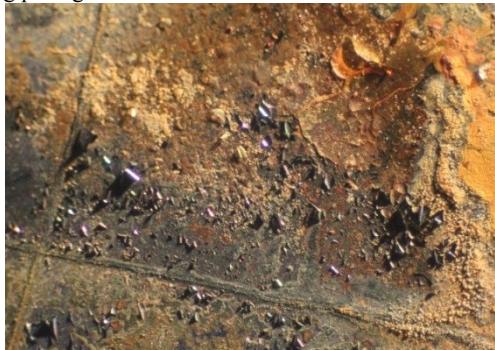
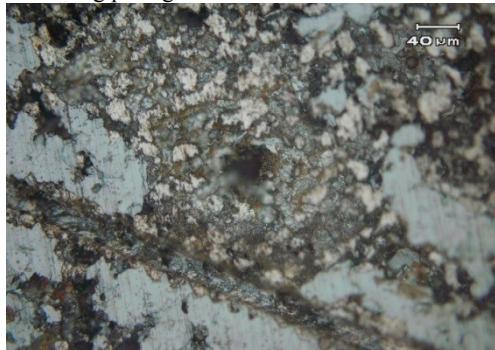
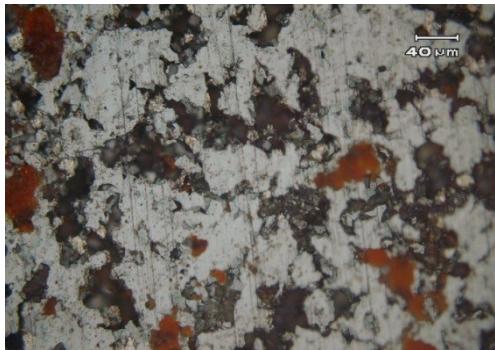
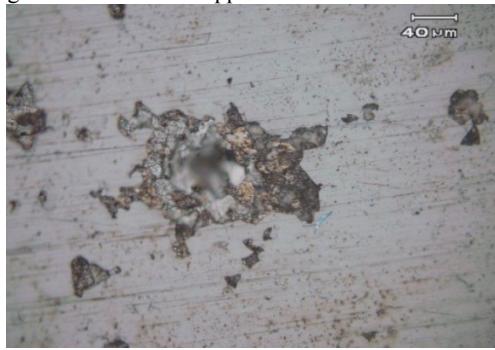
Figure 18: Optical images antimony coated and arsenic coated with carbon steel couple from test 2, pH 3 as-exposed and after clean.

a) View of cleaned 'scratched' antimony coated coupon surface showing pitting next to the scratch.

b) View of cleaned 'unscratched' antimony coated coupon surface showing pitting next to the scratch.

c) Close up view of as-exposed surface of "scratched" arsenic coated coupon showing coating spalling.

d) View of cleaned arsenic coated coupon near the scratched area showing pitting corrosion within area of damaged coating. Note the 'etched' appearance of the carbon steel.

e) View of cleaned arsenic coated coupon away from the scratched area showing localised corrosion and retained areas of coating.

f) "Unscratched" arsenic coated coupon surface showing isolated deep pit within small area of damaged coating.

Close up views of the cleaned antimony and arsenic coated coupons are shown in Figure 18. Both the antimony and arsenic coated coupons showed large areas of coating breakdown as well as localised coating damage. However, there was no preferential localised corrosion or pitting observed around the scratched areas. The pit depths on the coupons were measured and the five deepest pits observed on each of the exposed coupons are reported in Table 6.

The maximum pit depth measured on the antimony coated coupons was around 83 μm . For arsenic coated coupons, the extent of pitting corrosion was again less severe. A pit depth of up to 22 μm was observed within larger areas of damaged coating. Where the coating damage was localised, corrosion of the underlying carbon steel substrate was also observed to a depth of up to 20 μm which added to the total depth of corrosion penetration.

The "un-scratched" arsenic coated coupon which appeared to have maintained an intact coating after exposure in pH 3 solution also showed localised coating loss after the chemical cleaning. This under film corrosion is consistent with the observation of brown precipitate on the coupon surface (*i.e.* corrosion of iron and iron transport through defects in the coating). The cleaned un-scratched arsenic coated coupon surface had random areas of large coating loss. Where large areas of coating were lost, shallow pitting and general surface corrosion of the carbon steel substrate were observed. However, in areas where the coating damage was isolated, pitting corrosion to depth of up to 37 μm was observed (Figure 18f).

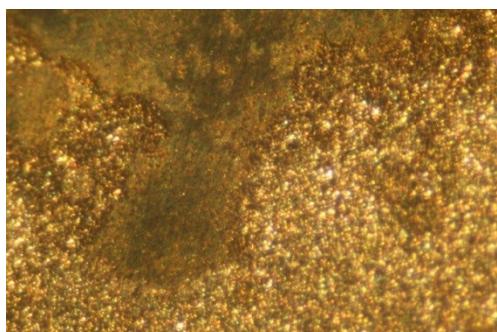
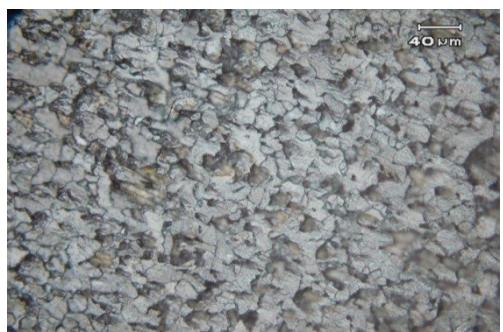
Figure 19: Views of CS coupon from Test 2, pH 3, 20°C aerated solution after cleaning.

a) Close up view of cleaned carbon steel.

b) View of the cleaned carbon steel coupon showing roughened and 'etched' surface.

Views of the cleaned carbon steel coupon surface are given in Figure 19. The corroded carbon steel surface had an 'etched' appearance with surface roughness of around 6 to 8 μm . No deep corrosion pitting was observed on the carbon steel coupon. The testing at pH 3 with aeration gave a maximum rate of attack of 7.6 mm/year and 3.4 mm/year for the antimony and arsenic coated carbon steel respectively, in contrast to the maximum rate of attack of 0.73 mm/year on the uncoated carbon steel.

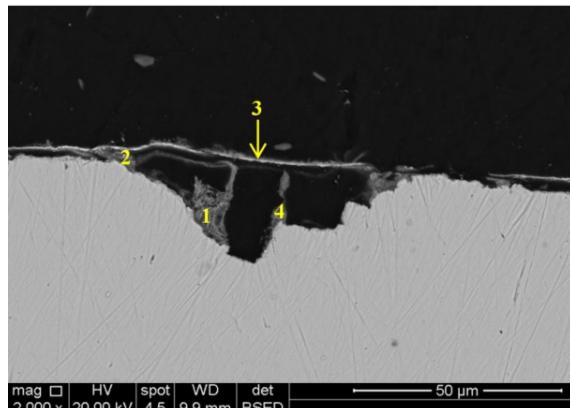
**Figure 20: SEM image of a pit on 'scratched' antimony coated coupon exposed to aerated pH 5.4 solution.****Table 7: SEM-EDX analysis of pit area shown in Figure 20.**

A profile of pitting corrosion found on the antimony coated coupon exposed to aerated pH 5.4 solution is shown in Figure 20. The SEM-EDX analyses results for this cross section are shown in Table 7. Carbon was not included as the results were unreliable. Figure 20 shows more or less intact antimony coating on the coupon surface, over the pit area (indicated by the bright layer, Spot 3 in Table 7). The pit contained small amount of corrosion product that were rich in iron and oxygen, indicating presence of iron oxide compounds. Low levels of chlorine were detected in all analysis.
