Heavy Metal Scaling and Corrosion in a Geothermal Heat Exchanger

Rosalind H. Julian, Keith A. Lichti, Ed Mroczek* and Bruce Mountain*

Quest Integrity NZL Ltd., PO Box 38096, Lower Hutt 5045, New Zealand

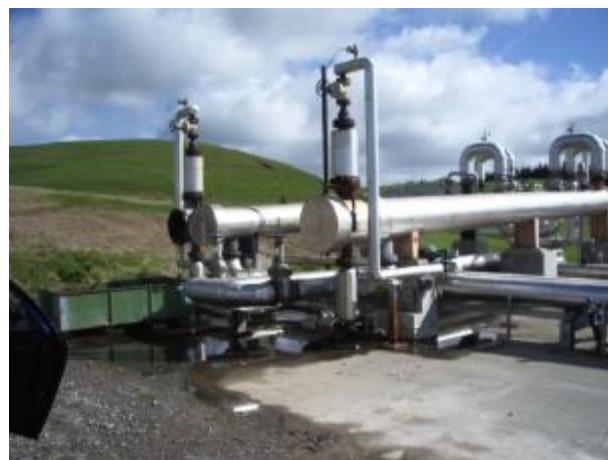
The two heat exchangers of concern in this report (Figure 1) used two-phase fluid from Mokai well MK3. They were used for heating recirculating hot water that was stored in a large reservoir. The heat exchange demand was variable but the heat exchangers were maintained under pressure at all times. At times of low load the fluid was stagnant in the pipes and in the heat exchangers. The two-phase fluid was transferred to the inlet headers of the heat exchangers on the tube sides and the heat exchangers were angled downwards so that the exit headers were filled with a condensed steam and brine mixture. Non-condensable gas was vented as needed from the top of the exit header and the cooled brine was pumped to a nearby power station brine pipeline for reinjection.

Figure 1: Heat exchangers.

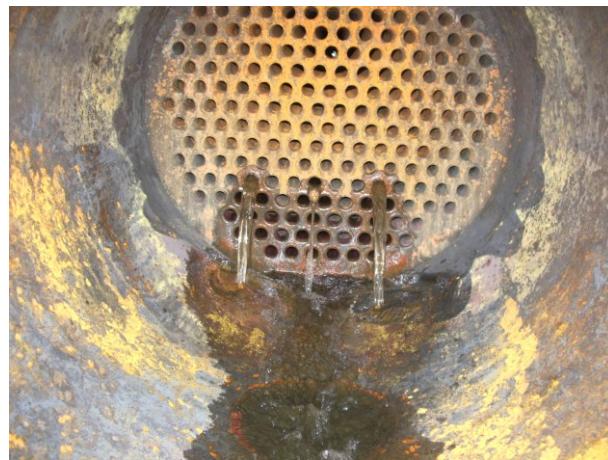
At least three pipes had perforated in the same row, see Figure 2. One tube was extracted from the angled heat exchanger, 8.5 m of the 9.5 m tube was recovered. The perforation by pitting shown in Figure 3 was at 2.2 m from the inlet header end plate.

Figure 2: Heat exchanger exit header end plate view showing leaking tubes from perforations in a single row of tubes.

Corrosion to perforation of several tubes within one row in the two-phase heat exchanger was observed. The mid layer tube corrosion was attributed to poor flow characteristics that allowed a buildup of condensing steam that was only slowly pushed through the heat exchanger resulting in gas build-up and lowered pH. However, elemental arsenic was also observed over the corroding pits, and the possible influence of elemental arsenic enhancing corrosion through galvanic effects could not be discounted.

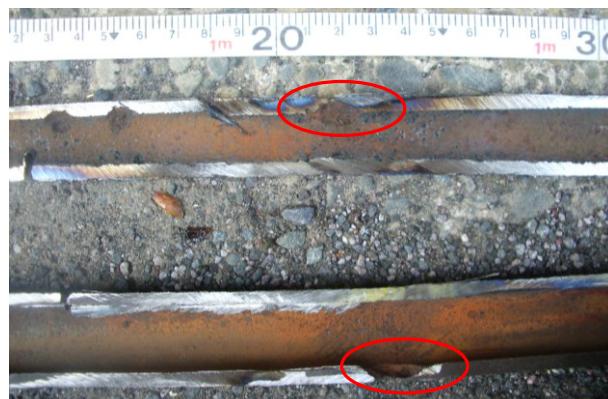
Figure 3: Pipe perforation at 2.2 m from the inlet header end plate (only 8.5 m of the 9.5 m long tube was recovered).

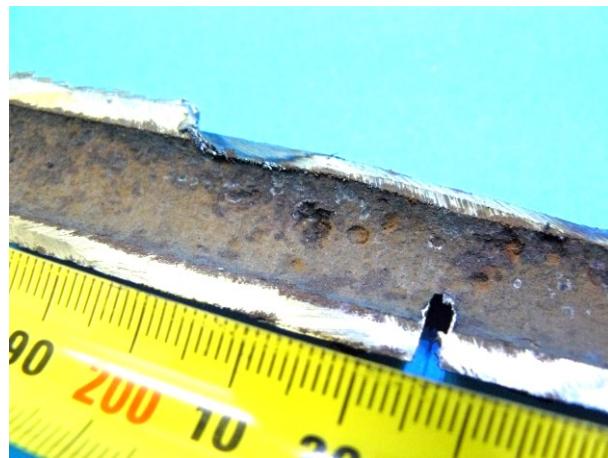
The sample tubes were reported to have been water blasted prior to removal. Deposit material removed from the heat exchanger was also provided. It had the appearance of well discharge solids, i.e. pumice and rock. The tube samples all had evidence of general corrosion along with localised small pits and a few large pits, some of which had reached perforation, as shown in Figure 4 and Figure 5. The pipe sample lost in the heat exchanger was presumed to have separated from the removed tube at a larger area of corrosion.

Figure 4: Small pits observed along the tube near the area of perforation of the removed tube section.

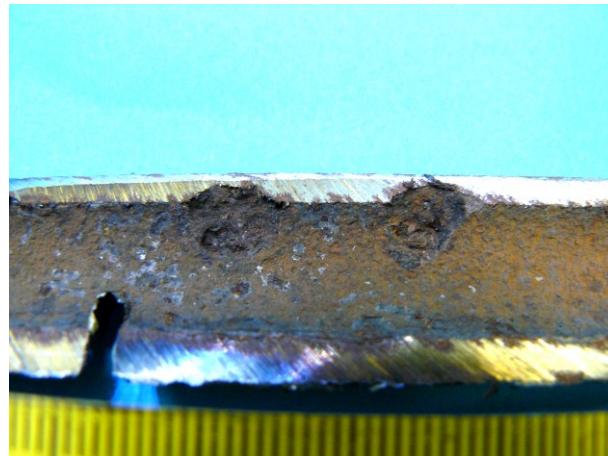
Figure 5: Large pits located close to the perforations.

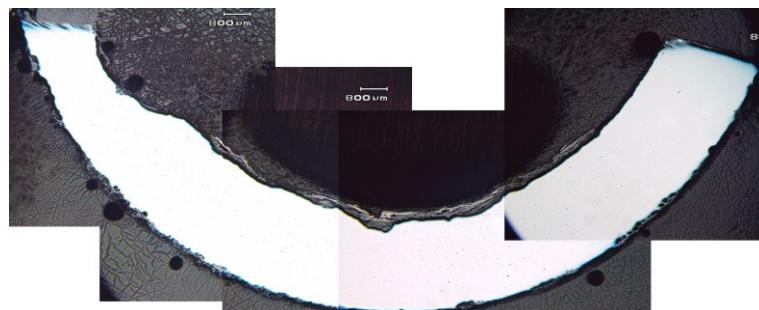
Cross sections were taken at representative pits. The scaling, corrosion and pitting were characterised by a thin layer of pale coloured deposit material overlaying a corrosion product deposit (Figure 6). The general inside surface of the tube was non-uniformly corroded and had a few wide deep pits, as well as some narrow shallow pits. Within the pits the cross sections show a pale outer deposit and inner corrosion products (Figure 7). The deposits and corrosion products in the pits show distinct layering effects, as illustrated in Figure 8. This is typical of cyclic operation where the growth of scale is interrupted by a change in conditions that results in thermal dislodging of the scale and subsequent growth on startup.

Figure 6: Cross section showing a range of corrosion penetrations.

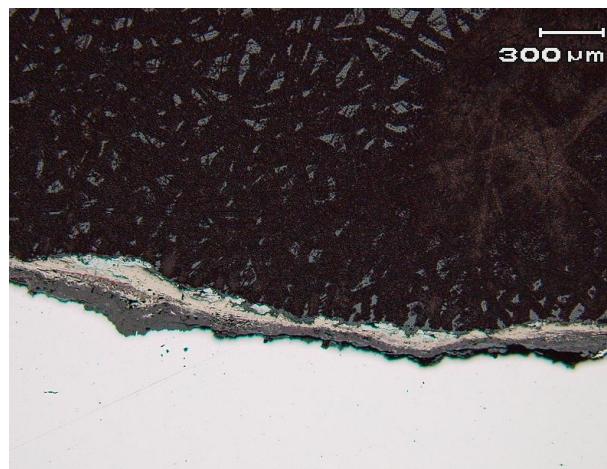
Figure 7: Cross section showing outer deposit and inner corrosion product.

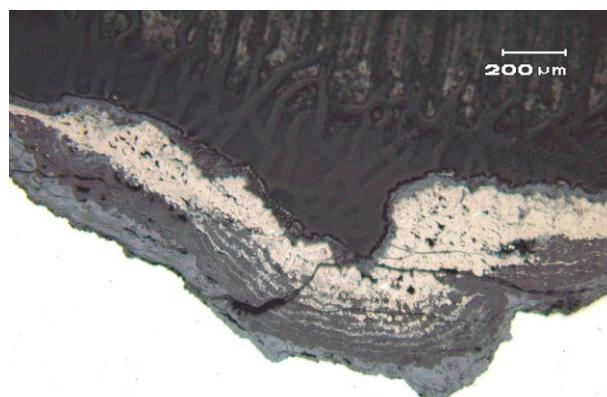
Figure 8: Layered deposit over underlying corrosion product.

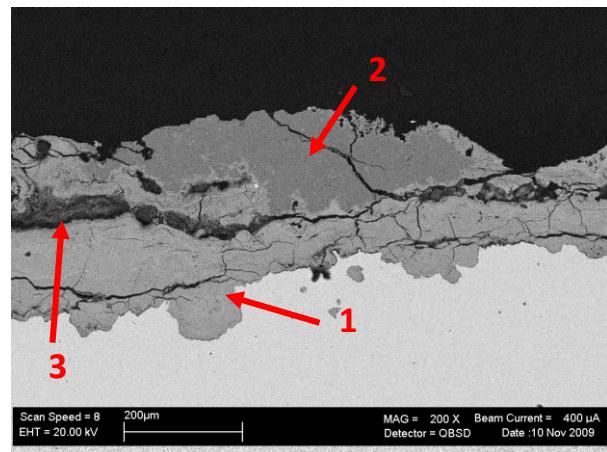
SEM EDX analysis was carried out on samples in cross section view. A cross section was analysed at one area of deposit without the white layer (Figure 9). The light grey area next to the metal surface identified as (1) was found to contain mostly oxygen with a smaller amount of iron and trace amounts of sulfur and arsenic. The dark grey area above identified as (2) was found to contain slightly less iron and slightly more oxygen with traces of sulfur and magnesium. The darkest strip between the light and dark grey identified as (3) was found to contain much less iron than the light grey and dark grey areas and much more oxygen. A small amount of nickel and trace amounts of silicon, aluminium, sulfur, chromium, arsenic, antimony and manganese were also found in all three deposits. In this location on the cross section, the outer white layer was absent.

Figure 9: SEM EDX analysis areas.

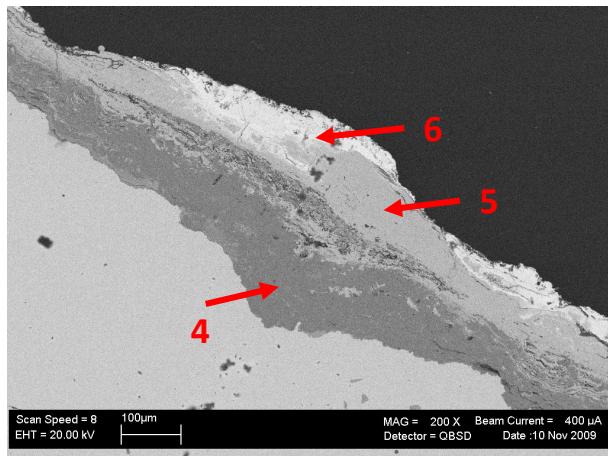
Another cross section that had an outer white deposit layer was selected for analysis, see regions marked in Figure 10. The dark grey area, next to the metal (4), consisted of mostly oxygen with a smaller amount of iron and trace amounts of sulfur and silicon. The light grey layer (5) consisted of similar amounts of sulfur and iron, with a smaller amount of oxygen and trace amounts of silicon, magnesium and arsenic. The white layer, retained after water blasting, on the top (6) was mostly arsenic with small amounts of oxygen and sulfur and even smaller amounts of antimony and iron.

Figure 10: SEM EDX analysis areas.

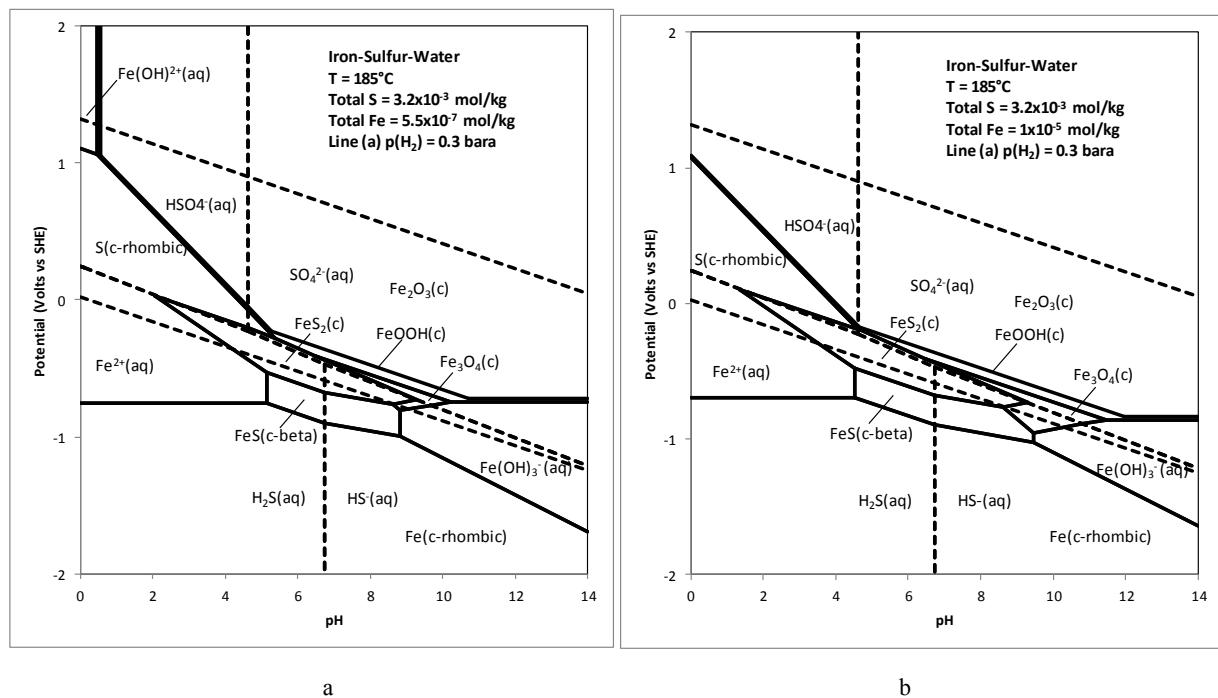
The total sulfur, iron content, pH and pH₂ values were used as input conditions for a potential pH “Pourbaix” type diagram for the stability of corrosion products in the Fe-H₂S-H₂O system at 185°C following the method described by Chen and Aral (1983), see Figure 11a. This diagram suggests that the fluid will be corrosive at pH less than 5.5. The “WATCH” calculations indicate that the pH drops below 5.5 within the heat exchanger. The silica saturation indices indicate minimal tendency for silica scaling as supported by a lack of silica deposit formation. The lower pH will also delay polymerisation of silica. The level of dissolved iron is an important consideration for the development of these diagrams. The diagram of Figure 11a was developed for a very low level of iron as indicated by the “WATCH” calculations and this level is likely in error – corrosion models are typically generated for a minimum of 10⁻⁵ iron concentration. A second Pourbaix diagram for this higher level of iron indicates good corrosion product stability to a pH as low as 4.5, see Figure 11b. There was a minimum of corrosion observed in the exit headers suggesting good shielding in these open areas where the fluids were well mixed.

Figure 11: Potential pH diagram at 185°C, the location of failure within the heat exchanger at two different iron concentrations.

The potential-pH Pourbaix diagrams show that at the calculated pH and iron concentration in solution there should have been free corrosion with no deposited corrosion products. However, the high corrosion rate increases the iron concentration next to the metal and iron sulfides becomes stable. The observation of iron oxides next to the metal surface under outer sulfide layers occurs as a result of shielding of the metal by the iron sulfides precipitated near the surface to give a lowering of the H_2S concentration and iron oxide stability next to the metal (Lichti *et al.*, 1997).
