In-Situ Material and Corrosion Studies at the Soultz-sous-Forêts (France) EGS Site

Julia Scheiber¹, Guillaume Ravier², Nicolas Cuenot¹ and Albert Genter¹

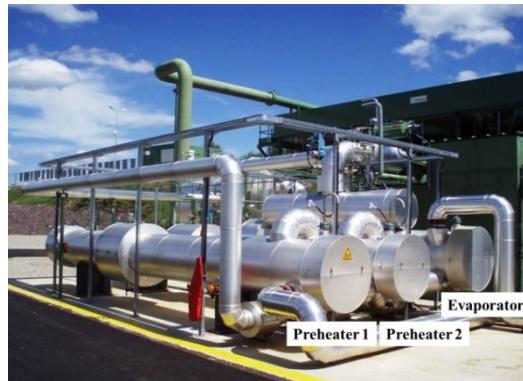
Figure 1: ORC tubular heat exchanger system of the Soultz geothermal power plant: ORC Evaporator, Preheater 1 and Preheater 2, (Picture: GEIE).

Energy production in Soultz is carried out in an Organic Rankine Cycle (ORC). The ORC heat exchanger system constitutes, of three low alloyed tube heat exchangers, the ORC Evaporator, Preheater 1 and Preheater 2, Figure 1.

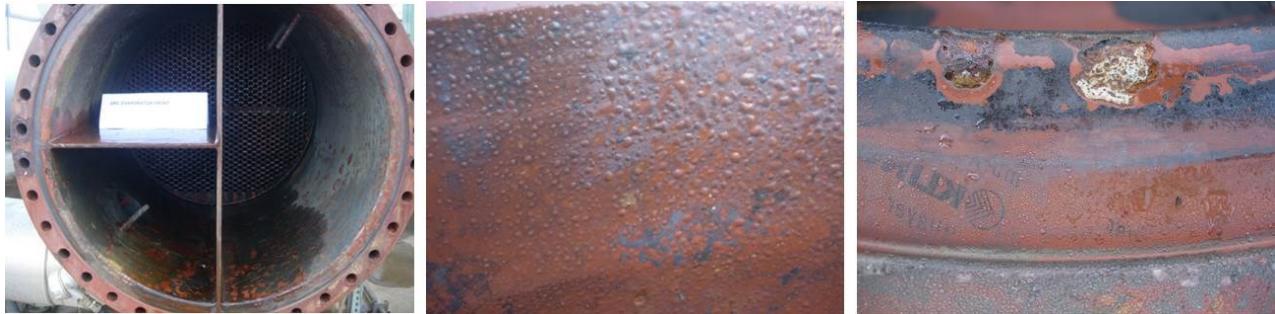
Blister formation, especially in heat exchanger caps, indicate a loss of thermal stability and decreasing diffusion resistance against dissolved gases like CO_2 , Figure 2 (middle). The hydraulic regime in the caps is very rough due to high turbulences when the fluid flow is turned by 180°. If gases manage to diffuse through the coating to the metals surface at 20 bars, these gases tend to expand their volume if heat exchanger operation is stopped and atmospheric conditions are allowed to adjust due to pressure decrease. This basically mechanical driven phenomenon pushes the coating from the metals surface and results in blister formation.

At various locations, spalling of the coating was observed and metal was exposed to the geothermal brine, Figure 2 (right).

Figure 2: Surfaces of the ORC Evaporator front side after water jetting (left). Blister formation in heat exchanger cap (middle). Coating spalling and exposure of metal surface to the geothermal brine (right). After Scheiber et al. (2013a)

Spalling of the coating exposed the low alloyed metal of the heat exchanger tubes to geothermal brine and aggressive in sub-surface corrosion and probably pitting corrosion was triggered. Finally, the mechanical strength of the heat exchanger pipes decreased to a complete breakdown. Geothermal brine broke to the isobutene cycle and polluted seriously the whole binary system. Soultz heat

exchangers are fully damaged and have to be replaced. Several metals and alloys are now in discussion for the new ORC heat exchanger system. For this equipment, coating will not be considered in the near future, consequences of failures are too serious.

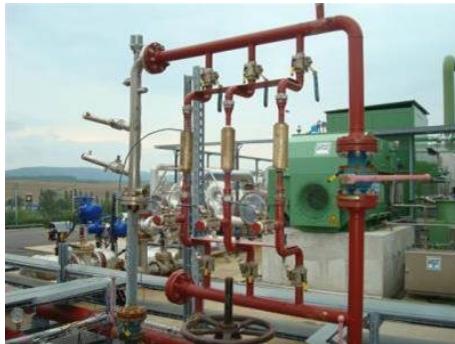
Corrosion experiments at this bypass system focused on material research at in situ conditions of 70°C and 18 bars. Metal coupons were exposed in three different chambers which were made of PEEK (Polyether Ether Ketone). Corrosion rate and type of corrosion were investigated on metal coupons made of carbon and stainless steels. Sample selection was based on those materials which were already in use in the surface and subsurface installations of the geothermal power plant in order to identify the weakest points at the power plant. For mild steels uniform corrosion were observed mainly at corrosion rates up to 0.2 mm/year. Pitting corrosion dominate at stainless steel samples. The more noble the material is the minor was the impact of the geothermal brine on the metal. The formation of a strong adhesive scaling was recorded especially for carbon steels, Baticci, (2009), Baticci et al., (2010), Mundhenk et al., (2012), Mundhenk et al., (2013), Scheiber et al. (2012).

Figure 6: Low temperature skid (LTS) is located downstream of the heat exchanger before injection well GPK-3 at the reinjection side of the geothermal loop at Soultz. After Scheiber et al., (2013a).
