# Risk mitigation of H2S exposure at ON Power

Dagur Helgason, Iða Brá Vilhjálmsdóttir, Sæunn Kolbrún Þórólfsdóttir
ON Power,
Bæjarháls 1, 110 Reykavík, Iceland
dagurh@on.is

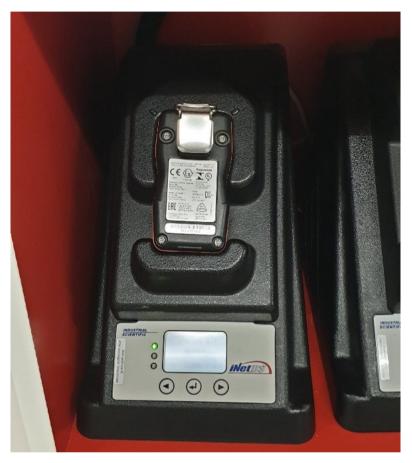
Figure 1: A personal H<sub>2</sub>S monitor docked for calibration.

In 2005 all employees started carrying personal H<sub>2</sub>S monitors at ON Powers' plant sites. The first monitors required manual calibration, a process that was time consuming and not feasible in the long run. Therefore, in 2012 the company started phasing in monitors that did not require calibration. These monitors were single use monitors that lasted 24 months. In 2015 the company started phasing in a new monitor system from Industrial Scientific, these monitors were fully implemented for all employees in 2017. These monitors require calibration every 2 weeks. To do this they are docked in a docking station where gas is used to automatically calibrate the monitor. These docking stations, see Figure 1, also read data from the monitors and upload to a database. The data consists of logs of all incidents where the monitor has measured any H<sub>2</sub>S, the maximum value, average value, duration of exposure, time of incident and more. This allows for better oversight of incidents, which has allowed the company to emphasize changes of equipment and working procedures where these changes are most needed.

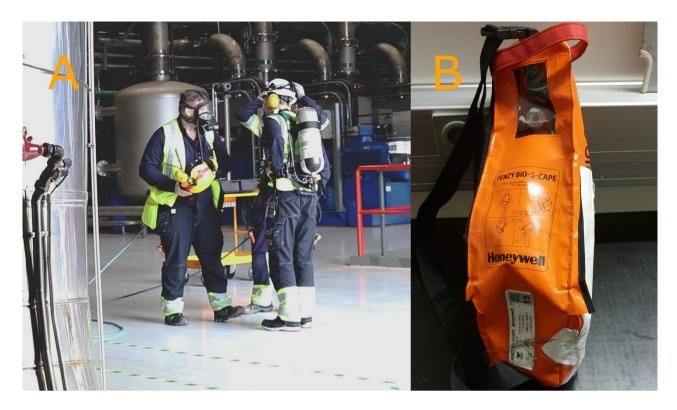
Figure 2: Example of supplied air breathing apparatus (SABA) and self-contained breathing apparatus (SCBA) used by ON Power employees. A) On the left is a worker using a SABA that connects to an air supply via a hose, on the right is "the third worker" using the a SCBA during work on gas systems. B) Emergency SCBA used by workers in emergencies to get out of contaminated areas.

Over the last few years ON Power has systematically worked on assessing the dangers of each job at its plants. To do this the company has hired consultants to assess these dangers with employees and set up standardized procedures and equipment for certain kinds of jobs. In cases of risk of H<sub>2</sub>S exposure, for example when work is being conducted on gas rich systems, workers are required to have a supplied air breathing apparatus (SABA) while working, see Figure 2A. Further, they are required to work in pairs and have a third worker standing at a safe distance ready to respond to emergencies, ready to call in any emergencies via radio. The workers working in gas use SABAs that are connected via a hose to the building's fresh air system. The third worker on the other hand has a self-contained breathing apparatus (SCBA) that includes a fresh air tank, allowing the worker to move freely where needed, see Figure 2A. The third worker also carries an emergency SCBA with a small air supply intended to allow others to get the air needed to get out of the building in case of emergencies, see Figure 2B. These emergency SCBAs are also placed at strategic locations around the plants and can be easily reached in emergencies.

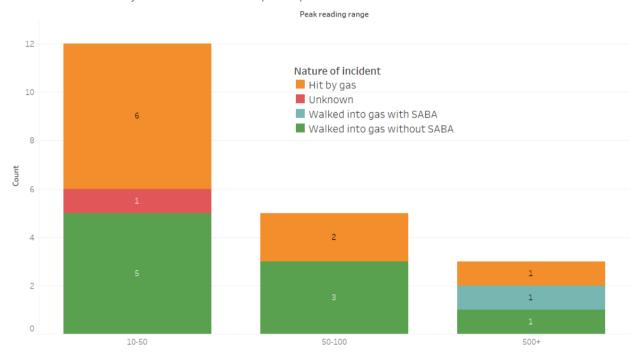
### H2S incidents in May 2019 at ON Powers' powerplants

Figure 4: Number of H<sub>2</sub>S incidents at ON Power's powerplants in May 2019. The figure only shows those incidents that received a response during inquiry. The incidents are shown in 3 ranges depending on the highest H<sub>2</sub>S reading during the incident: 10-50 ppm, 50-100 ppm and 500 ppm+. No incidents in the 100-500 ppm range received a response. Most of the incidents are in the 10-50 range. The 3 incidents with 500 ppm+ measurements posed little threat to the people involved due to the nature of the incidents (see section 3.3). The incidents are categorized by their nature into 3 categories: hit by gas (where gas was unexpectantly released close to the worker), walked into gas with SABA (where the worker walked into a contaminated area with a SABA or SCBA) and walked into gas without SABA (where the worker walked into a contaminated area without a SABA or SCBA).

Out of the 39 incidents that took place that month, 19 have been mapped. As can be seen in Figure 4, most of the incidents, 11 out of 19, were in the lowest range of 10-50 ppm H<sub>2</sub>S. However, in 3 cases the monitor maxed out at 500 ppm, a potentially lethal level. In the first incident the monitor was used to check for gas in a pipe after a valve was opened, the valve was closed immediately after the user saw that gas was coming out of the pipe. The second incident was the result of the monitor being used as a sniffer, it was lowered into an area suspected of contamination and the user was out of harm's way while doing so. The third incident took place during work on a gas extraction system, the person involved was wearing a SABA and all protocol was followed to minimize the danger. In 9 of the 19 incidents the H<sub>2</sub>S monitor was used as a sniffer to minimize risk to workers.
