Corrosion Testing in Direct Geothermal Steam of Cladded and Standalone Materials at 210°C and 450°C

Ingolfur O. Thorbjornsson¹, Bente C. Krogh², Gunnar S. Kaldal¹, Gisle Rørvik², Sigurdur S. Jonsson¹, Larus Gudmundsson¹, Finnbogi Oskarsson¹, Omar Sigurdsson³, Hans Husby², Arni Ragnarsson¹

¹ Isor-Iceland Geosurvey, Grensásvegur 9, 108 Reykjavik

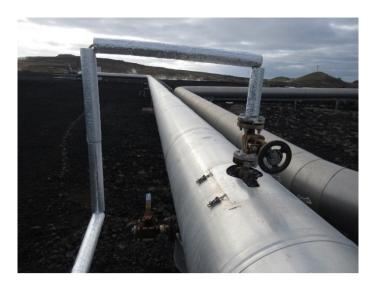
Figure 1: Sampling point used as a steam source.

Sampling/connection point was selected further downstream on the steam pipe. The 1" valve/sampling point was located on the high-side of the steam pipe, approximately 25 m from the well-head as shown in Figure 1. From this point, gravitationally separated steam could be anticipated, and relatively dry steam would be obtained, without the operation of a Webre steam-separator. A sample taken from a condensate fluid from the sampling point yielded conductivity of 65 μ S/cm at 25°C, confirming good separation of steam and brine at the location.

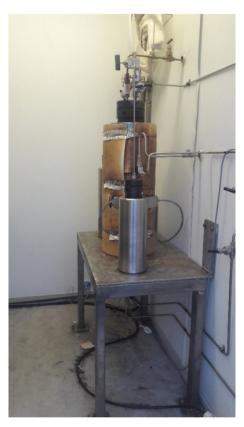
Figure 4: Side view of autoclave for testing at 450°C, support table and pipework. The needle valve near the wall, leading from the top of the autoclave, restricted the outflow of steam to maintain constant temperature and control effective heating.

After passing through the outer vessel, the steam was piped into the laboratory inside the container (Figure 4). A by-pass circuit had been constructed to flush out the piping before diverting the steam through the autoclave. A needle valve (control valve) was located at the input connection. At the bottom of the autoclave another needle valve was located. The third needle valve was located at the top of the autoclave to restrict the steam flow, in the event that the set temperature (450°C) could not be maintained, due to high flow of steam through the autoclave.

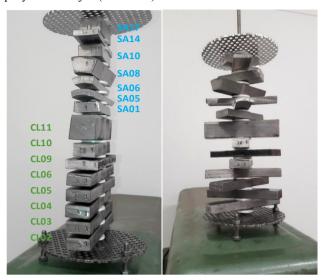
Figure 5: Assembled sample holders and position of samples listed in Table 3. The setup of both sample holders, for testing in 210°C and 450°C, were identical.

For testing, both in the test chamber outside the container and in the autoclave setup inside the container, identical sample holders were designed and constructed. Mesh screens were used for centralization and alumina ceramic collars and washers for insulation. Figure 5 shows the test coupons listed in Table 3.

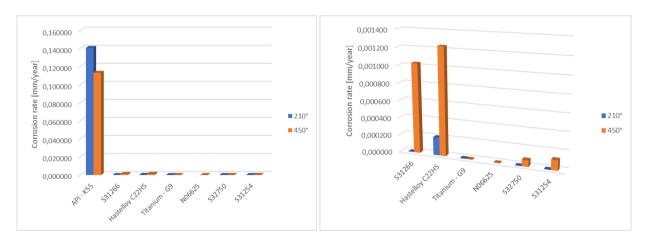
Figure 7: Measured corrosion rate for stand-alone samples. Values for N06625 at 210°C are missing.

For the sample rack at 450°C, iron oxide formed on the bottom perforated plates, and the samples close to it, as can be seen in Figure 6. This is believed to be due to oxygen entering the autoclave during changing of a thermocouple. The results from weight loss measurements are used to calculate the corrosion rate as shown in Figure 7.

Results from weight loss measurements show medium carbon steel API-K55, as expected, with very high corrosion rate and the only material tested to be above the commonly accepted corrosion rate of 0.1 mm/year for geothermal applications. This material shows higher corrosion rate in 210° C than 450° C, as expected due to higher risk for fluid film on the material at 210° C causing higher corrosion rate. For the Corrosion Resistant Alloys (CRA), the corrosion rate is higher for all materials in 450° C than in 210° C. For CRA alloys the protection films on the surfaces give them resistance to fluid-based surface corrosion, at higher temperatures the corrosion rate is higher. For the S31266 that is a super austenitic type with PREN value of ≈ 60 , it was expected to see corrosion level

close to or better than for S312254 that is lower alloyed super austenitic type with PREN \approx 43. Relative high corrosion rate of N05022 (C22-HS) both in 210°C and 450°C is unexpected.

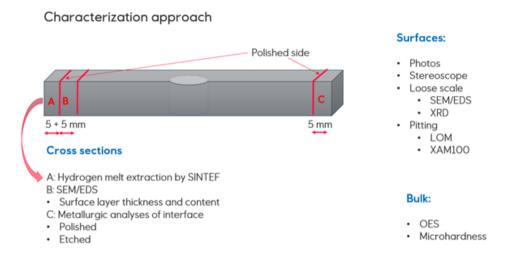
Figure 8: Overview of experimental analyses used in this work. Most of the methods where used to characterize selected and representative cladded samples.

In Figure 8, an overview of the experimental plan for the metallurgical and microstructural examination of the cladded samples is given. Most of the samples were examined by several of the methods listed.
