ADVANCES IN MULTIPLE-LEGGED WELL COMPLETION METHODOLOGY AT THE GEYSERS GEOTHERMAL FIELD, CALIFORNIA

Roger C. Henneberger and Murray C. Gardner
Geothermex, Inc., 5221 Central Avenue, Suite 201, Richmond, California 94804-5829, USA
and
Daniel Chase, Geothermal Energy Partners, Ltd., 18101 Von Karman Avenue, Suite 1700, Irvine, Ca 92715-1007, USA

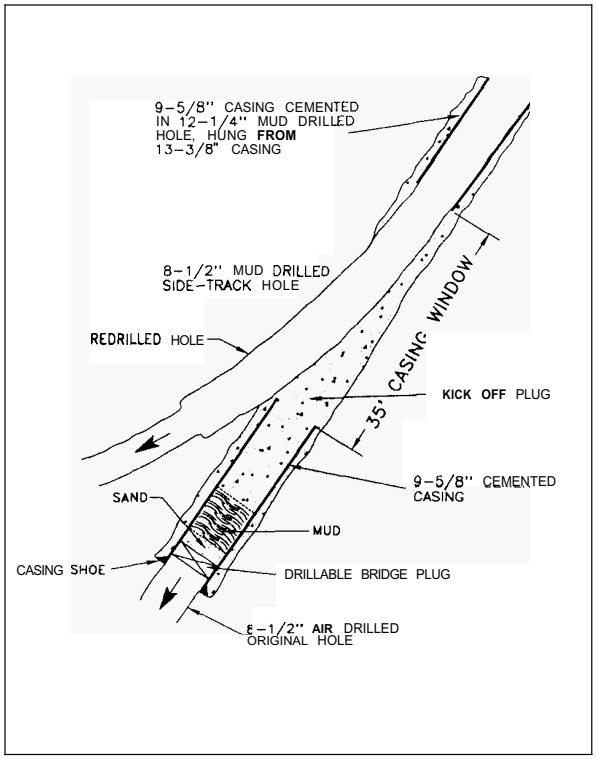
Figure 3. Detail of sidetrack and casing window (modified from Yarter *et al.*, 1988).

To begin the procedure, a drillable bridge plug is placed in the production casing below the intended kickoff depth of the sidetrack (fork), and sand is placed on top of the plug. A window about 35 feet (9 to 10 m) long is milled in the casing above the bridge plug, and sufficient cement is spotted to cover the sand and fill the window (Figure 3). After cleaning out the cement to the top of the window, a directional drilling assembly with a mud motor is used to deviate out of the original wellbore and begin the sidetrack. Directional drilling with mud continues until the sidetrack reaches its desired course. The wellbore can then be deepened by air drilling to its total depth; in this stage, the deviation angle may be controlled using different drilling assemblies, but azimuth control is not normally possible.

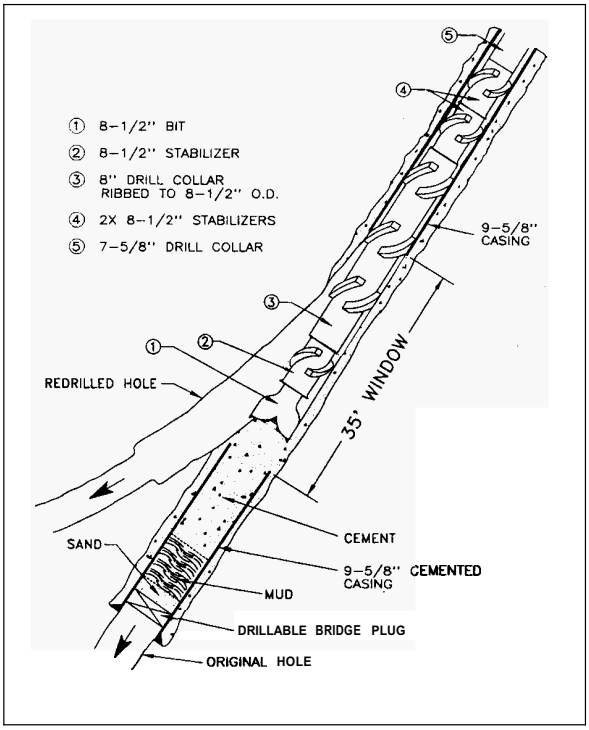
Figure 4. Re-entering the original hole (modified from Yarter *et al.*, 1988).

After the fork is completed, a stiff drilling assembly (incorporating closely spaced stabilizers and large-diameter drill collars) is used to clean out the casing window and to enter the casing stub below the window (Figure 4). The cement, sand and bridge plug in the stub are drilled out, and the original hole is cleaned out as necessary.

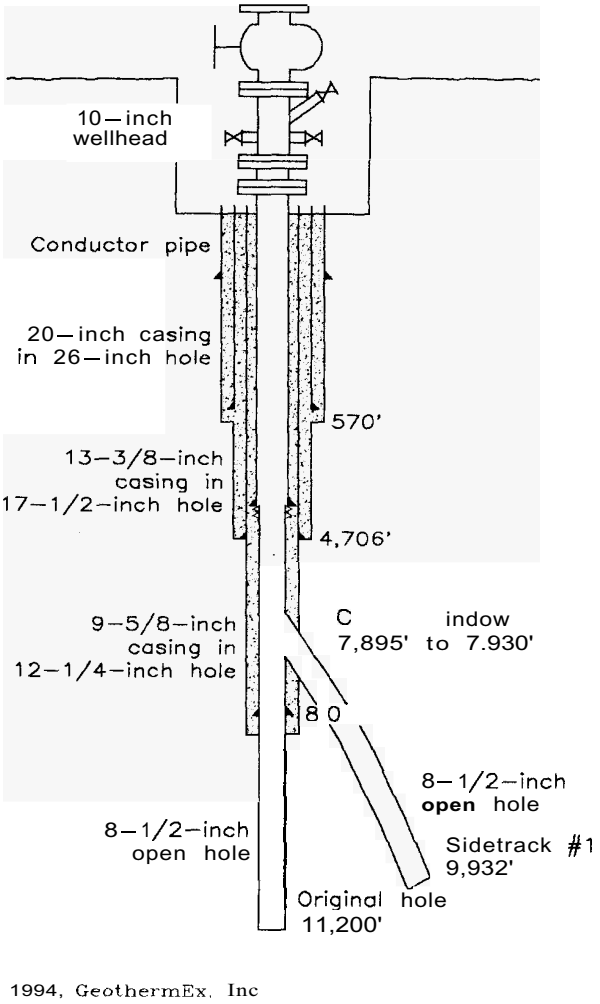
Figure 5. Schematic diagram of Aidlin No. 7 after recompletion.

Problems related to poor cementation of the production casing were encountered in the initial stages of the operation. As soon as the milling of the window in the production casing was begun, circulation was lost completely through the casing annulus, causing drilling mud to flow into the original productive wellbore. The bridge plug set in the production casing was drilled out in order to investigate the condition of the open hole, which was found to be bridged several hundred feet below the production casing shoe. The hole was backfilled with sand placed on top of the bridge, and a cement plug was placed to seal and secure the zone around the production casing shoe. The milling of the casing window and drilling of the fork then proceeded as planned.

The fork was kicked off and drilled directionally to its intended course without difficulty, then drilled with air to its final depth of 9,932 feet (3,027 m). A short flow test of the

fork was performed, after which the original hole was successfully re-entered. Several days were spent cleaning sand and other fill from the original hole in order to re-establish its productivity. The total drilling time required to recomplete the well as a forked producer was 31 days. Figure 5 shows the final configuration of Aidlin No. 7, and Figure 6 shows the trace of the well in plan view.

A flow test of the completed well indicated that the recompletion resulted in an increase of productivity from 70,000 pounds per hour (32,000 kg/hr) to 125,000 lb/hr (57,000 kg/hr), or an increase of 79%. However, the final flow rate was less than the sum of the flows of the two legs measured separately (Table 1). This indicates that some interference exists between the two producing legs. Such interference was expected, because the major productive zones of Aidlin No. 7 are located not far below the production casing shoe; therefore the separation of the two legs of the well is small where most of the steam production originates.

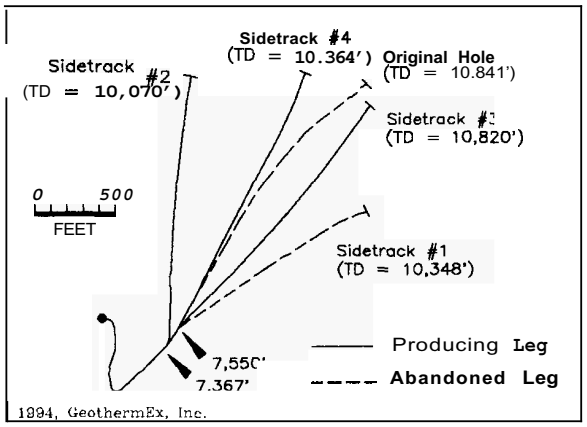
Figure 7. Well trace map of Aidlin No. 9 after recompletion.

The new fork was deviated to the opposite side of the original hole from the first fork (Figure 7), and was inclined to **a** maximum drift angle of 66" from the vertical near its total depth of 10,070 feet (3,069 m). Although no serious drilling problems occurred, the productivity of the fork was **a** subcommercial 10,000 to 15,000 lb/hr (4,500 to 7,000 kg/hr).

The casing stub between the two windows was successfully re-entered. Howevever, while milling the bridge plug set above the bottom window, the drill string torqued up suddenly, then released, allowing several hundred feet of drill string to back off and fall into the first fork. A 10-day fishing job failed to retrieve all of the lost string, so it was not possible to clean out the first fork. Instead, **a** third sidetrack was drilled alongside the the first, to **a** depth of 10,820 feet (3,298 m; Figure 7). This sidetrack, in combination with the subcommercial second fork, yielded **a** steam flow approximately equal to that of the abandoned first fork.

It remained to re-enter and clean out the original hole in order to complete the forking operation. However, by this time the casing stub below the bottom window was too damaged by drilling and fishing to be re-entered, despite repeated attempts. It was decided that the most prudent option was to drill **an** additional sidetrack, close to the course of the original hole, in order to replace its lost production. The fourth sidetrack was therefore drilled in the same manner as the third, reaching **a** total depth of 10,384 feet (3,165 m) in **a** drilling time of **13** days.

Aidlin No. 9 was recompleted with three legs open and producing (Figure 7) in **a** total elapsed drilling time of 97 days. **A** flow test performed after finishing the fourth sidetrack indicated **a** combined productivity for the three legs of 116,000 lbhr (53,000 kg/hr), a net increase of about 55% **as** the result of the recompletion.
