ENVIRONMENTAL IMPACTS DURING GEOTHERMAL DEVELOPMENT: SOME EXAMPLES FROM CENTRAL AMERICA

Sue GOFF and Fraser GOFF

Los Alamos National Laboratory, Los Alamos, NM 87545 USA

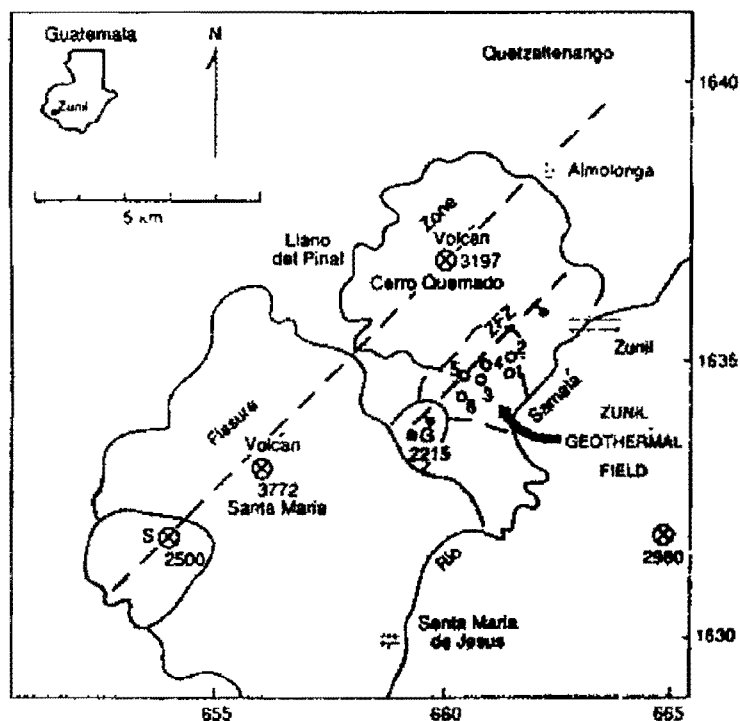
Fig. 1: Map of Zunil geothermal region, Guatemala showing major volcanoes and tectonic features; ZFZ=Zunil fault zone; S=Santiaguito Volcano; G=Cerro Galapago. Numbers by small circles are geothermal production wells ZCQ-1 to ZCQ-6. Elevations at volcano summits are in meters. Ball and bar on downthrown side of ZFZ. Landslide headwall occurs just west of well ZCQ-4 and ZFZ. Slide traveled SE toward the Río Samala (from Flynn et al., 1991).

Although relatively heavy vegetation and colluvium masks much of the bedrock, the landslide exposed a major trace of the Zunil fault zone (ZFZ, Figs. 1 and 2) on either side of the headwall area. The fault juxtaposes weathered to slightly altered andesite/dacite flow and flow breccia on the NW (upthrown side) against severely altered and brecciated volcanic rocks on the SE. The main fault plane is sharply defined by gouge, breccia, open cracks, and color contrast. Weak fumarolic emissions, smelling of H_2S and visible from steam, discharge from open cracks along isolated locations on the main fault trace. Alteration consists mainly of kaolinite with minor Fe-oxides, silica minerals, and various sulfates formed by oxidation of acidic gases rising from the underlying geothermal system (reservoir temperature $\leq 300^\circ C$) and by oxidation of disseminated pyrite in the host rocks. Oxidation of sulfur forms natural sulfuric acid.
