WAYANG WINDU POWER STATION TURBINE ROTOR REPAIR REVIEW

Alan C. Robinson, Scott G. Baigent & H. Brett Houston*

Progen Ltd, 2/829 Heaphy Terrace, Hamilton, New Zealand 3140

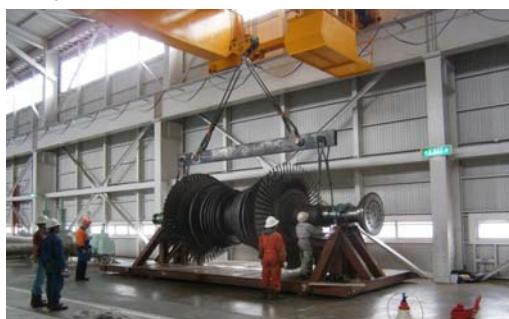
Figure 1 – Turbine Rotor

The rotor was commissioned in the Star Energy Wayang Windu geothermal power station 110MW Unit 1 Turbine in 2000. A picture of the rotor in a maintenance stand is shown in Figure 1.

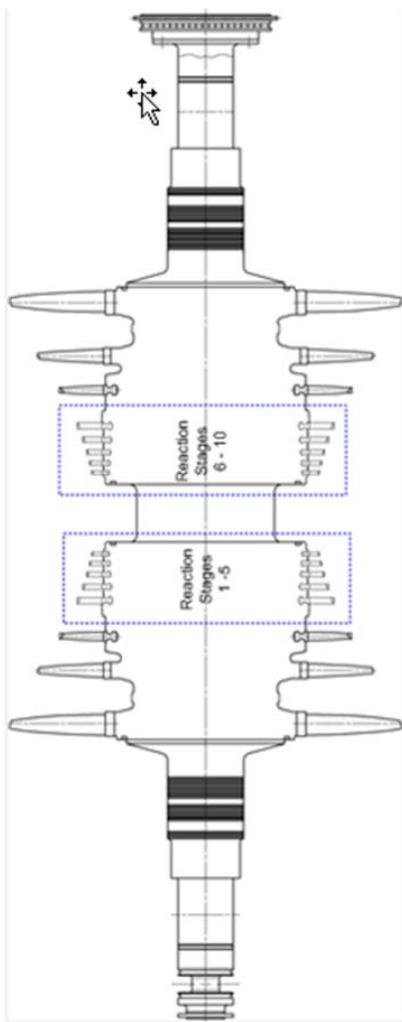
Figure 2 – Turbine rotor and staging

The turbine rotor and staging is shown in Figure 2.
