FLATNESS SURVEY AND CORRECTION OF TURBINE-GENERATOR ALIGNMENT USING LASER MEASUREMENT TECHNIQUES

Michael A. Robinson¹ and H. Brett Houston²

^{1, 2} ProGen Ltd, 2/829 Heaphy Terrace, Hamilton, New Zealand 3240

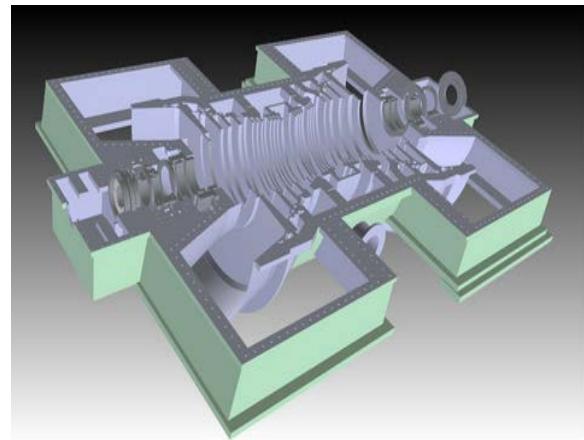
Figure 1: Representative Image of Lower Casing.

pedestals. The lower casing rests on the TG plinth on a series of shim packs ranged around the perimeter of the casing. There is a void, or unsupported section, in the centre around the turbine cylinder. The lower casing has an inclination to sag toward this unsupported centre. The weight of the condenser and the vacuum applied by it to the casing may also contribute to this tendency. The casings may also change attitude relative to the generator due to plinth movement.
