# WAYANG WINDU GEOTHERMAL POWER STATION – REINSTATEMENT OF LANDSLIDE DAMAGED GEOTHERMAL FLUID SUPPLY PIPELINES

Sanjay Banerjee<sup>1</sup>, John Cranston<sup>1</sup>, Wilis Wirawan<sup>2</sup> and David Burns<sup>1</sup>

Wayang Windu geothermal power station, located in hilly terrain about 40 km south of Bandung, West Java, Indonesia, delivers 227 MW of electricity into West Java transmission grid.

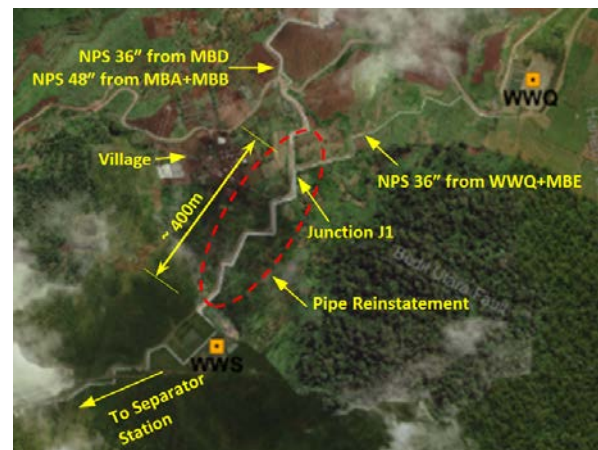
**Figure 10: Pipeline Configuration (before Landslide)**

The following main pipelines, damaged by the landslide, were reinstated:

- NPS 36" (914 mm outer dia) pipeline conveying geothermal fluid from northern wellpads MBD;
- NPS 36" pipeline conveying geothermal fluid from eastern wellpads WWQ & MBE;
- NPS 48" (1219 mm outer dia) pipeline conveying geothermal fluid from northern wellpads MBA & MBB;

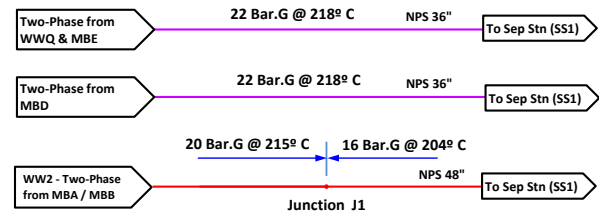
Figure 13: Reinstatement Piping Design Pressure

The same design pressure, temperature and piping material specifications, as established in the original development of the power station, were followed (Figure 13). The “Junction J1” in Figure 13 signifies the location of a set of pressure balancing lines that interconnect the two-phase mains.

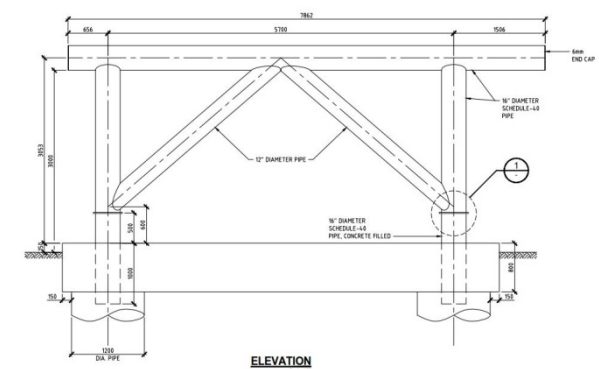
Figure 14: General Form of Pipe Support Trestles

Pipe support trestles were mostly elevated trestles of the structural form shown in Figure 14.

Wherever possible, immediately available materials were used to construct the support structures. These were 16" diameter Schedule-40 pipe sections for pipe support beams and columns, and 12" diameter Schedule-40 pipe sections for diagonal braces. On some trestles, longitudinal forces required the use of 30" diameter columns and 24" diameter pipe support beams. All joints were fillet welded, and all columns were filled with concrete up to the flange connections just above the top of the pile caps to assist longitudinal load transfer into the pile caps.
