FAILURE ANALYSIS AND MITIGATION OF CORROSION ON CONDENSATE REINJECTION PIPELINE IN WAYANG WINDU GEOTHERMAL POWER PLANT

Gian Ganjar Zatnika¹, Stefanus Wisanto¹, Aryo Wityasmoro¹, Djamaludin Kurniadi¹, Amri Zein¹

¹Star Energy Geothermal (Wayang Windu) Ltd., Pangalengan, Bandung, West Java, Indonesia.

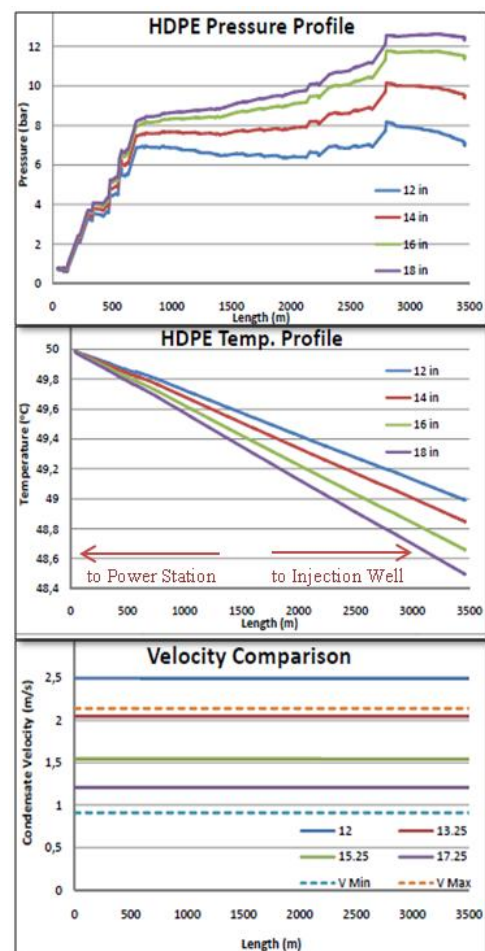
Figure 7 Process parameter simulation results

Figure 7 indicates internal pressure increase in direction to reinjection wells. The configuration of the condensate pipeline, which drives by gravity, creates such hydrostatic pressure that would cause the maximum pressure takes place at the lowest point. On the other hand, pipeline temperature would slightly decline in a minor rate for pipeline performance and reinjection system requirement.

The pipe sizing would be relied on the velocity criteria since both simulated pressure and temperature profile complied with API RP 14E requirement. The 16" pipe was then selected due to providing higher flow rate than 14" pipe and lower manufacturing cost than 18" pipe. Whilst, the 12" pipe size would likely cause the fluid initiates erosion process due to excessive velocity (Nalco, 1993). Moreover, the application of 16" HDPE pipe would not reduce the initial flow capacity thanks to lower absolute roughness surface although it possesses smaller internal diameter than other typical steel pipe size.

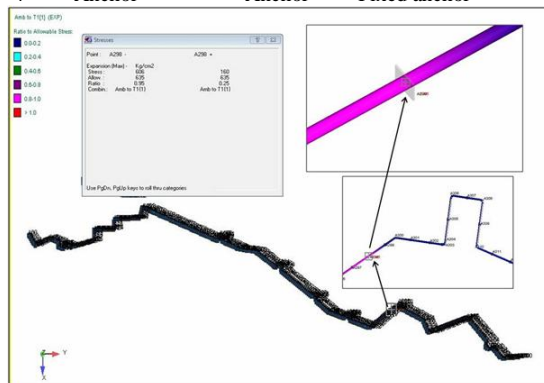
Figure 8 Illustration of simulation result showing location of maximum applied stress ratio

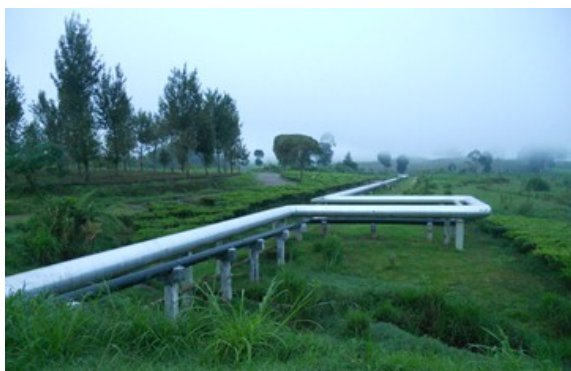
In the field, HDPE pipes were joined by butt fusion method. The join process was remarkably fast up to 10 join per day (~60 meter). There was no non-destructive examination applied for quality control of butt fusion process, so the quality was merely based on tight controlling of butt fusion process parameters as shown on Table 14. The installed pipeline is exemplified on Figure 9.

Figure 9 Installed HDPE line (black pipe) next to existing steel condensate line and insulated brine reinjection line

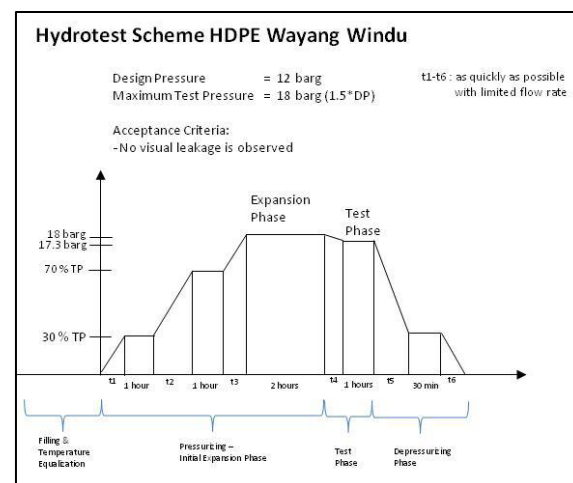
Figure 11 Hydrostatic test diagram

Fresh water was filled up with controlled rate to avoid transient pressure surge. Temperature equalization was not required since both fluid and section test temperature are below 27°C (PPI, 2008). During the initial expansion, the test section was pressurized gradually to test pressure 18 bar and make-up water was added to maintain the pressure above 12 bar. Afterwards, the pressure was slightly reduced during test phase hence visual check and pressure monitoring could be carried out with minimum expansion effect. No visual leakage was observed in all test phases and the pipeline integrity was not altered.
