WAIRAKEI - STILL GOING AFTER ALL THESE YEARS

Chris Morris

Wairakei Power Station, PB 2001, Taupo 3352, New Zealand

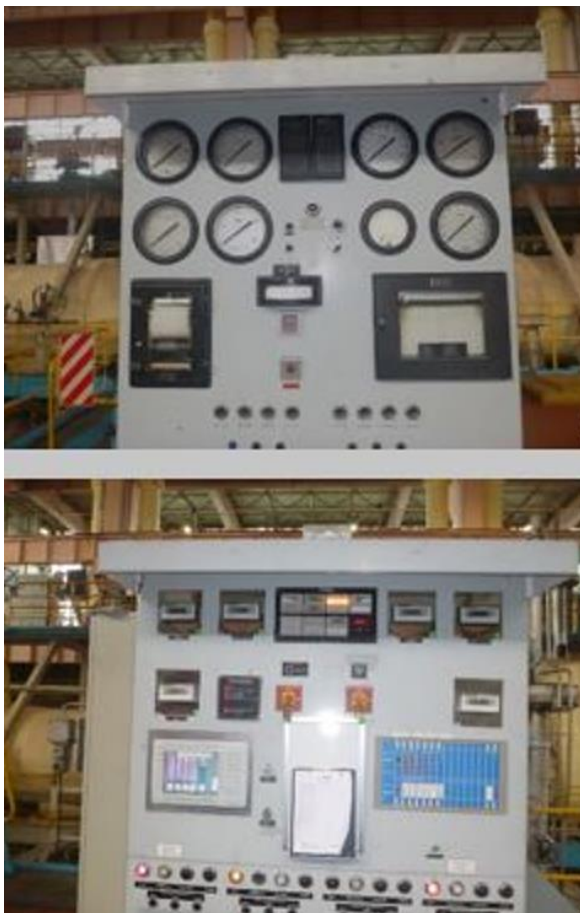
The backpressure turbines originally had 7 gauges in the control room, another 8 on the turbine gauge board (TGB), 18 points on a chart recorder and the annunciator panel giving the status of another 9. Now, there are 63 points where status or data is logged by the historian system and another 8 on the gauge board. The change to the TGBs is shown in Figure 10. For the MP machines, there are about 150 points.

Figure 10: The original analogue TGB at top with current digital version below

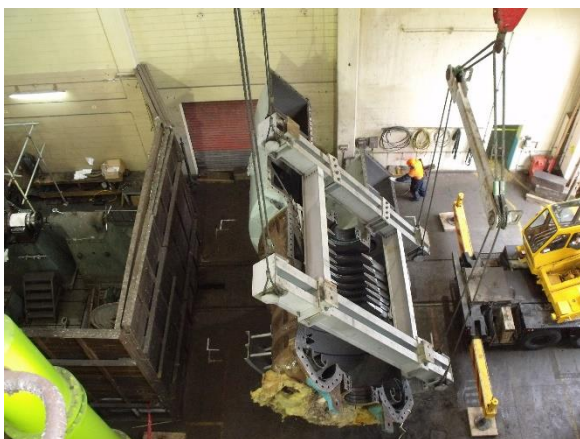
Figure 11: Rolling the MPLP top casing using two cranes and special turning frame.

Work practices have changed over the years, often to shorten the outage time. A comprehensive set of jigs and fittings have been assembled to aid this. The turning frame for the MPLP casing (Figure 11) allowed the job of diaphragm removal and refitting to be done faster yet with less risk. The complete replacement of grit blasting by high pressure waterblasting reduced the risks of contamination and metal removal. Even using slings rather than wire strops for lifting made the lifts easier.
