RESTORING WELLBORE INTEGRITY IN A COLD BRINE AND CONDENSATE INJECTOR, MAK-BAN GEOTHERMAL FIELD, PHILIPPINES

Ng, N. J. U.¹, Alvarez, R.R.¹, Guevarra-Segura, I.F.¹ and Torres, A.C.¹

¹Philippine Geothermal Production Company, Inc., 14/F 6750 Ayala Avenue, Makati City 1226, Philippines

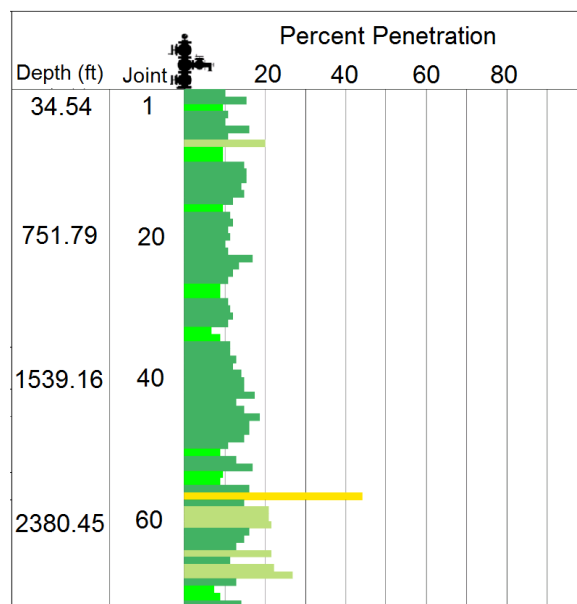
Figure 3: A well's penetration profile showing good casing condition.

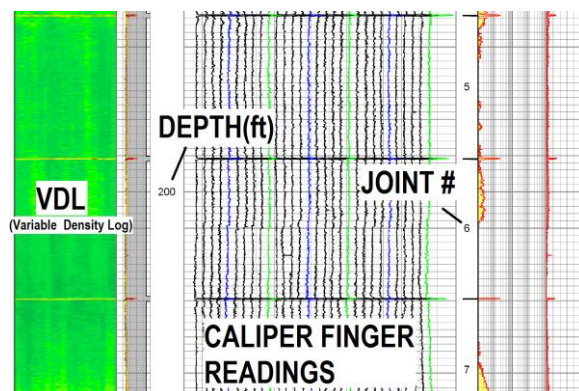
The last section of the report is a visualization of the data captured by the CIC, which shows data from each caliper finger as it moved up the wellbore (see Figure 4). This is valuable for double checking the notable wellbore sections to check if damage is localized or is prevalent throughout the wellbore.

Figure 4: A diagram showing the separate readings of the caliper's fingers.
