MICROBially INDUCED DEGRADATION OF FIBRE REINFORCED PLASTIC (FRP) IN THE COOLING TOWER OF A GEOTHERMAL POWER STATION

T. Clark¹, K. Wade², N. Gibson³

This paper describes a technical investigation, undertaken following discovery of wide-spread degradation of the Fibre Reinforced Plastic (FRP) structure of a geothermal cooling tower, after only 7 years' of service. The degraded FRP was found only in the top section of the tower, above the Drift Eliminator level. The subsequent investigation identified the cause of degradation as microbially-induced corrosion of the FRP material, due to the presence of sulfuric acid at about 1% concentration (pH 1). Several studies were conducted to understand the nature of the FRP degradation, its effect on the strength of the structural elements, and the extent of degradation over the tower's structure. Subsequent work considered a few possible ways to control bacterial growth and prevent the acid from accumulating. However, no suitable method could be found, with the decision taken to replace the affected FRP with new, acid-resistant FRP material. Because this type of degradation had not been previously reported, selection of new material require

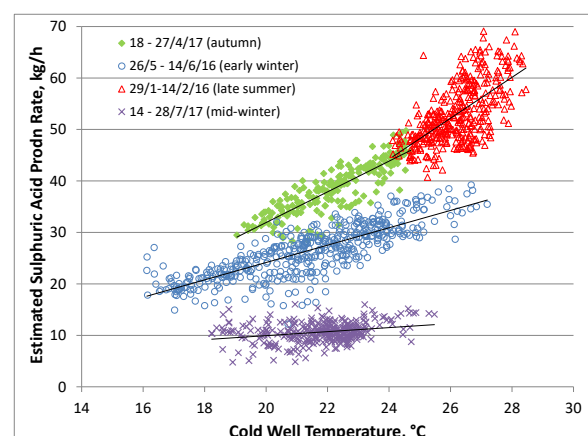
and composition in their geothermal steam. As a result, a significant amount of hydrogen sulfide is dissolved in the cooling water while in the condenser. Hydrogen sulfide provides a readily metabolised energy source for the growth of sulfur oxidising bacteria (SOB) which colonise the tower, forming a biofilm on the large surface area provided by the tower's fill material. The SOB bacteria oxidise hydrogen sulfide to either elemental sulfur or completely to sulfate, in the form of sulfuric acid (Janssen et al. 1995; Jensen et al, 2011). The rate of bacterial activity and, hence, sulfuric acid production depends strongly on the cooling water temperature and the extent of biofilm growth, and is at its highest level during the warm months of summer (see Figure 1). Consequently, control of cooling water pH is required to avoid low pH induced damage to water-touched equipment.

Figure 1: Estimated sulfuric acid production rate versus Cold Well temperature for different seasonal time periods (from Clark and Richardson, 2017)

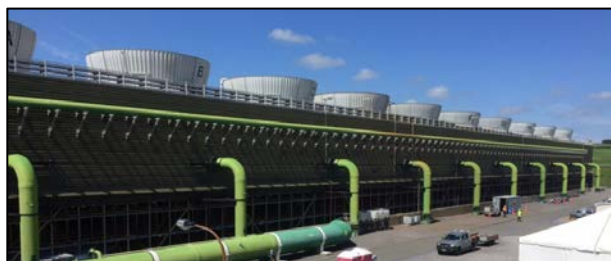
Figure 2: Cooling Tower at Nga Awa Purua Power Station (cells A to F run from left to right in photo)

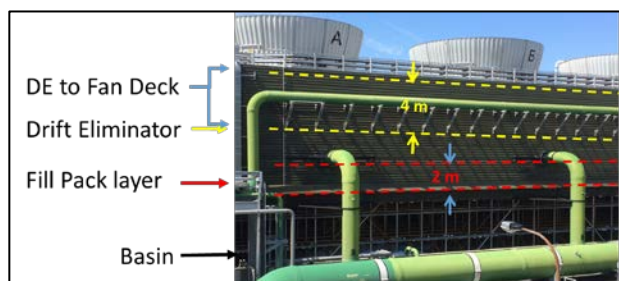
The 10-cell cooling tower at NAP station is shown in Figure 2 with the location of the internal functional zones shown schematically in Figure 3. The volume of water within the system is about 6,500 m³. Due to the rapid rate of water circulation between the condenser and the tower (27,000 t/h), this large volume of water is essentially fully mixed. The warm water from the condenser is distributed across the top of the Fill Pack layer. Consequently, with good pH control, the main cooling tower structure, below this level, is exposed to water at about pH 7 (range of pH 6 – 7.5).

Figure 3: Schematic diagram of cooling tower in cross-section

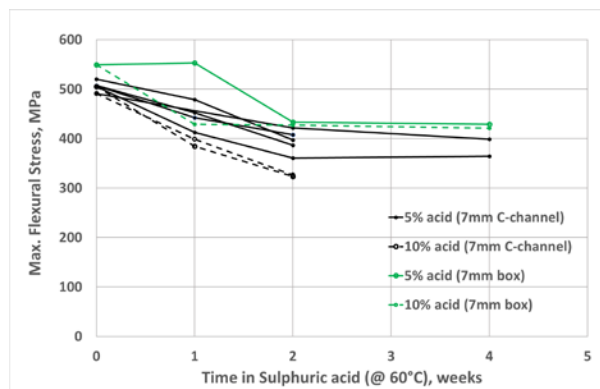
The key variables were acid concentration, temperature and time. Initial trials were run at 60°C with specimens immersed in either 5 or 10wt% sulfuric acid. As shown in Figure 7, the flexural strength of specimens cut from two different FRP profiles (7mm C-channel and 7mm box column) degraded only slightly faster in 10% acid, so 5% acid was selected for future work.

Figure 7: Comparison of the effects of 5% and 10% sulfuric acid on FRP sample flexural strength during

accelerated aging tests at 60°C (results for 7mm C-channel and 7mm box sections of a vinyl ester product)

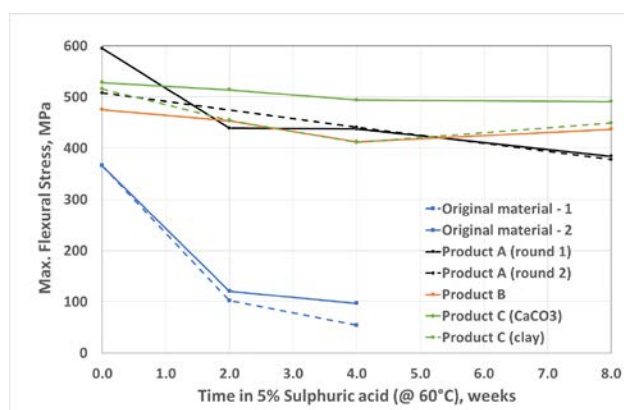
To illustrate typical results from the comparative testing, Figures 8 and 9 show the flexural bending strength and modulus results for one set of trials. It was immediately clear that the vinyl ester products were much more resistant than

All three vinyl ester products performed well under the test conditions, which were typically run to 8 weeks and showed similar rates of loss in flexural strength and stiffness. Some tests were extended to 16 and 32 weeks, to provide confirmation of the trends observed at the shorter times. However, there were some clear differences between the products, mainly in terms of stiffness (modulus).

Figure 8: Time-course of Flexural Stress changes during accelerated aging tests

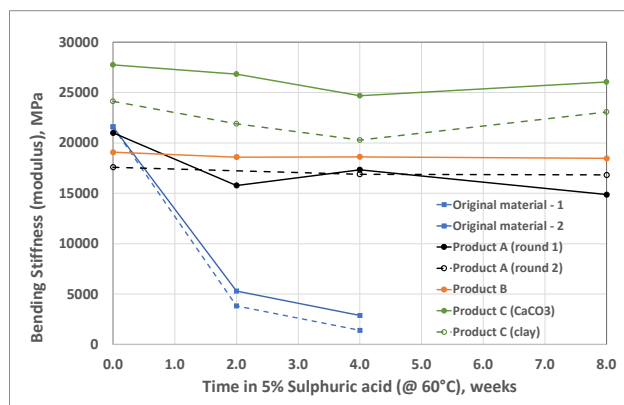
Figure 9: Time-course of Flexural Stiffness changes during accelerated aging test

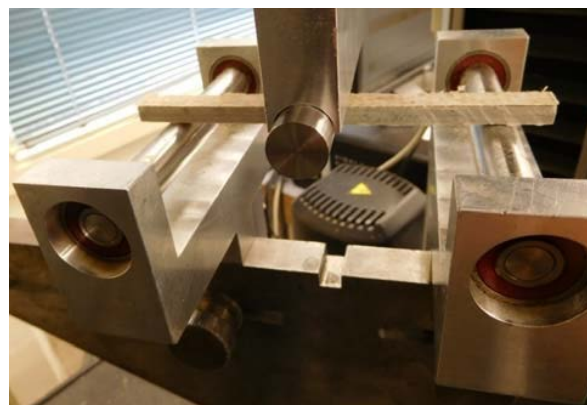
This was done in accordance with the standard conditions specified in ASTM D618 Standard Practice for Conditioning Plastics for Testing. The flexural testing was performed in accordance with ASTM D790 using an Instron Universal Testing Machine 5566 equipped with 3-point bending apparatus and a 10 kN load cell, see Figures A1 and A2. Depending on the sample thickness, the crosshead speed was set at 2.77 mm/min (for 6.5 mm thickness) or 3.78 mm/min (for 9 mm thickness), the support span was 104 mm or 144 mm respectively (to ensure a 16:1 length to depth ratio), the radius of the supports and loading nose was 7.5 mm and five specimens were tested from each sample per time period.

Figure A1: Flexural testing set-up.

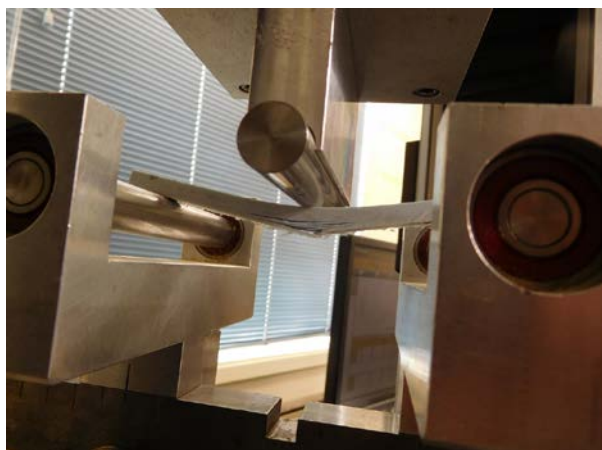
Figure A2: Flexural testing showing normal fracture mode of a well-performing FRP sample.
