Lifetime Prediction of a Recirculating Geothermal Cooling Water Pipeline

Keith A. Lichti¹, Rolan P. Vera Cruz² and Melchor A. Ballesteros³

A carbon steel recirculating cooling water pipeline in a geothermal power station experienced an increasing number of leaks after 17 years of operation. A risk based inspection internal and external survey of surface corrosion and remaining wall thickness measurements by Non-Destructive Ultrasonic Testing (UT) identified specific areas of continuing high risk of perforation while other areas exhibited low and acceptable rates of damage accumulation. A Life Cycle Analysis (LCA) approach was used to identify options for repair / replacement, comparing new coated steel vs. new stainless steel or relining of existing pipeline. Replacement with Type 316L stainless steel was the most economic option with a pay back period of 7 to 10 years for the additional capital investment.

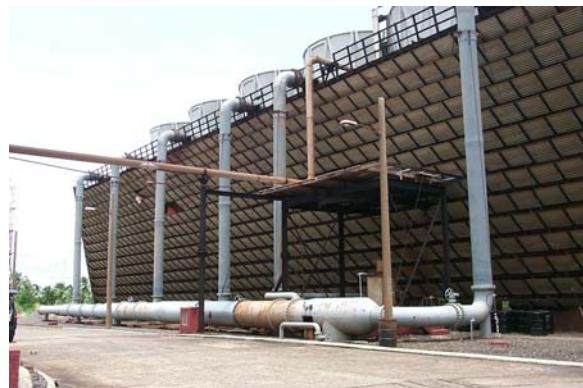
Figure 2: MakBan Plant C Unit 6 cooling tower and Hot Side CW distribution and riser pipelines.

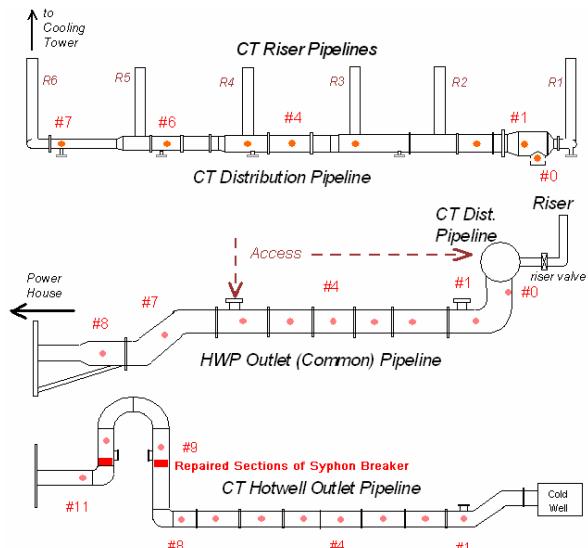
The results for the thickness survey for the Hot-Side and Cold-Side CW pipelines at the locations identified in Figure 5 are presented in Figures 6, 7 and 8 for the Hot-Side HWP Outlet Common Pipeline, the Hot-Side CW CT Distribution Pipeline and the Cold-Side CW Cooling Tower Cold Well Outlet Pipeline, respectively.

Figure 5: Locations for Hot-Side and Cold-Side CW wall thickness measurements.

Table 2 gives a summary of the worst-case UT measurements in a number of areas in the Hot-Side CW pipeline that provide the basis for corrosion rate estimates for approximate determination of lifetime of the PE coating. The original pipe thickness values required for the rate estimations varied from 12 to 9 mm, Table 2. Original Thickness at UT points 0 and 1 on Figure 5 where perforation had been experienced was 12 mm.
