Mitigating a Deep-Seated Landslide Hazard- the Case of 105 Mahiao Slide Area, Leyte Geothermal Production Field, Philippines

Winston Philip C. Pioquinto¹, Joeffrey A. Caranto¹, Lauro F. Bayrante¹, Mark H. Zarco² and Sandra G. Catane³

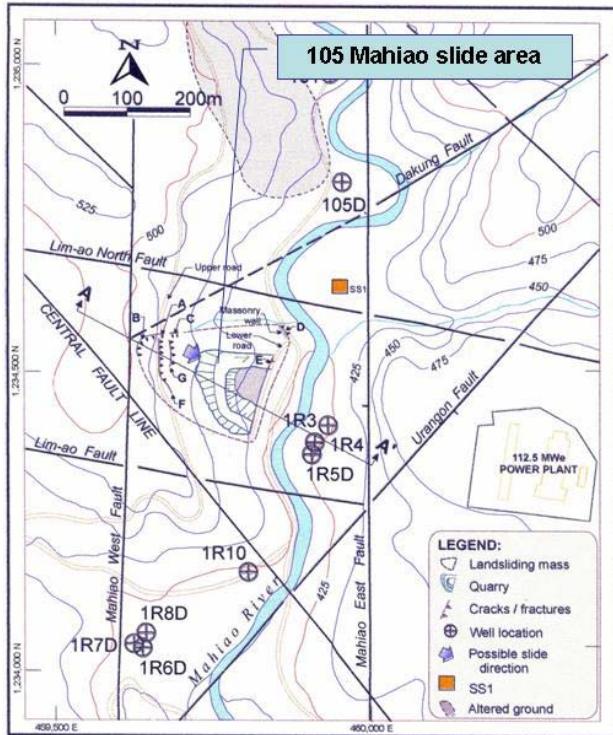
The lithology in the area is composed of andesite volcanics and tuff breccias. The 105 vicinity is veneered predominantly by sandy tuff and coarse-grained pyroclastics with some boulders of andesitic volcanics embedded in some portions in the upper slopes. In the lower slopes or along the toe, outcrops of tuff breccias are observed with clayey to sandy layers exposed at the base wherein groundwater seepage is manifested. Local faults are also present in the vicinity and are shown in Figure 6.

Figure 6. Structural map showing local faults in the vicinity of 105 Mahiao slide.
