Gunung Salak Geothermal Power Plant Experience of Scaling/Deposit: Analysis, Root Cause and Prevention

Gunung Salak Geothermal Power Plant, PT. Indonesia Power

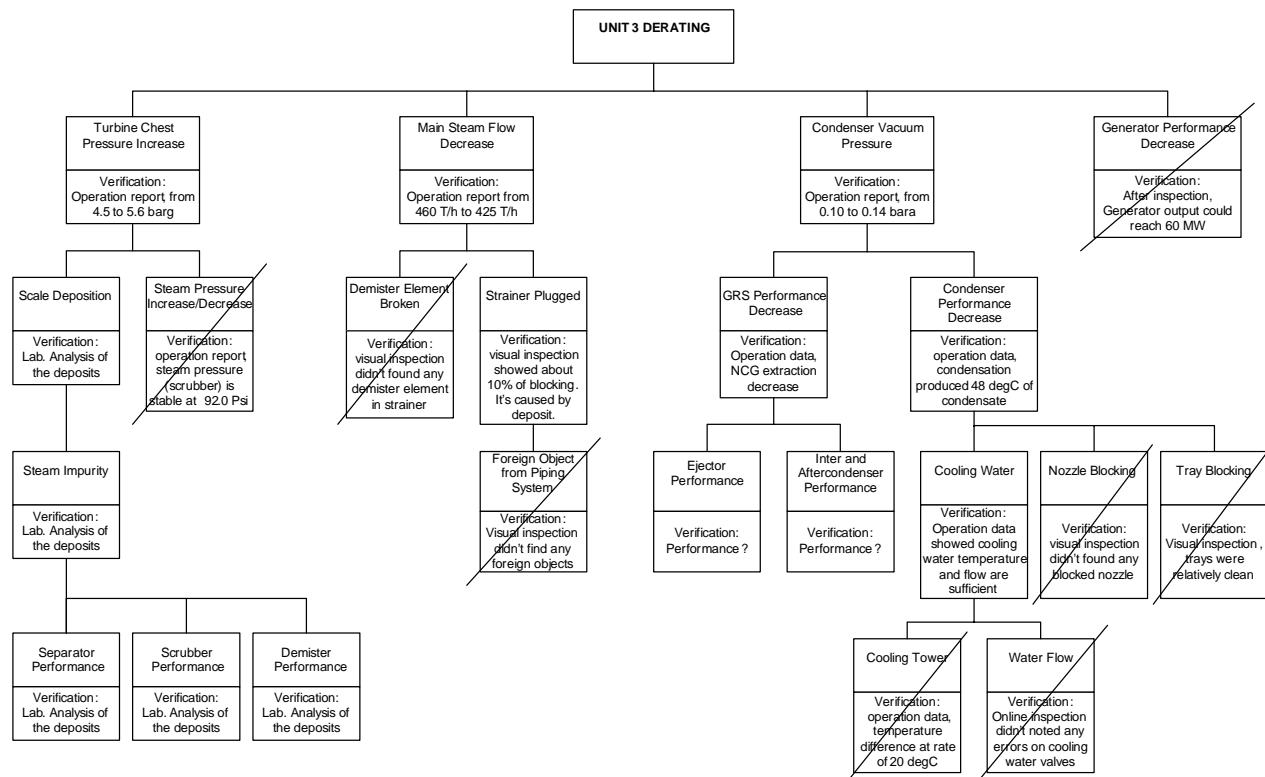
The investigation team performed root cause analysis in order to find the main cause of de-rating. Figure 1 shows root cause analyses of unit de-rating. There were four possibilities that could make the unit decrease performance. The first factor was steam chest pressure change. This symptom could be caused by scale deposition and/or the fluctuation of steam pressure. Since the steam gauge

Figure 1: Root cause analyses of de-rating.

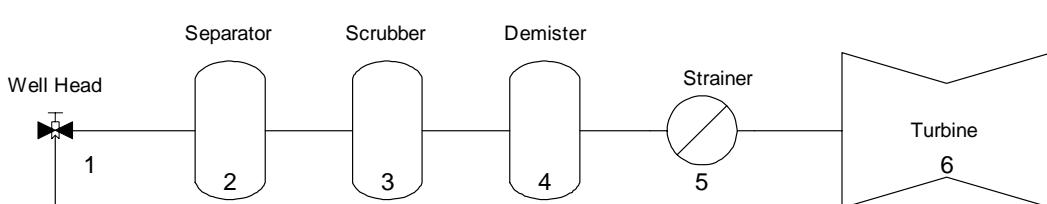
The material deposited in the steam line needed to be tested to figure out its source and to solve the problem. The material testing used samples of deposits from most of the equipment. Figure 11 shows a flow diagram of where samples were located.

Figure 11: Main steam flow system for material testing samples.
