Corrosion of Cu-Base Alloys in Geothermal Condensates

M. Ko and K. A. Lichti

Quest Reliability Ltd., Gracefield Research Centre, Lower Hutt, New Zealand

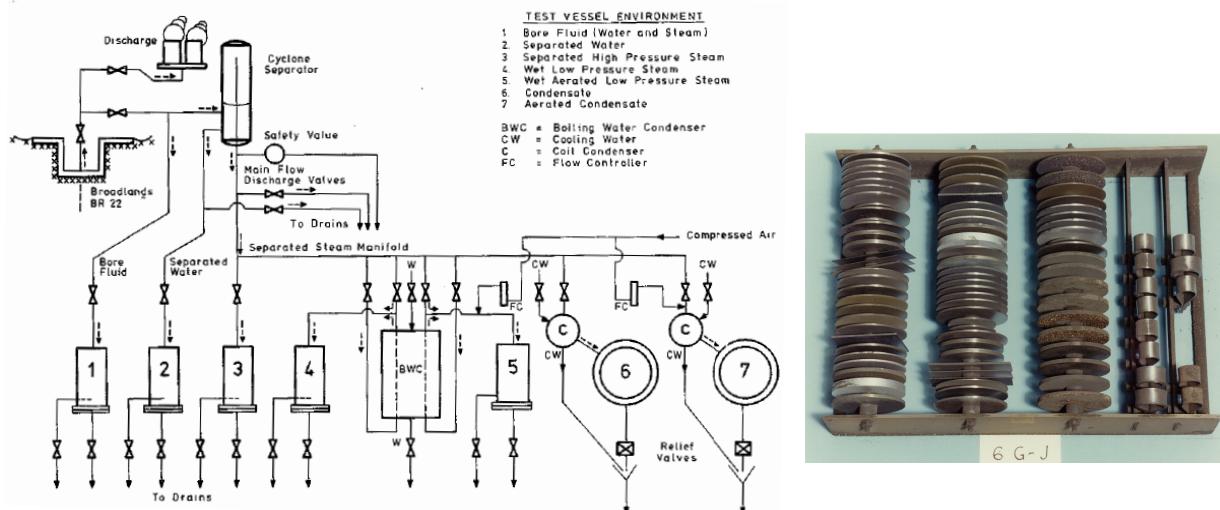
a. Schematic diagram of corrosion rig constructed in Broadlands, NZ.

Figure 1: Schematic diagram of corrosion rig in Broadlands, New Zealand. Vessel 6 coupons shown after 12 months.
