Corrosion and Scaling in Habanero 4 Produced Fluids and 1 MWe Demonstration Plant

Ben Humphreys¹, Claus Christoffersen¹, Keith. A. Lichti², Jessica Wong², Monika Ko² and Robert Dudley²

¹Geodynamics Ltd., PO Box 2046, Milton, Queensland, Australia

²Quest Integrity NZL Ltd., PO Box 38096, Lower Hutt, New Zealand

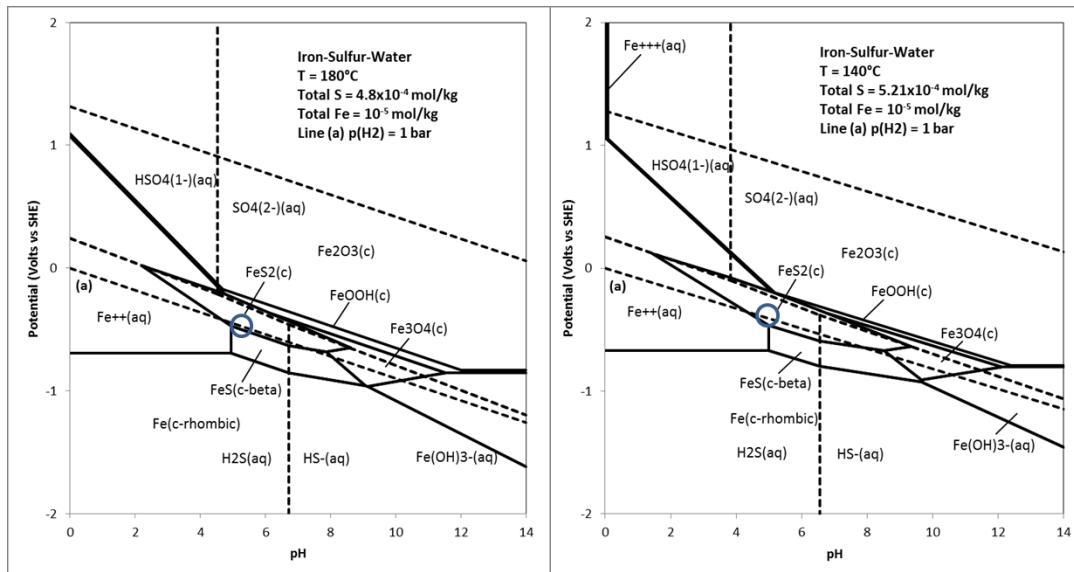
Pourbaix diagrams were prepared for a Fe-H₂S-H₂O system at 180°C, 140°C and 80°C as given in Figure 2 and Figure 3. Pourbaix diagrams were prepared for a Fe-CO₂-H₂O system at 140°C and 80°C as given in Figure 3 and Figure 4. Two values for Fe²⁺ in solution were used for the 80°C models.

Figure 2: Potential-pH Pourbaix diagram for Fe-H₂S-H₂O steam chemistry at 180°C and 140°C.

The Pourbaix diagrams for Fe-H₂S-H₂O show that iron sulfides, Pyrrhotite and Pyrite, are the dominant phases that form and these phases were demonstrated as stable in the Habanero fluids on carbon and low alloy steels. These phases, once formed, can block the corrosive solution from the environment and iron oxides can form next to the metal surface. This same process was demonstrated to be occurring in the Habanero 4 high temperature fluids in cross sections with the complication that both iron oxide and iron carbonate are both observed under the iron sulfide layers.

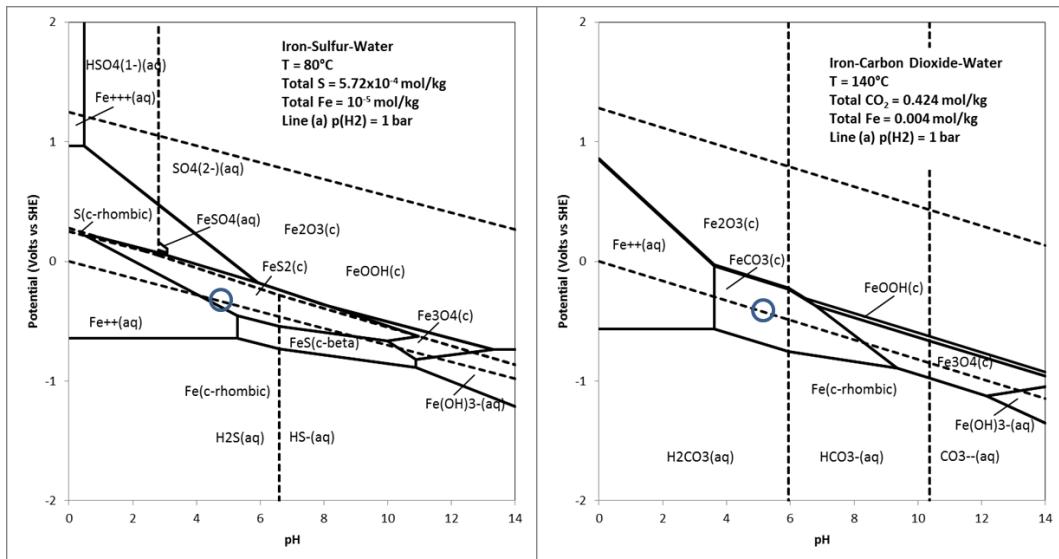
Figure 3: Potential-pH Pourbaix diagram for Fe- H₂S-H₂O steam chemistry at 80°C and for Fe-CO₂-H₂O steam chemistry at 140°C with high iron

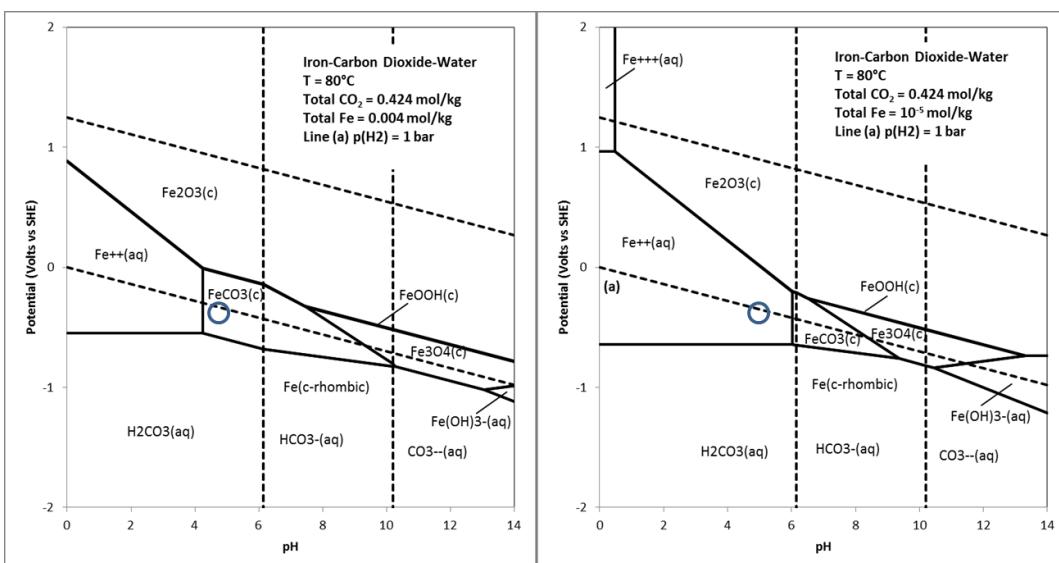
Figure 4: Potential-pH Pourbaix diagram for Fe-CO₂-H₂O steam chemistry at 80°C with high iron (left) and reported iron (right)

The Pourbaix diagrams for Fe-CO₂-H₂O demonstrate that with reducing effect of H₂S, iron carbonate stability is achieved but this is dependent on iron concentration used for preparation of the diagrams, see Figure 4. At high concentrations of iron, iron carbonate stability is achieved through low pH values (pH < 4) whereas at low concentrations of iron, free corrosion would be predicted (pH < 6).

These diagrams suggest that Location D, for example with a lower flow velocity than Location E, has less risk of erosion corrosion. The rate of erosion corrosion in high velocity fluids at 80°C might be of the order 4 mm/year with H₂S making a strong contribution to corrosion control. Without H₂S corrosion control, the erosion corrosion rate might be of the order 12 mm/year.

- The erosion corrosion observed matches the increasing magnitude of corrosion in the absence of passivating effect of H_2S , as shown in Figure 5.
- The Pourbaix diagrams for $\text{Fe}-\text{CO}_2-\text{H}_2\text{O}$ of Figure 4 at 80°C that shows Siderite stability as a function of iron concentration provide insight into the reason for the onset of erosion corrosion – poorly protective iron carbonate formation under low iron and close to the border with free corrosion (Fe^{2+} region).

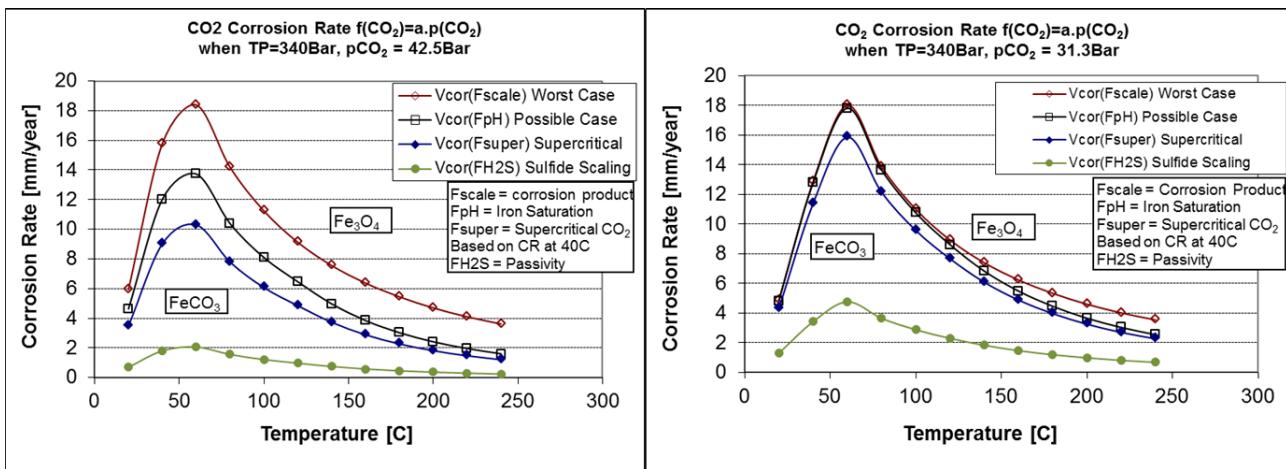
Application of the additional factor for H₂S corrosion product formation in the model using the data of Lee (2004) successfully matches the apparent suppression of CO₂ corrosion observed in this work, see Figure 5.

Figure 5: CO₂ corrosion rate nomogram valid for temperatures greater than 120°C (left) and temperatures less than 120°C (right). CO₂ Corrosion based on de Waard and Lotz (1994) with enhancements from Seiersten (2000) for high partial pressure of CO₂ and from Lee (2004) for H₂S corrosion.

- The observed pitting rates match the model for CO₂ corrosion in Figure 5 with a strong effect of pH, supercritical pressure and presence of H₂S.
- The localised corrosion observed matches the increasing magnitude of pitting corrosion suggested by Shannon (1977) as the temperature is lowered for 1% NaCl in CO₂-bicarbonate brines.
- The Pourbaix diagram for Fe-H₂S-H₂O of Figure 2 is considered to be less dominant than that for Fe-CO₂-H₂O of Figure 3 as Siderite is becoming more prevalent than the iron sulfides.
- Reductive deposition of heavy metal scale is having some impact on the rate of pitting corrosion and is difficult to quantify.

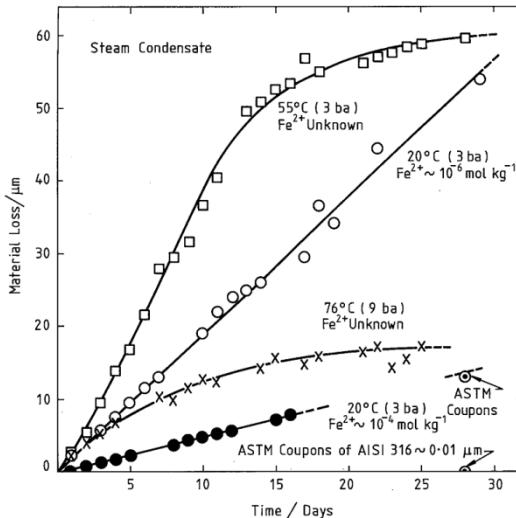
Lower temperature geothermal fluids (less than 80°C) have been shown to require extended time to form protective films and in some instances, for example under high flow and low Fe²⁺ in solution, protective scales may not form. This is demonstrated in Figure 6.

Figure 6: Quest Integrity data for H₂S corrosion in steam condensate as a function of temperature and dissolved iron, Lichi and Julian (2010)
