## Discharge Testing of Magma Well IDDP-1

Kristján EINARSSON, Karl E. SVEINSSON, Kristinn INGASON, Vilhjálmur KRISTJÁNSSON, Sveinbjörn HÓLMGEIRSSON

Landsvirkjun, Háaleitisbraut 68, 103 Reykjavík, Iceland

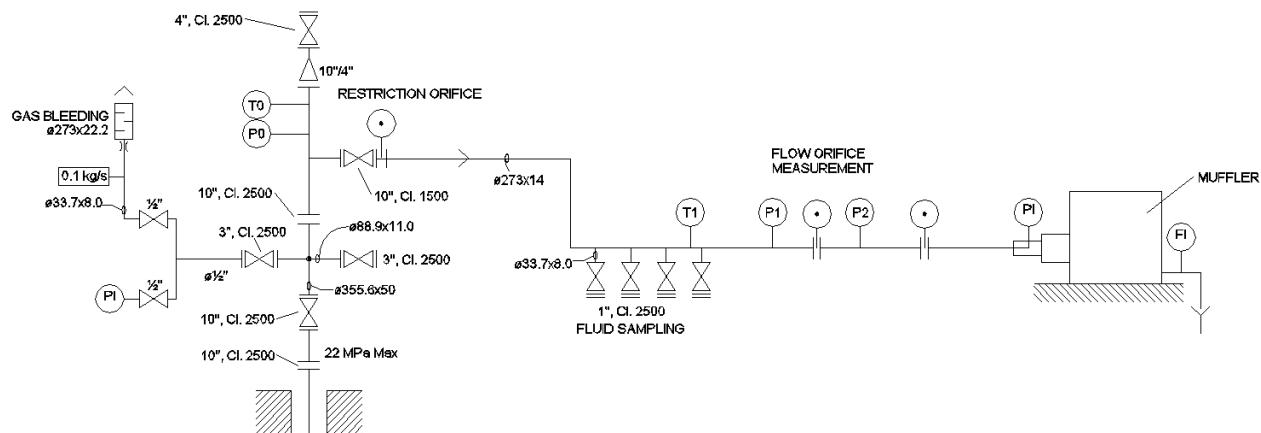
In phase II, it was decided to discharge the well at full flow and changes were made to the discharge line accordingly, as indicated in Fig. 4. The well discharged for about 3 months during the summer of 2010 and proved to be very powerful, discharging approximately 30 kg/s of superheated steam having an enthalpy of close to 3200 kJ/kg as can be seen in Fig. 6. Temperature and pressure measured during this time are shown in Fig. 5 and evaluated enthalpy in Fig. 6.

Figure 4: Discharge system in Phase II.

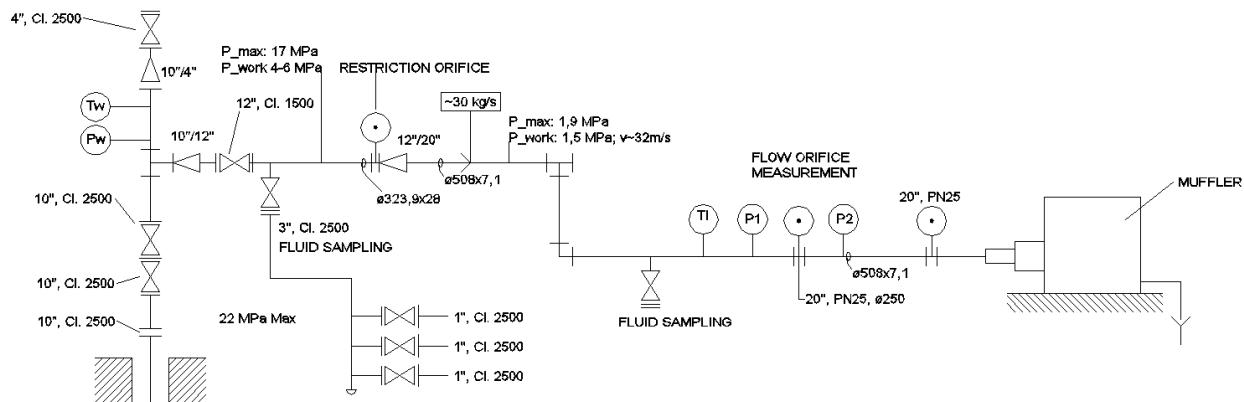
Phase III consisted of two short discharges that took place on May 17 and May 25 in 2011. The discharge system had been redesigned to keep steam velocity and well head pressure manageable, Fig. 7. Surprisingly, the well discharged at an estimated flow of about 50 kg/s on both occasions. Intense vibration during these discharges resulted in damage of pipelines and equipment. The most likely source of the vibration was the orifice controlling the flow from the well head where the flow was critical. Measurements taken during the discharge are shown in Figures 8 and 9.

**Figure 7: Discharge system in Phase III**

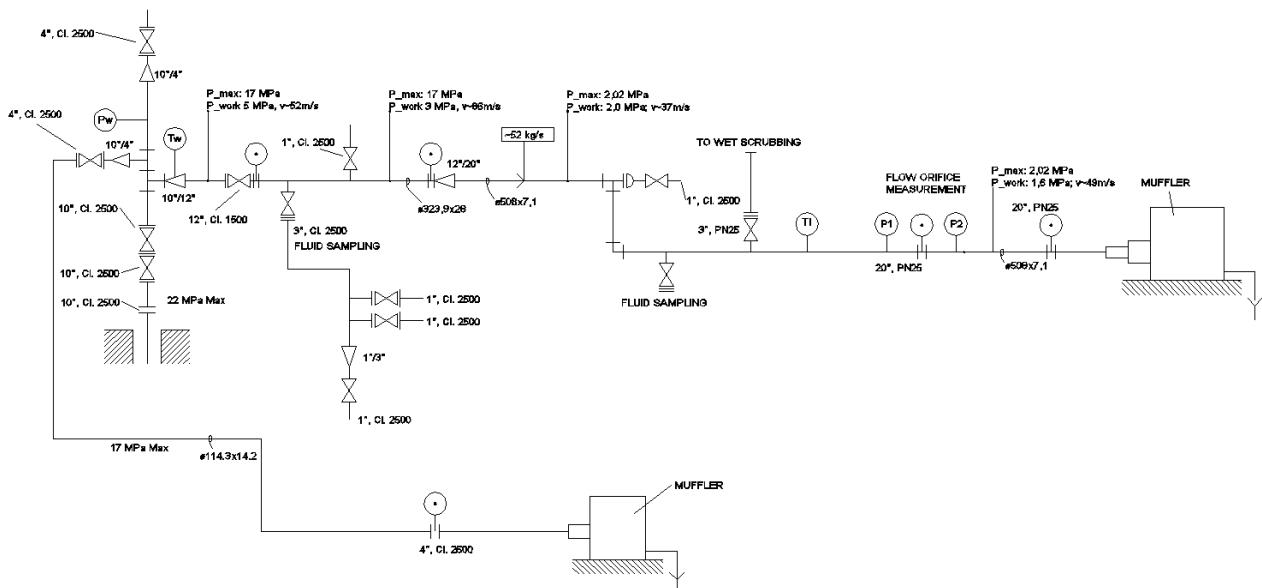
During phases I-III it was necessary to shut for the flow (shut the well in) during maintenance or for other service. Repeated heating and cooling of the well casing was therefore inevitable. Another load factor on the casing was acid condensate. To eliminate the need to completely shut the well in a secondary discharge line was installed prior to start of phase IV, Fig. 10.

Figure 10: Discharge system in Phase IV

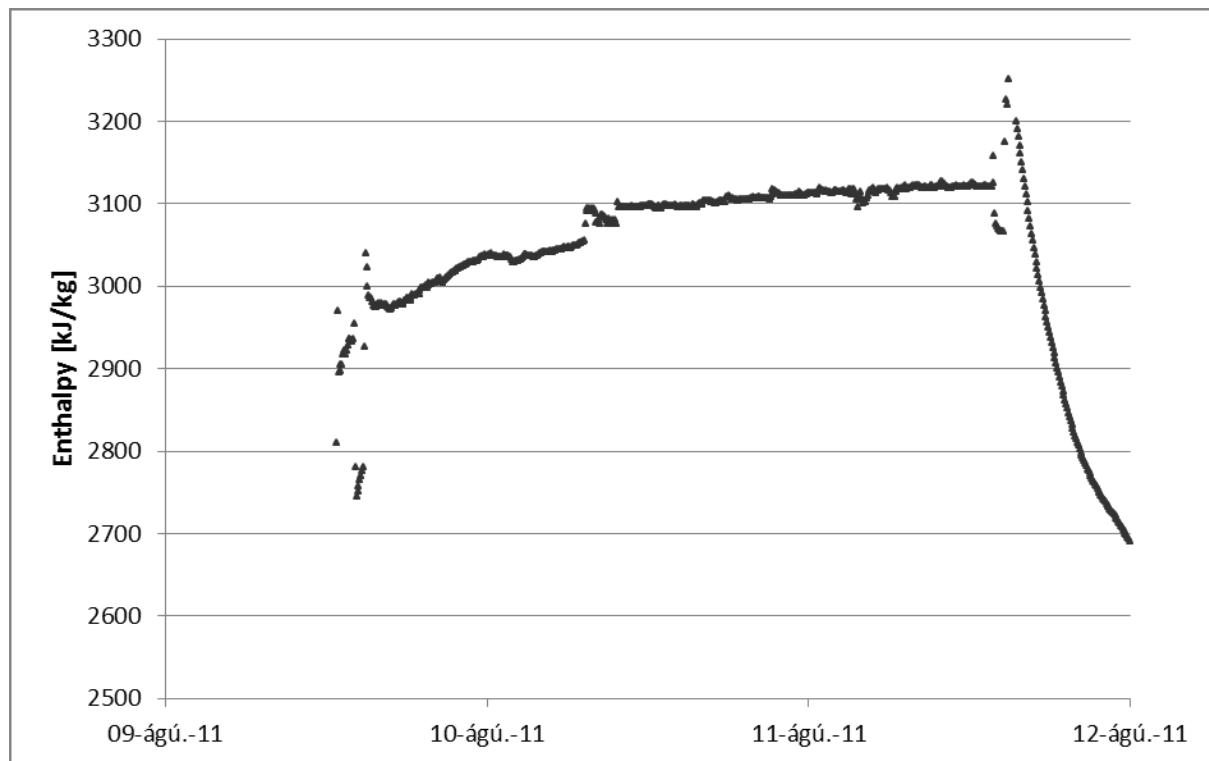
Discharge of Phase IV started on August 11 and lasted for 2 days (Figures 11 and 12). It revealed problems of discharging the well at full flow as the steam carried debris and corrosion residue from the sacrificial casing which resulted in clogged orifices and damaged valves.

**Figure 12: Enthalpy evaluated from temperature and pressure measurements in Phase IV.**

Consequently a decision was made to restrict the flow to 8 – 12 kg/s for the next phase, Fig. 13. Size of valves used for discharge was reduced. Discharge of Phase V started in late September of 2011. Initial problems due to silica scaling in orifices were overcome and eventually led to the longest continuous discharge of the IDDP-1 well or for about 10 months. Results of measurement during the discharge of Phase V are shown in Figure 14 and 15.

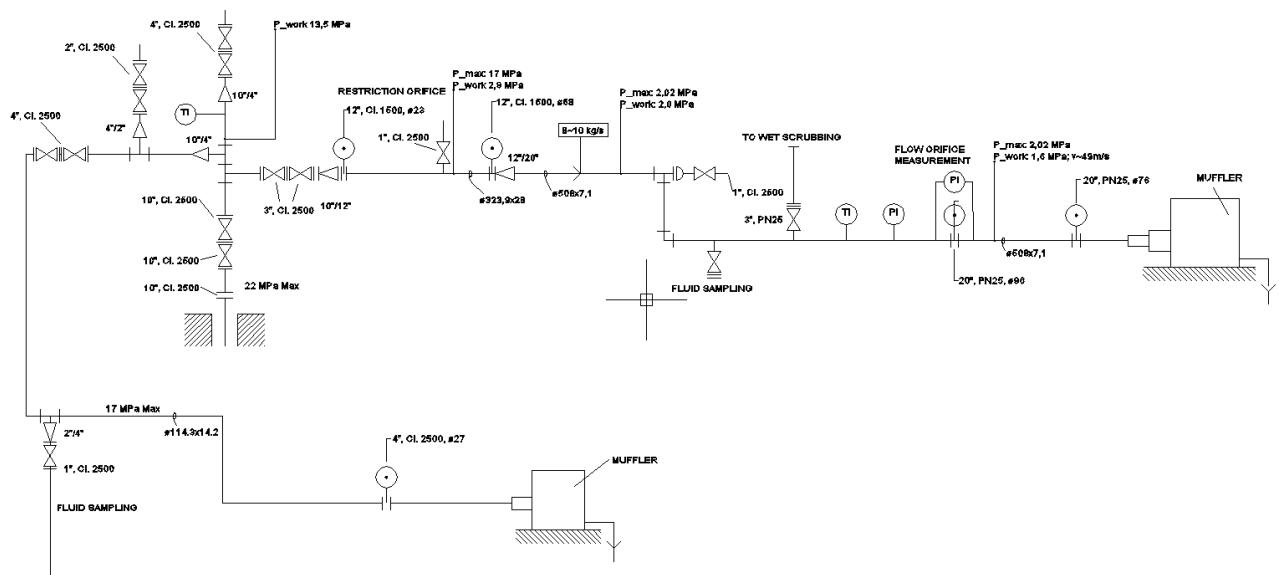
**Figure 13: Discharge system in Phase V**

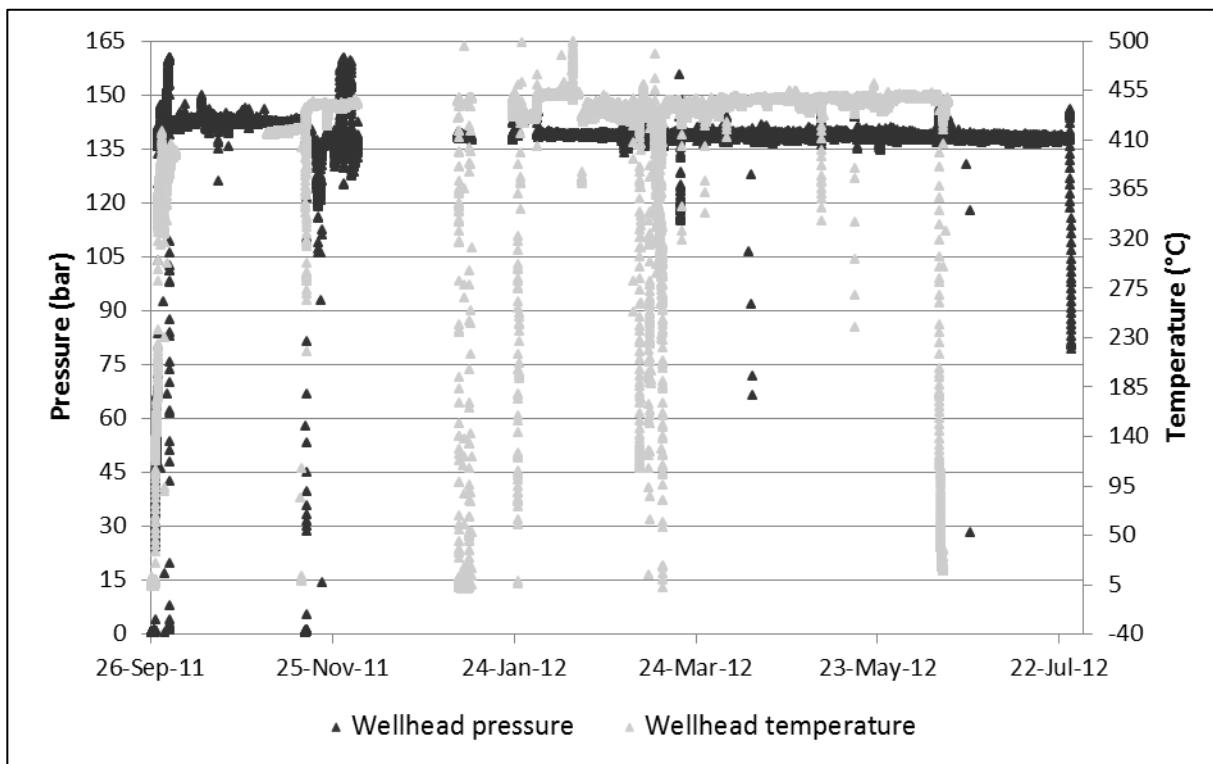
Figure 14: Result of measurements in Phase V. Absence of temperature measurements is caused by faulty sensor.
