Stuck Pipe Prediction and Avoidance: Invocation of Basic Principle of Standard Methods, Pre and Post Sticking

Douglas MATI

785 - 20117 Naivasha, Olkaria/Kengen

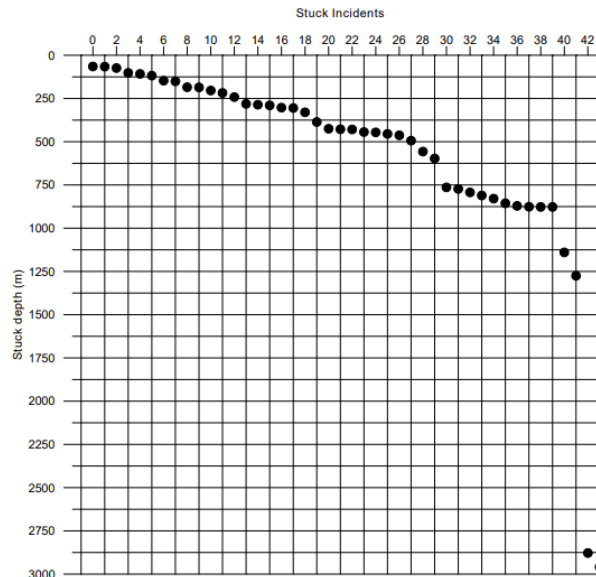
In this investigation, the stuck incidents were plotted against the stuck depth as shown in figure 1. It was therefore found that 86.96% of all the stuck pipe cases happened in shallower depths above 1000m. These findings therefore make this region a point of interest that calls for more than average attention by the relevant stakeholders. As earlier mentioned, in well planning, the key to achieving objectives successfully is to design drilling programs on the basis of anticipated potential hole problems. At the design

stage of a well, planning and preparing for drilling challenges in the range of 60m to 1000m is key. Below 1500m, the stuck pipe cases have not been common.

Figure 1: Stuck incidents vs stuck depth

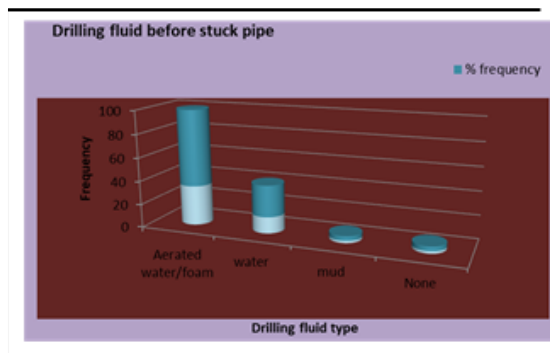
Most stuck pipe occurrences happened while using aerated air and foam at 65%, water at 26.92% and mud at 3.85% as is indicated in figure 2. As has been observed, drilling fluids can create as many problems as they can solve. Application of the correct mud system is therefore crucial if drilling troubles were to be avoided.

Fig. 2 drilling fluid on use at the instance of stuck pipe.

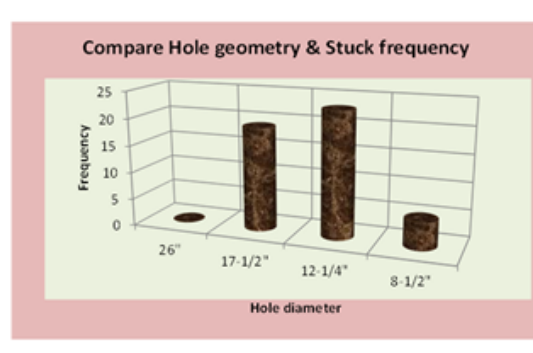
Fig. 3 Hole geometry relative to stuck pipe

With other factors held constant, the diameter of the hole section was considered with respect to stuck pipe incidents in trying to relate the sensibility of the hole section to stuck pipe occurrence. Under gauge hole arising from drilling long sections of abrasive formations was noted to have been as a direct result of stuck pipe. As shown in figure 3, most stuck pipe incidents happened while drilling the main hole section (12-1/4") at 49% and interestingly 11% of stuck cases during production hole, which is the longest hole section. No stuck pipe instance was reported while drilling surface hole.

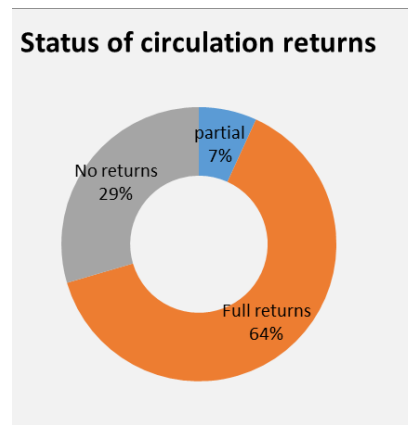
When intermediate or severe losses occur, cuttings will settle out around the BHA, and mechanically stick the pipe. The cuttings will act as a packer, and make the losses worse. It was observed that 64% of stuck pipe incidents occurred while circulation returns was received on the surface, 29% during blind drilling (total loss of circulation) and 7% with partial returns. More often, it is assumed that with full circulation returns, chances for getting stuck are minimal contrary to the findings of this research. According to C. Bowes & Procter [Drillers Stuck pipe Handbook, 1997], the effect of mud rheology on hole cleaning depends on the annular flow regime. When laminar flow exists, increasing the mud viscosity will improve hole cleaning. This is particularly effective if the low shear rheology and YP/PV ratio are high.) · When turbulent flow exists, reducing the mud viscosity will help remove cuttings [2], [3].

Fig. 4 Stuck pipe in relation to status of circulation

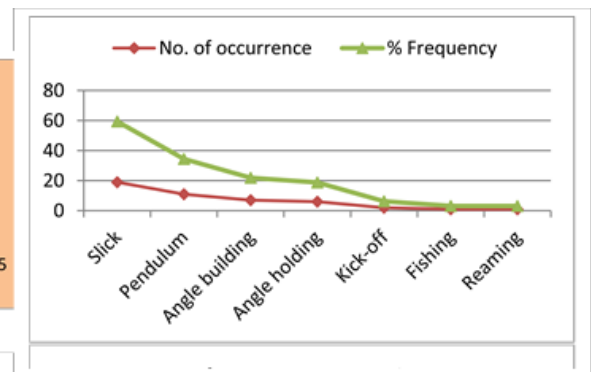
As figure 5 indicates, 65% of problems were encountered while drilling the vertical section of hole contrary to anticipated deviated section which conventionally poses more challenges due to cleaning problems. The hole pack-off incidents which have immensely contributed to stuck pipe happened majorly in vertical sections of the hole. Arising from these findings, potentially risky hole sections should be drilled with rotational drill string, even if it requires to re-programme motor kickoffs [3].

Fig. 5 Effects of hole orientation

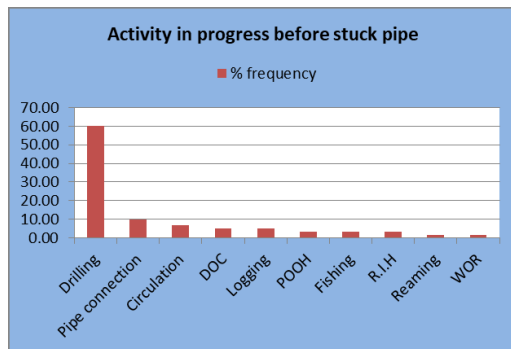
For better understanding of the true cause and stuck mechanism, it was of interest to review the drilling activity on progress shortly before, during and after stuck pipe situation. Figure 8 shows 60% of cases to have occurred while drilling on bottom, 10% while making up the pipe and in the least of cases while reaming and waiting on repairs at 1.67% each respectively.

Fig. 8 Activity prior to stuck pipe

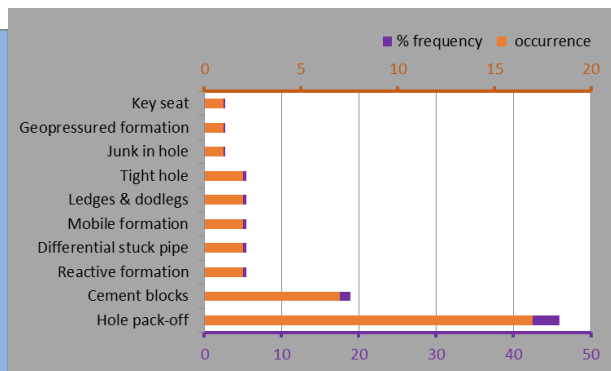
Fig. 9 Stuck mechanism

Most cases of stuck pipe are avoidable with proper attention to detail, and once stuck pipe is recognized, fast action is necessary. The best chance of getting free is just after getting stuck. Recognizing the different ways drill pipe can get stuck is the first step in prevention and recovery [4]. Before any attempt is made to get the drill string free, it is of paramount importance to try and identify the possible cause and mechanism of stuck pipe. Different stuck mechanisms may require different approach if any success to overcome the problem is to be achieved in timely and cost effective manner. For instance, due to insufficient hole cleaning, when the circulation stops, cuttings will settle around the drill string, effectively leading to hole pack-off, which in this case accounted for 45.95% of stuck pipe. Cement blocks related stuck situations was established to have been 18.92% while key seats, geopressed formations and tight hole was found to contribute the least stuck pipe incidents at 2.70% respectively as indicated in figure 9. Pipe stuck in a key seat which was one of the least contributors to stuck pipe had occurred at 2.7% of the total cases.

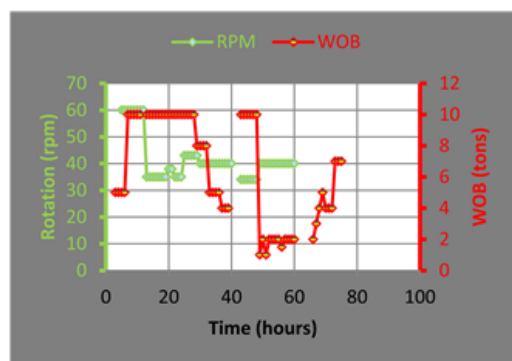
Fig. 13 Performance of bit weight and string rotation.

Before running in hole new bit, there ought to have been wiper trip to casing shoe in order to confirm hole condition in terms of cuttings quantity. While tripping in new bit, reaming should have begun at least three stands to bottom. After well reaming, use of maximum circulation velocity was necessary in addition to sweeping the hole with weighted pills. Adequate circulation time and confirmation by use of hole cleaning chart could have changed the course of events. It is therefore very important to check at all times that the hole is cleared effectively by the mud. Monitoring cuttings at the shale shakers is also helpful [2].

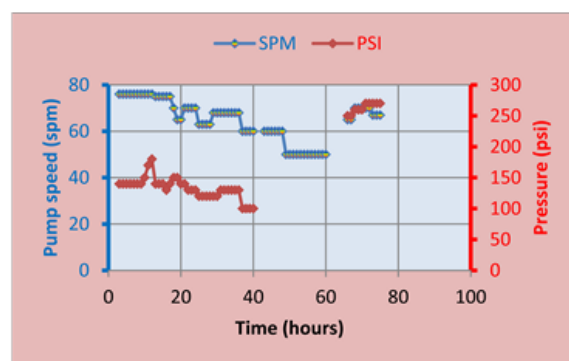
Fig. 14 Pump stroke vs. output flow line pressure
