Fitness for Service Assessment of Geothermal Steam Turbines

Stephen Rowbotham, Sean Norburn and Cole Davis

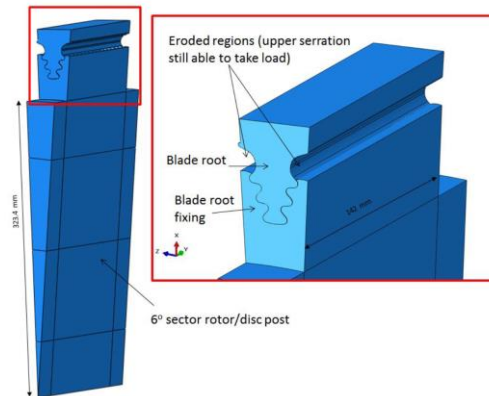
**Figure 6. Model geometry – 6° symmetry sector of final stage disc/rotor with blade root in fixing.**

The finite element analysis was undertaken using the symmetry of the rotor. There were 60 blades on the last stage disc and therefore a 6° sector of the final stage disc post and rotor was modelled, with symmetry boundary conditions on the symmetry faces as shown in Figure 6. Centrifugal loading was considered as the primary source of load in this instance. This was prescribed by defining the rotational speed of the rotor which was assumed conservatively to be a 10 per cent over speed, (i.e. 110 per cent of normal operational speed). Normal operation was at 60 Hertz or 377 radians per second, therefore a 10 per cent over speed of 414.7 radians per second was considered in the analysis. The centrifugal load was calculated on the entire finite element model using the prescribed material densities. However, since only the blade root was modelled, the mass of the aerofoil section of the turbine blade and the integral shroud was not included in this calculation these needed to be determined and added to centrifugal load. The calculation was based on calculating the cross-sectional area of the turbine blade at four separate heights of the blade. Denoting the area of each section by A_i , at a distance of R_i from the axis of revolution, the centrifugal load (F) was calculated as follows

Therefore, the total centrifugal load applied to the blade root area (to account for un-modelled blade and cover-band mass) is 250,459 N + 24,992 N = 275,451 N. This calculated centrifugal load was then used in the finite element model as a radial force distributed across the upper surface of the truncated geometry of the blade.

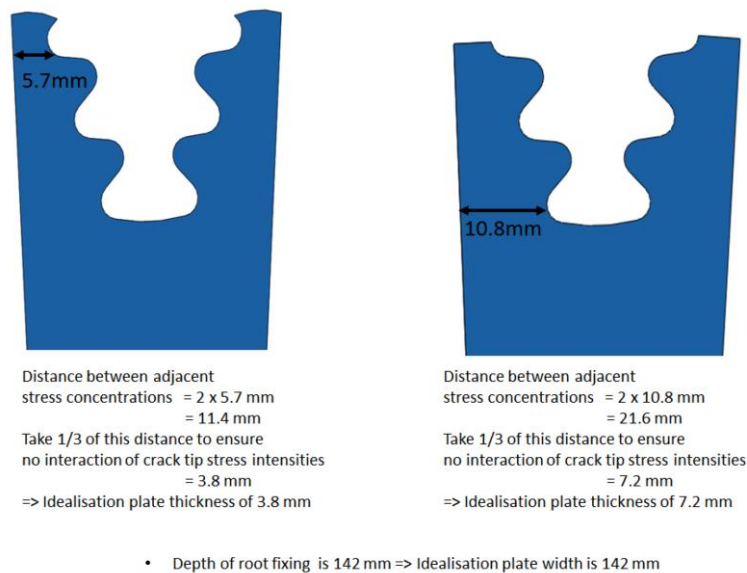
Figure 9. Illustration of how dimensions of fracture mechanics idealisation are derived

Model	Location	Plate width (mm)	Plate length (mm)
Conservative estimate of current state of erosion	Uppermost serration	142	3.8
Extreme state of erosion (upper most serrations eroded away)	Lowermost serration	142	7.2

An illustration of how the flat plate dimensions are derived is provided in Figure 9.
