## Refurbishing the Wellhead Master Valves from IDDP 1 for the IDDP 2 Well at Reykjanes.

**Keywords:** Geothermal, IDDP 1, IDDP 2, Expanding Gate Valves.

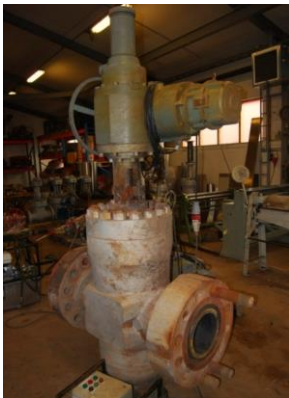
The wellhead master valves on the IDDP 1 well in Krafla were purchased in 2008 by Landsvirkjun. The valves have a class 1500 body with class 2500 flanges. The valve actuation was by an electrical motor drive as can be seen on fig.1.

Figure 1: Expanding gate valve from IDDP 1 in the Krafla workshop in 2012 after removal from IDDP 1

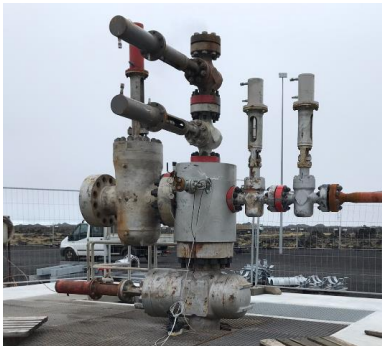
Figure 5: IDDP 2 arrangement of IDDP 2 wellhead
