Casing failure analysis and proposed repair for well OW-740A in Olkaria Geothermal Field

Nahashon Karanja Nzioka, Kristinn Ingason and Málfríður Ómarsdóttir.

Kenya Electricity Generating Company (KenGen), Olkaria Geothermal Projects,

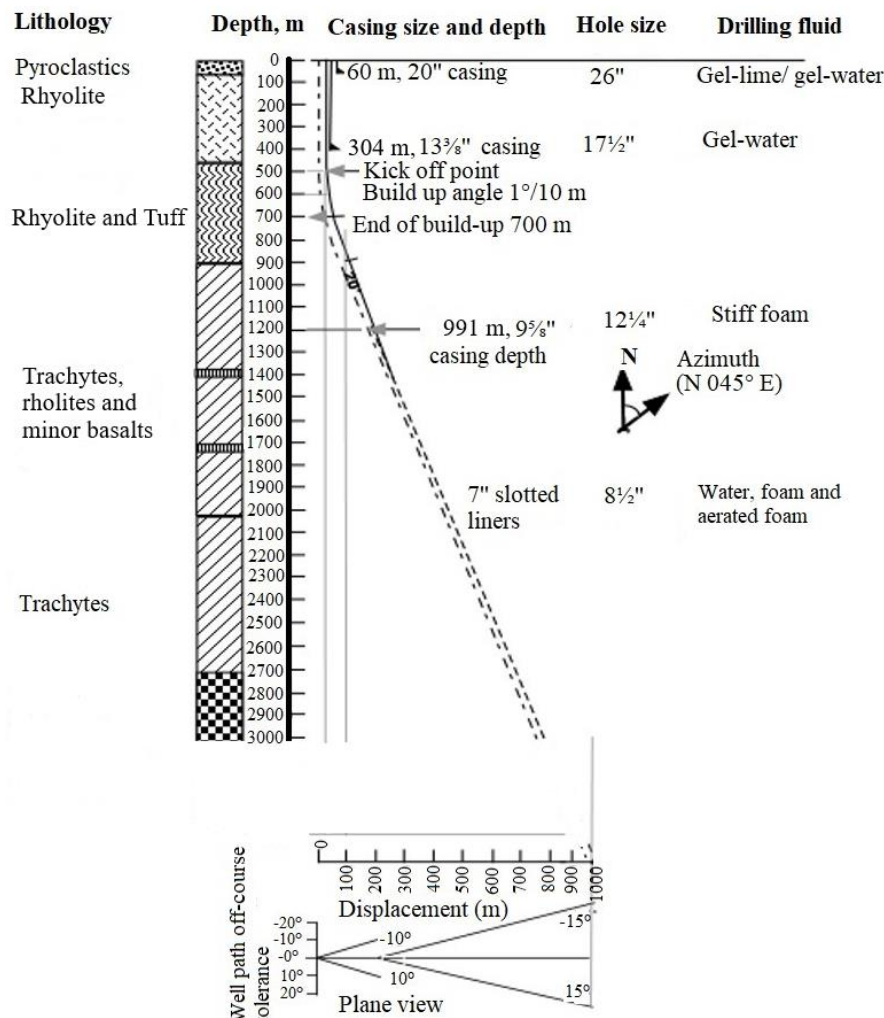
FIGURE 7: Well design for well 740A showing the lithology (KenGen, 2018)

Stratigraphy encountered during drilling was as presented below in Figure 7 (KenGen internal report, 2018)

0-50 m: Pyroclastics. loose unconsolidated cuttings mainly of tuffs, trachytes, lithic material, obsidian, volcanic glass, and pumice. Washouts and cavings are likely to be experienced in this zone.

50-200 m: Rhyolite. This zone consists of relatively fresh to slightly altered and oxidized rhyolitic lavas with minor intercalations of scoria and tuff. Formation is mainly medium-hard and generally massive although fractured. Circulation losses may occur.

600-1200m: Trachyte and interactions of rhyolite. This zone consists of trachyte with occasional rhyolite. Minor intercalations of basalts and tuffs may be intercepted. This zone is moderately hard to hard and partial losses may be experienced. Production casing may be set in this zone.

650-3000 m: Trachytes. This zone is mainly made up of trachytes with occasional interactions of thin layers of rhyolitic lava flows. The formation is expected to be medium-hard and moderately altered. Minor losses may be experienced.
