# Coiled Tubing Live Well Cleanout

Daniel Wilson<sup>1</sup>, Josh Anderson<sup>2</sup>,

<sup>1</sup> Contact Energy Ltd., Taupo, New Zealand

<sup>2</sup> Western Energy Services, Taupo, New Zealand

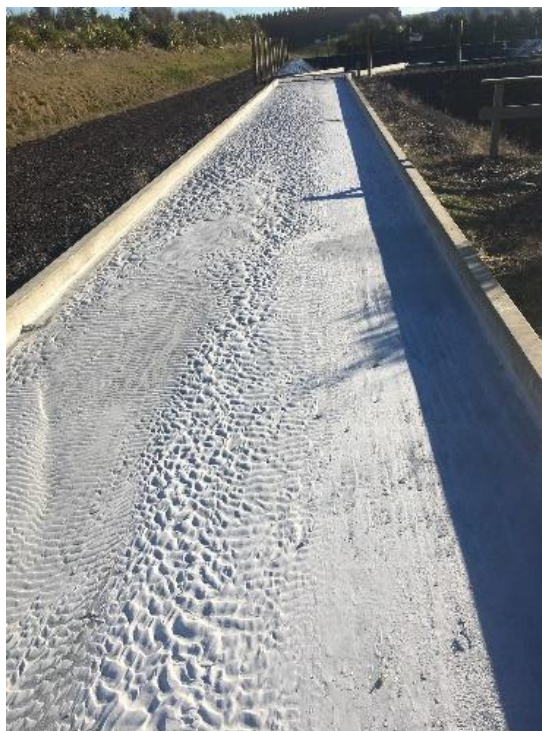
**Figure 1: Cooling channel lined with fragments of calcite scale removed from a production well with live well cleanout technology.**

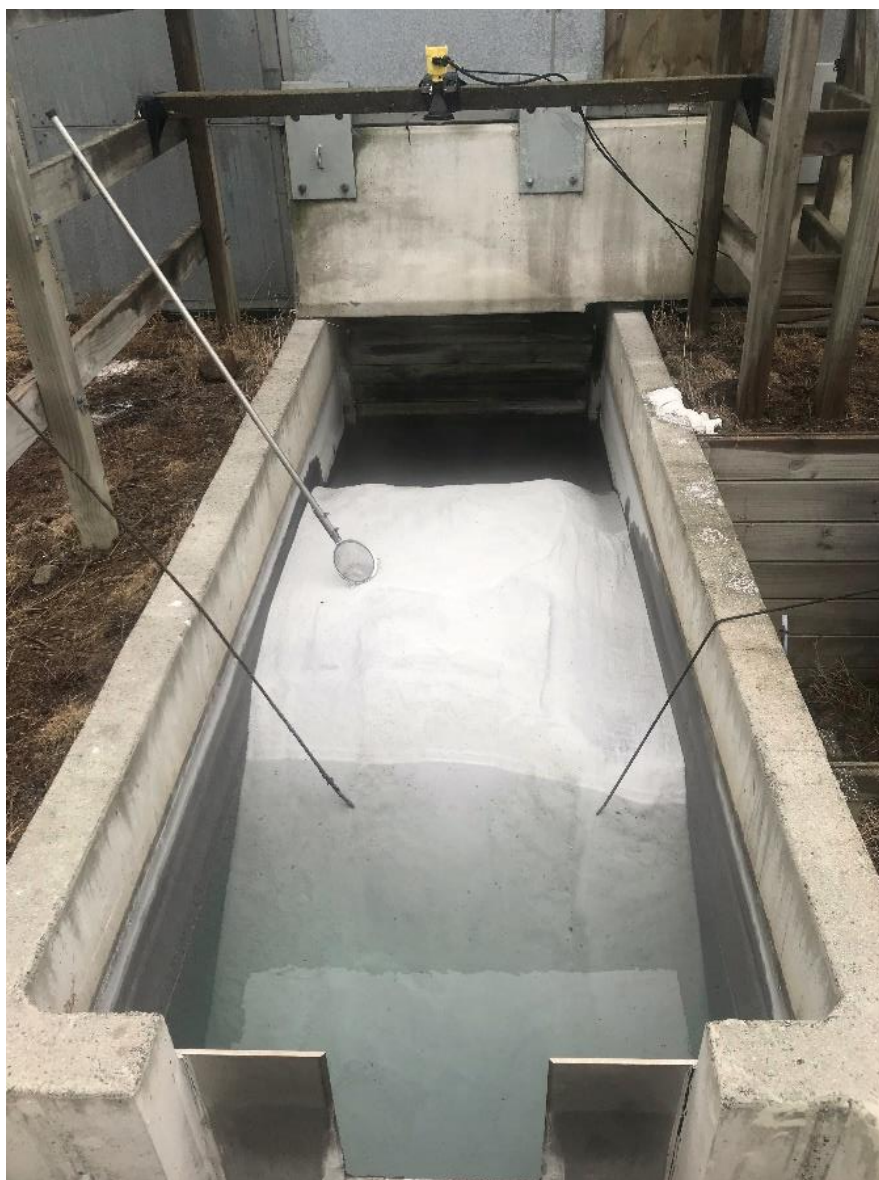
**Figure 2: Over 5m<sup>3</sup> scale removed from WK267 with the CTH, deposited in the weir box beyond the silencer.**

In contrast, the CTH utilises percussion to break scale by smashing it and overloading the tensile strength while keeping the crystal lattice together. The CTH has by far the greater rate-of-penetration (ROP) potential. However, the motor is suited for complex wells where obstructions can be present, which will affect the success rate. Currently, there is the capability to use both methods (CTH and motor) to clean out to 14.5" diameter and to depths of 3000m. With the surface handling facilities at CEL the effectiveness of live well cleanouts is easily apparent. Full weir boxes, as shown in Figure 2 are a common occurrence.

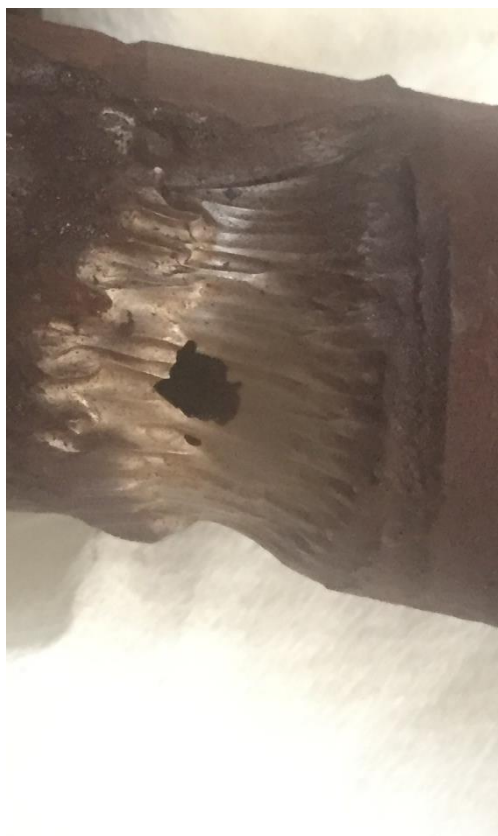
**Figure 3: Severe internal erosion**

After two successful well cleanouts (one Wairakei production well WK123a and another Ohaaki reinjection well BR40, which was cleaned out in less than half a day), we thought we were set and ready to take on the world. The next well brought us crashing back to earth. Ohaaki production well BR48 was the site where nothing would work. At BR48 severe internal corrosion in the string was encountered, which induced severe erosion on the inside of the tools. It took over a month to remove rust and fully treat and prevent more problems from occurring in the coil. This was a lesson in effective coil management and erosion-corrosion mitigation and humility. Figure 3 shows severe erosion on internal tools.

- In 2016 a CTH run was attempted, and severe internal erosion was suffered. A motor had to be brought in for a quenched cleanout on the coil. This job took 3 days, milling 2 m of hard scale in 40 minutes. Production recovery was 90% at the cost of 25% of the rig AFE. While the well was out-of-service for 2 weeks, this mostly comprised time for re-heating the well.
