Coiled Tubing Live Well Cleanout

Daniel Wilson¹, Josh Anderson²,

¹ Contact Energy Ltd., Taupo, New Zealand

² Western Energy Services, Taupo, New Zealand

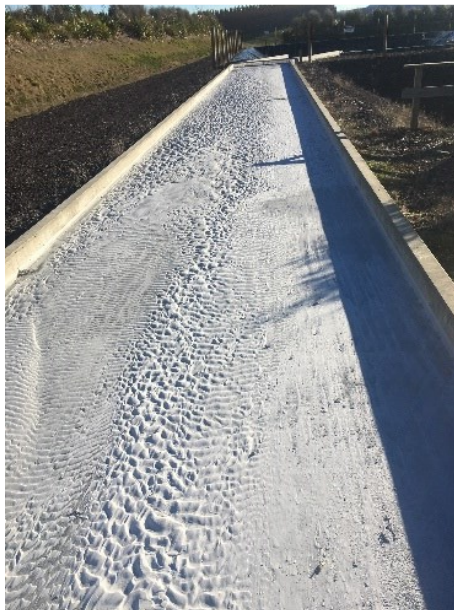
Figure 1: Cooling channel lined with fragments of calcite scale removed from a production well with live well cleanout technology.

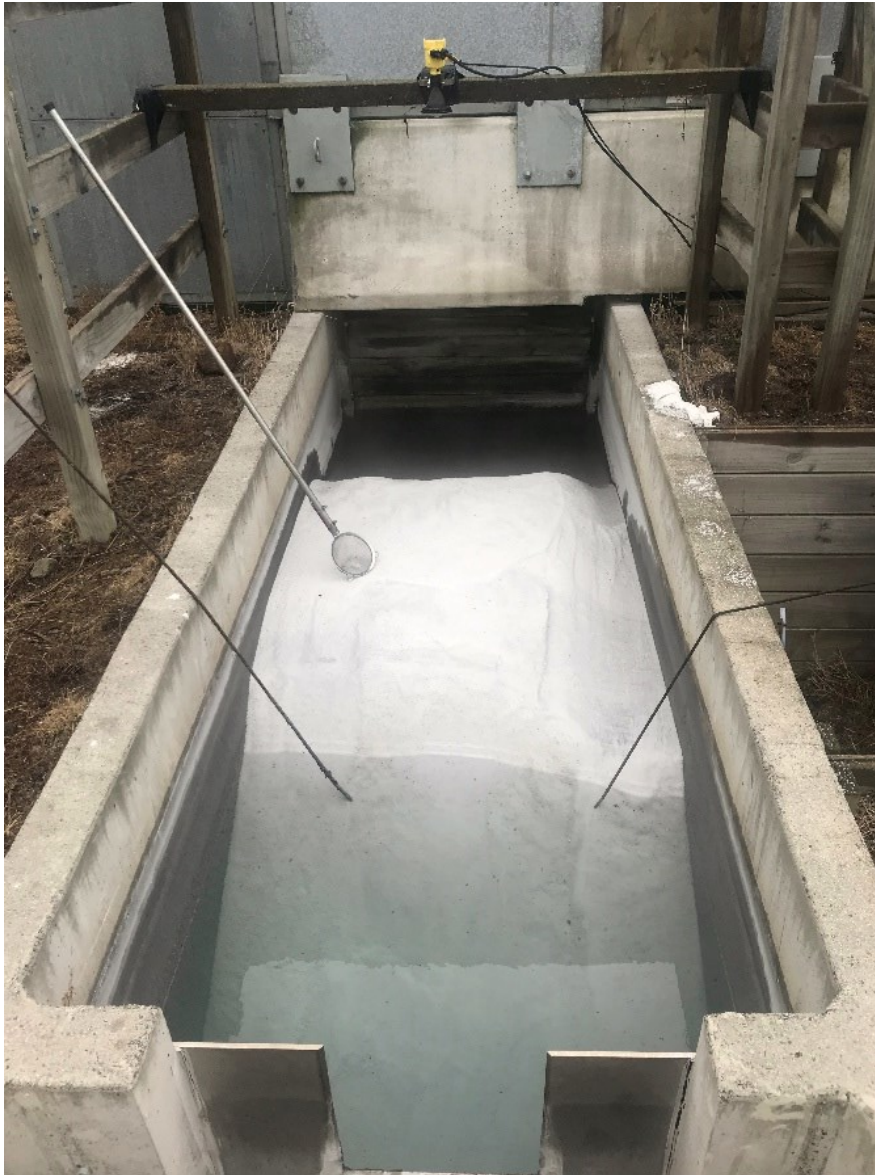
Figure 2: Over 5m³ scale removed from WK267 with the CTH, deposited in the weir box beyond the silencer.

In contrast, the CTH utilises percussion to break scale by smashing it and overloading the tensile strength, while keeping the crystal lattice together. The CTH has by far the greater rate-of-penetration (ROP) potential, however the motor is suited for difficult wells where obstructions can be present, which will affect the success rate. Currently there is capability to use both methods (CTH and motor) to clean out to 14.5" diameter and to depths of 3000m. With the surface handling facilities at CEL the effectiveness of live well cleanouts is easily apparent. Full weir boxes as shown in Figure 2 are a common occurrence.

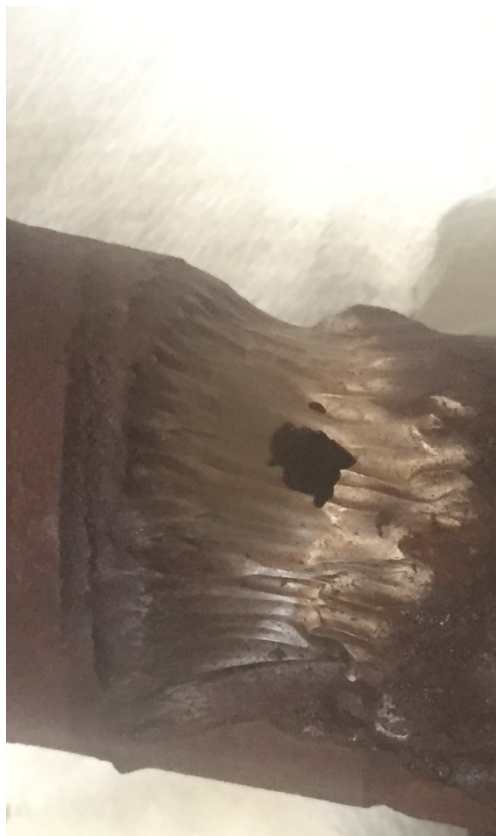
Figure 3: Severe internal erosion

After two successful well cleanouts (one Wairakei production well WK123a and another Ohaaki reinjection well BR40 which was cleaned out in less than half a day), we thought we were set and ready to take on the world. The next well brought us crashing back to earth. Ohaaki production well BR48 was the site where nothing would work. At BR48 severe internal corrosion in the string was encountered, which induced severe erosion on the inside of the tools. It took over a month to remove rust and fully treat and prevent more problems from occurring in the coil. This was a lesson in effective coil management and erosion- corrosion mitigation, and humility. Figure 3 shows severe erosion on internal tools.

- In 2016 a CTH run was attempted and severe internal erosion was suffered. A motor had to be brought in for a quenched cleanout on coil. This job took 3 days, milling 2 m of hard scale in 40 minutes. Production recovery was 90% at a cost of 25% of the rig AFE. While the well was out-of-service for 2 weeks, this mostly comprised time for re-heating the well.
